UNITARIAN MEMORIAL CHURCH CONDITIONS ASSESSMENT

Unitarian Memorial Church | Fairhaven, Mass. | February 13, 2019

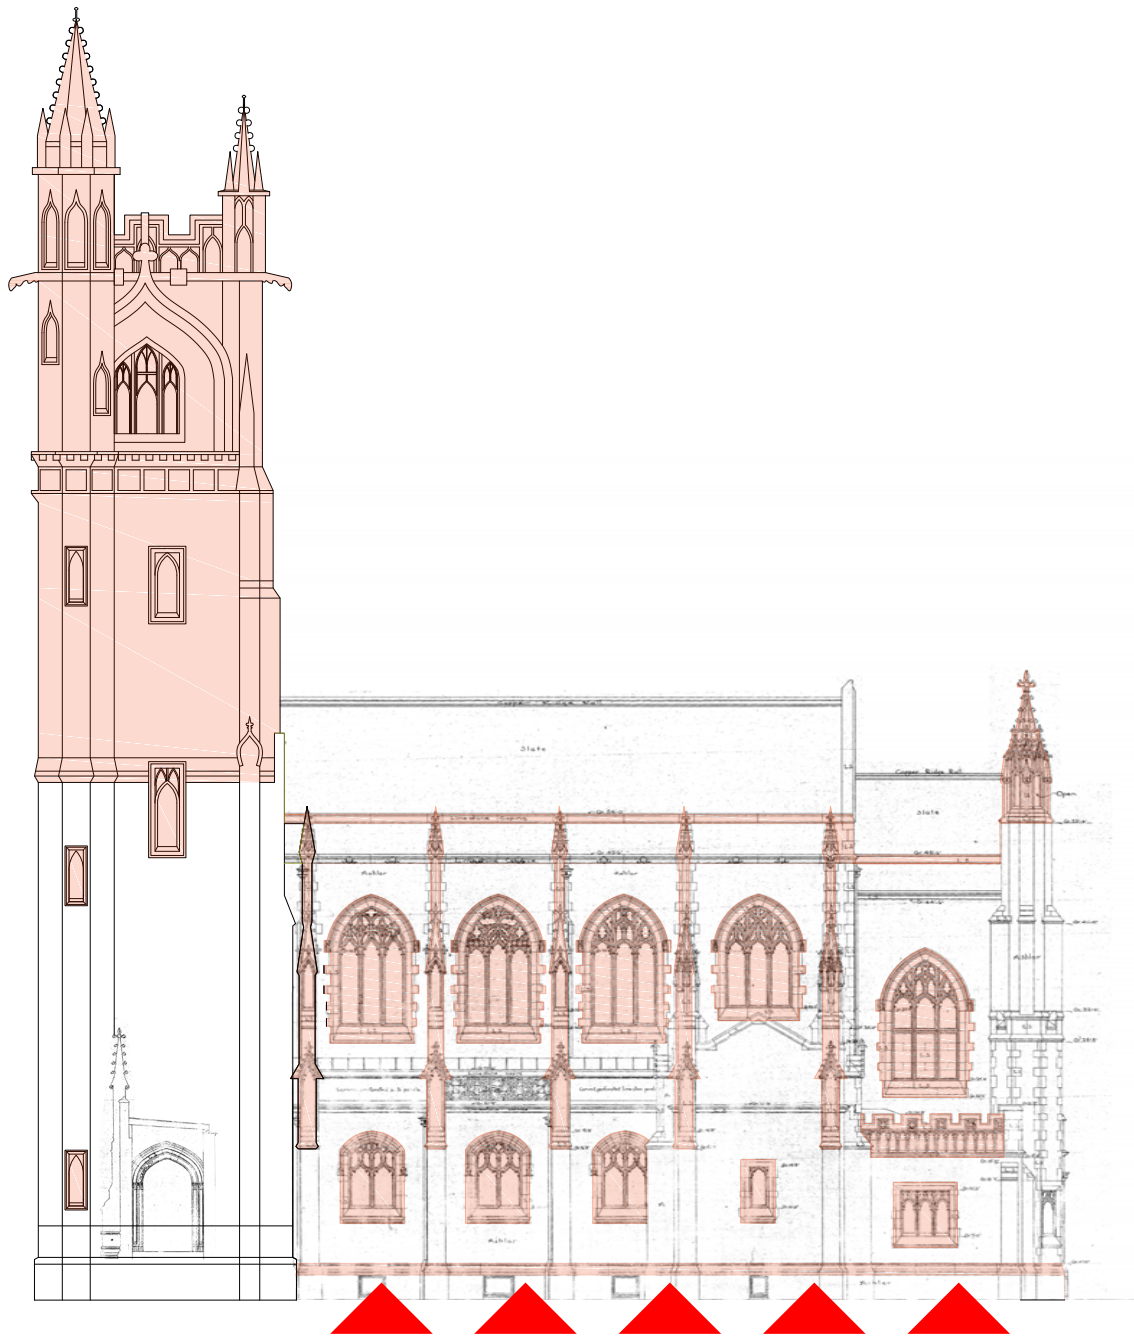
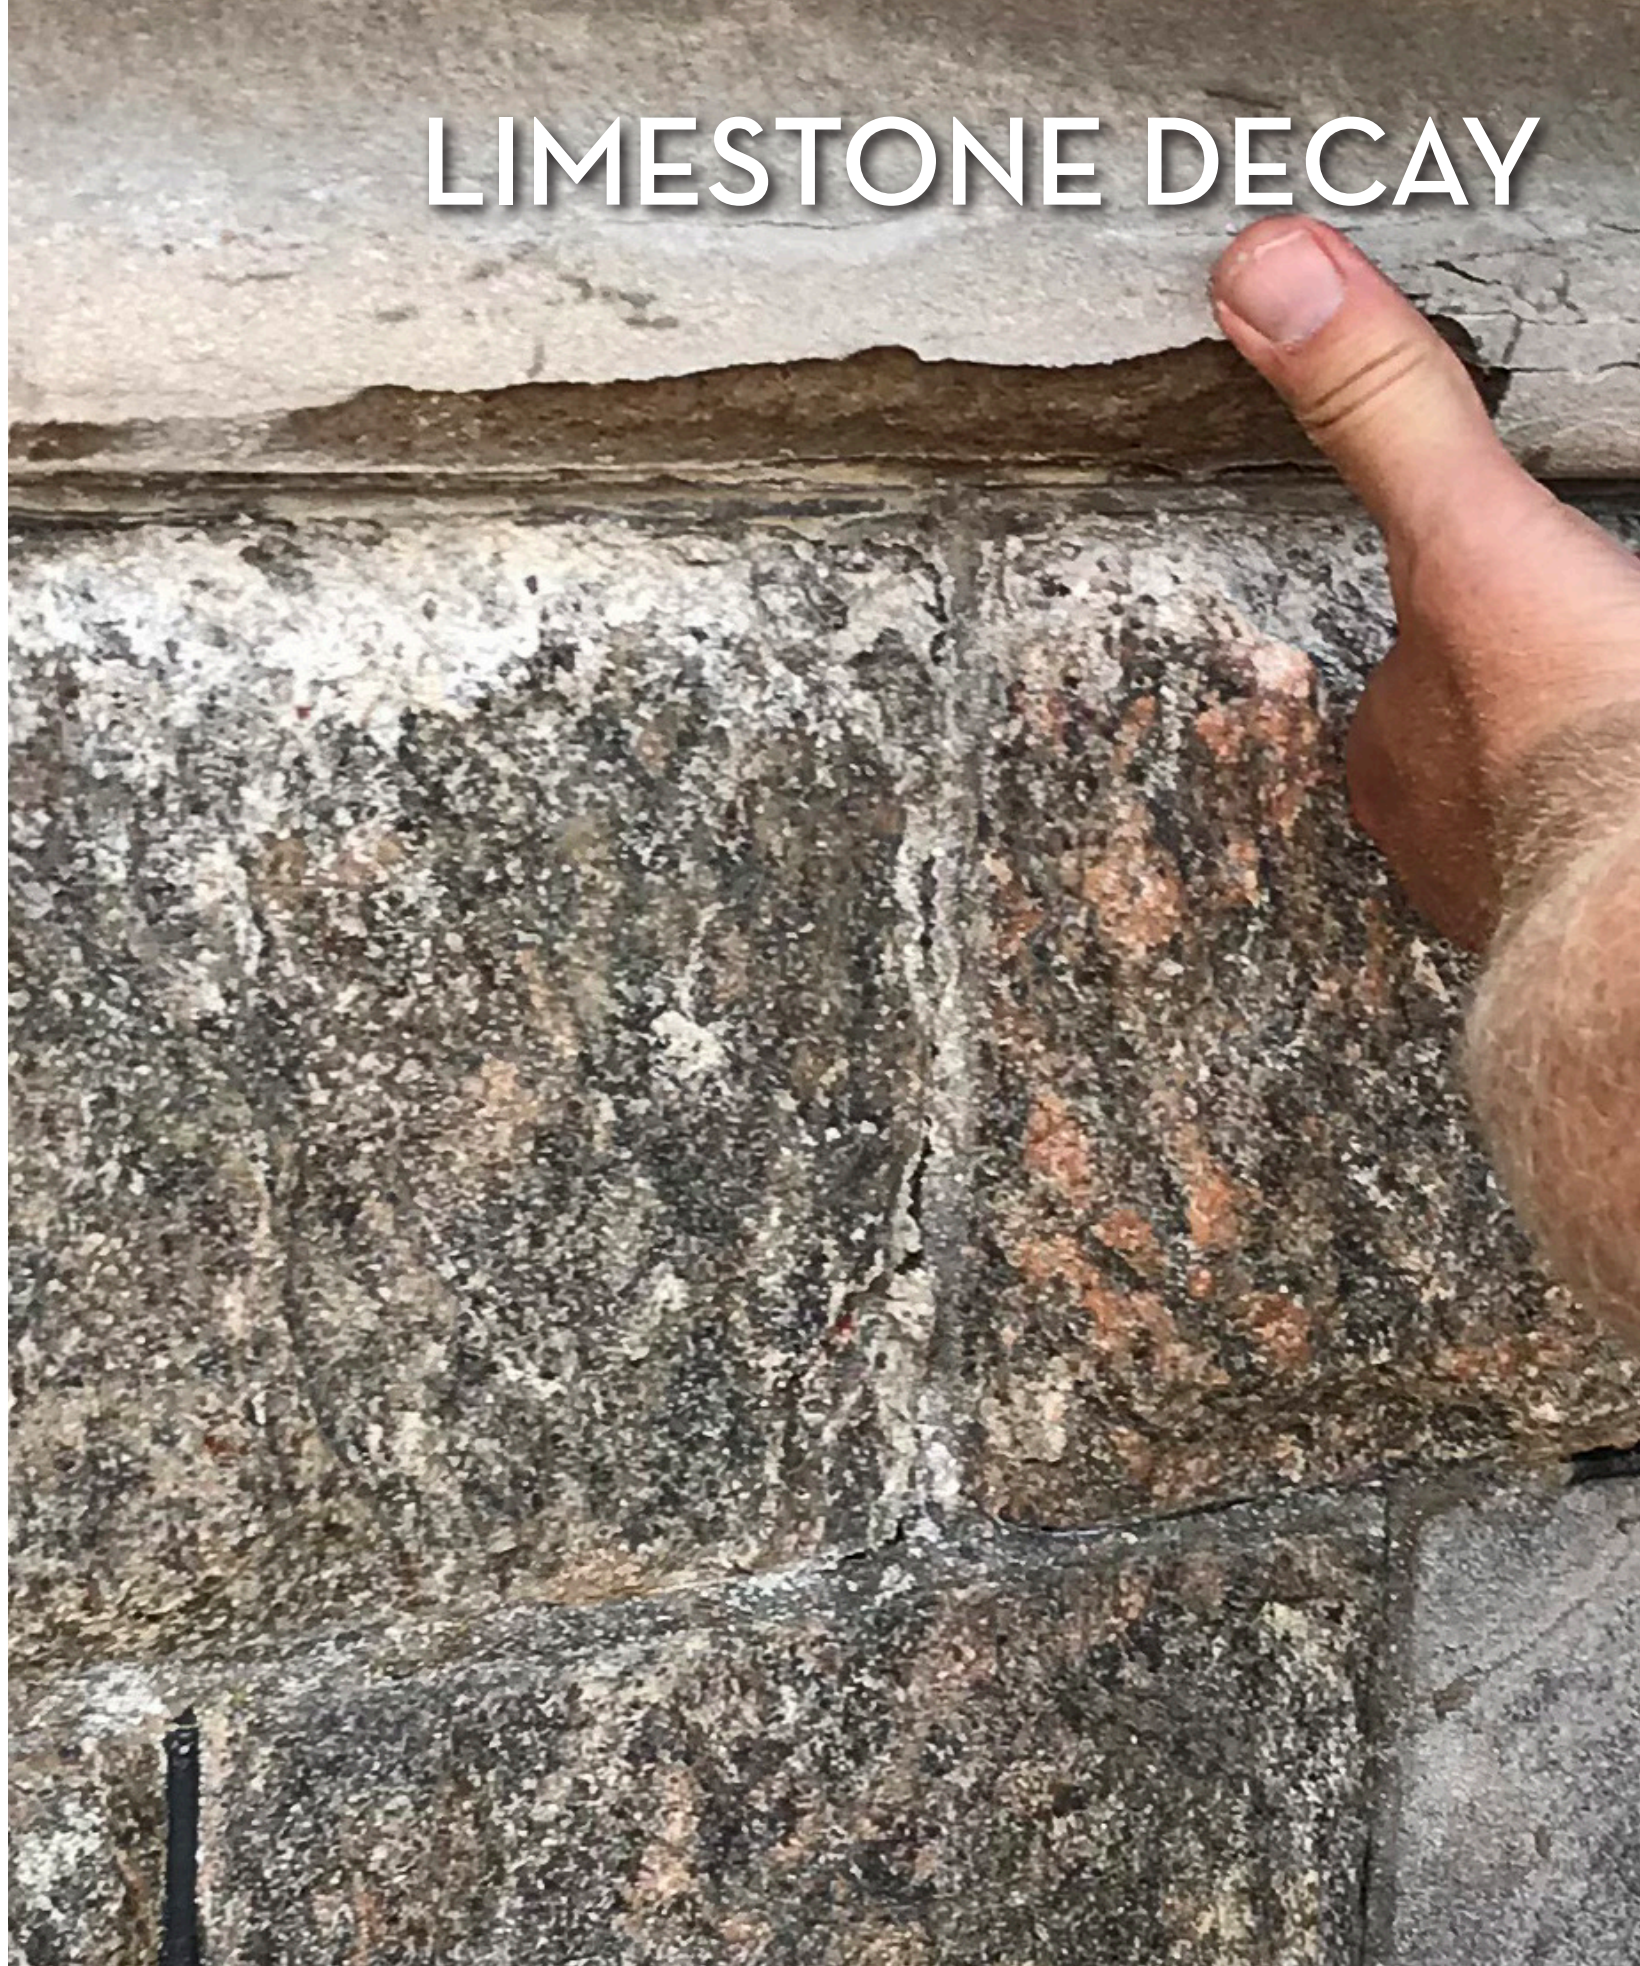
NORTH ELEVATION - primary

LIMESTONE DECAY

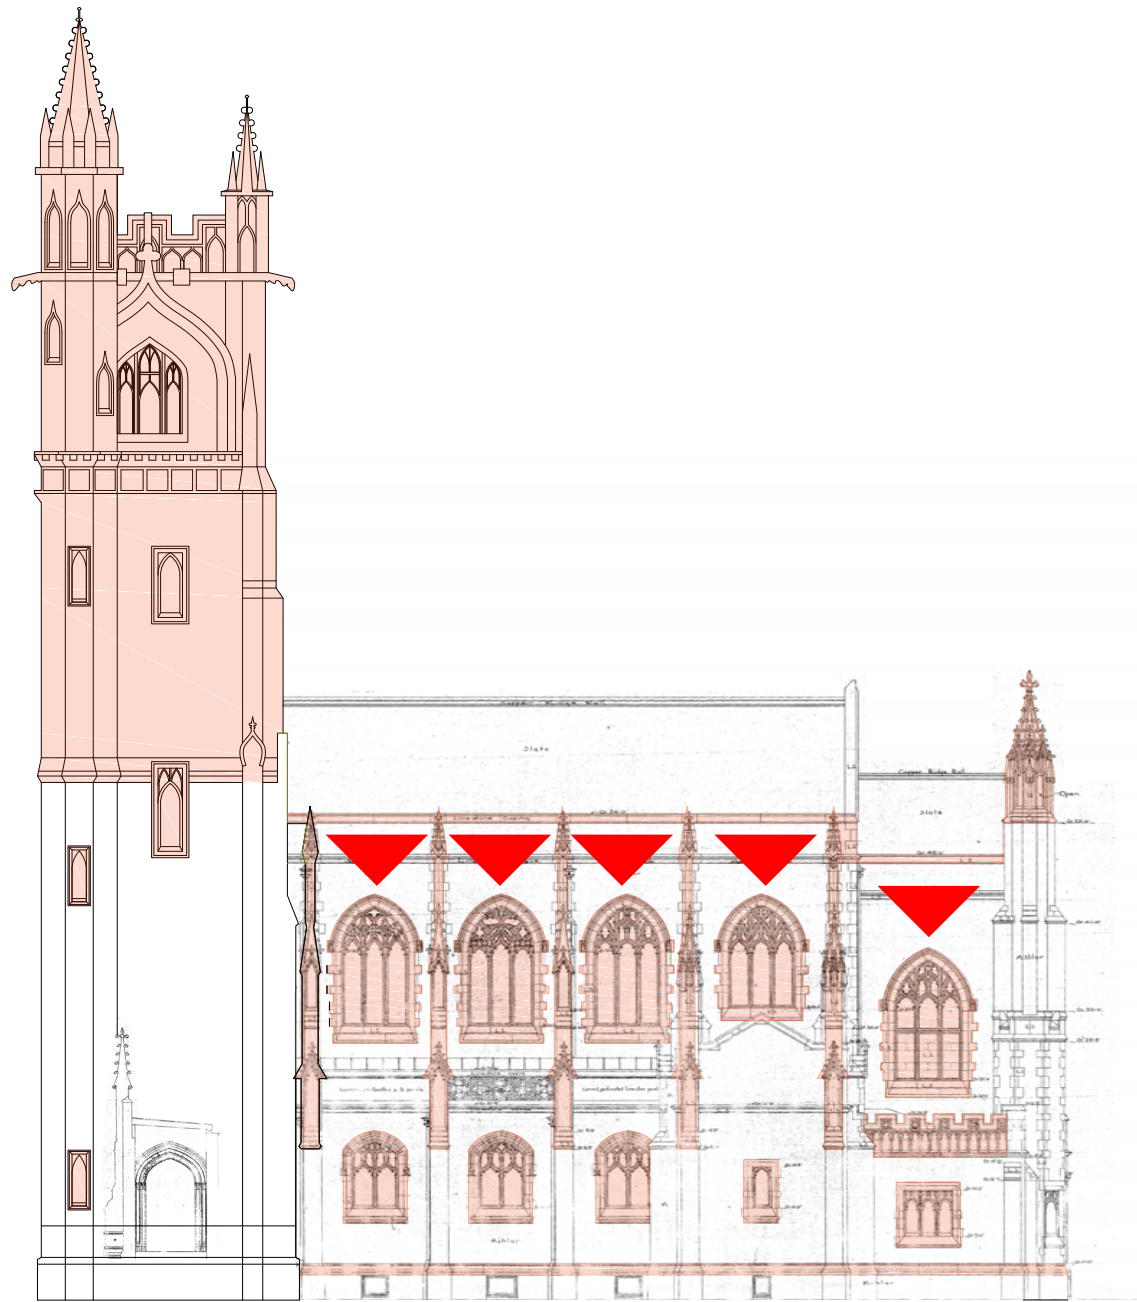
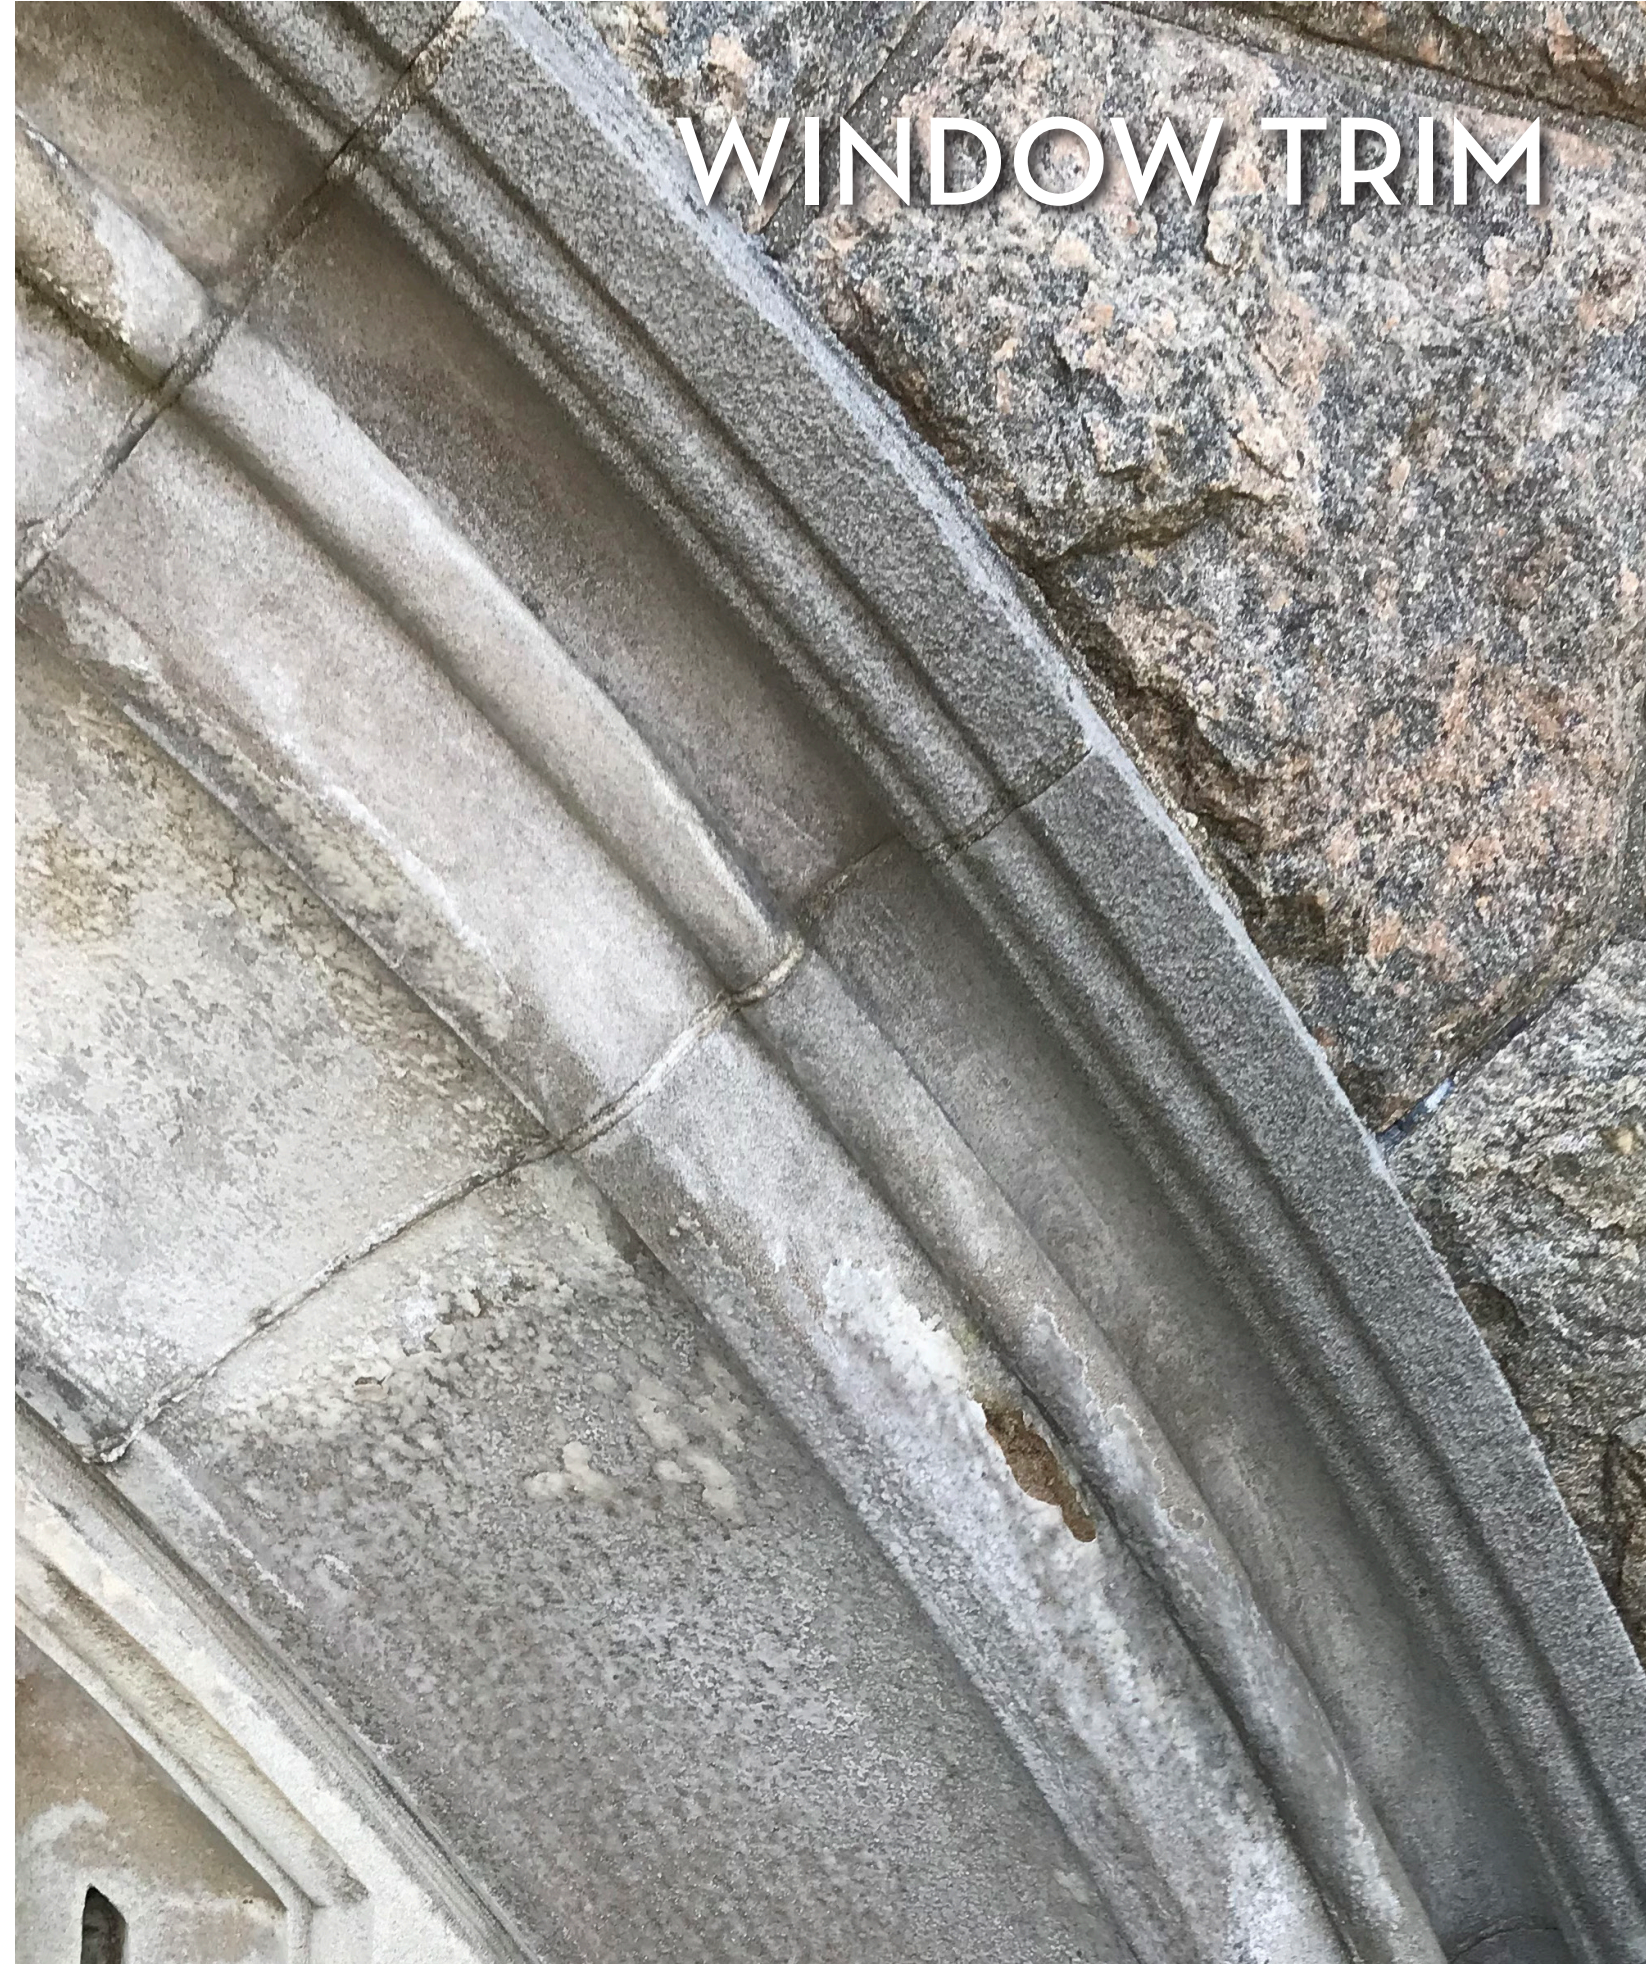
NORTH ELEVATION - primary

WINDOW TRIM

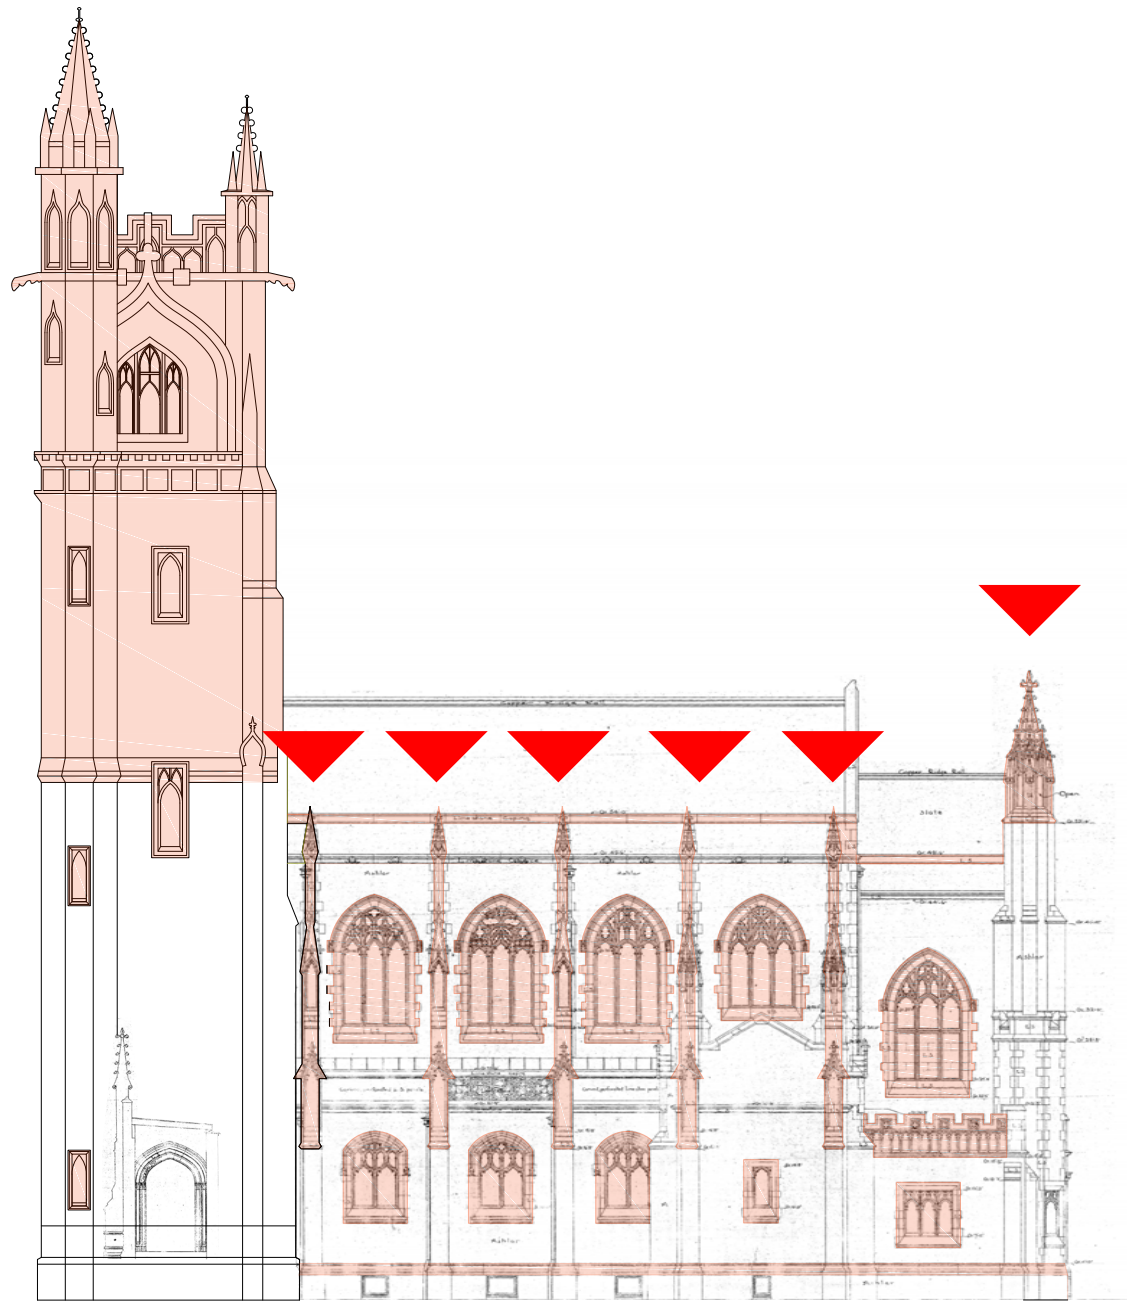
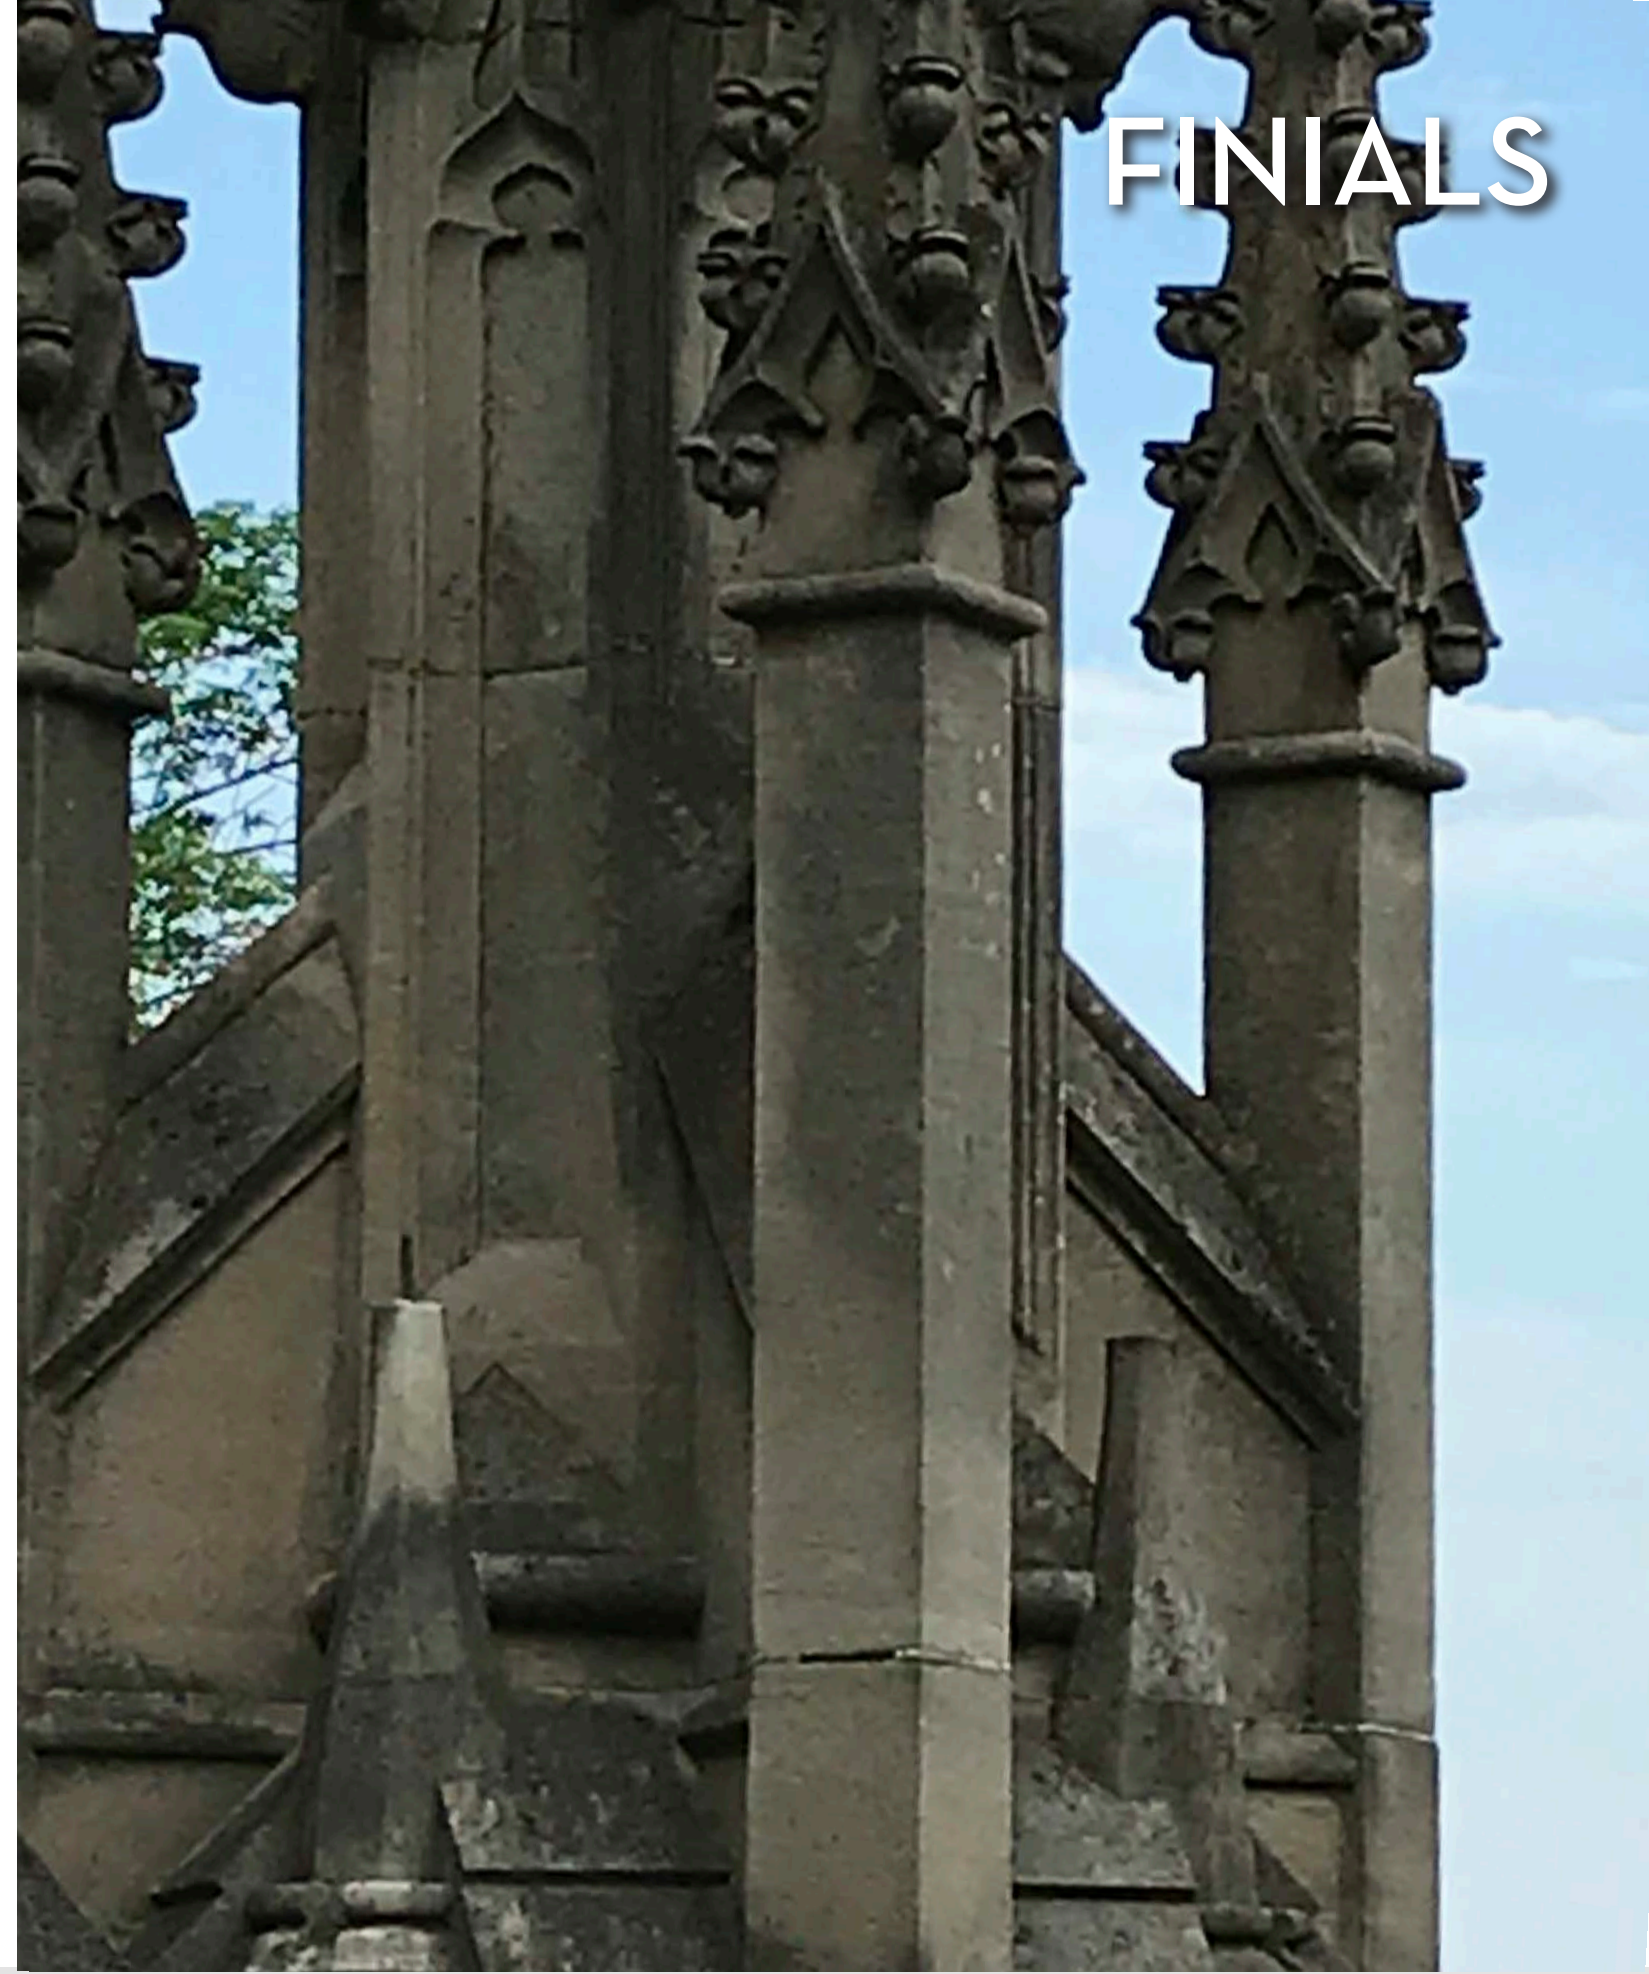
NORTH ELEVATION - primary

FINIALS

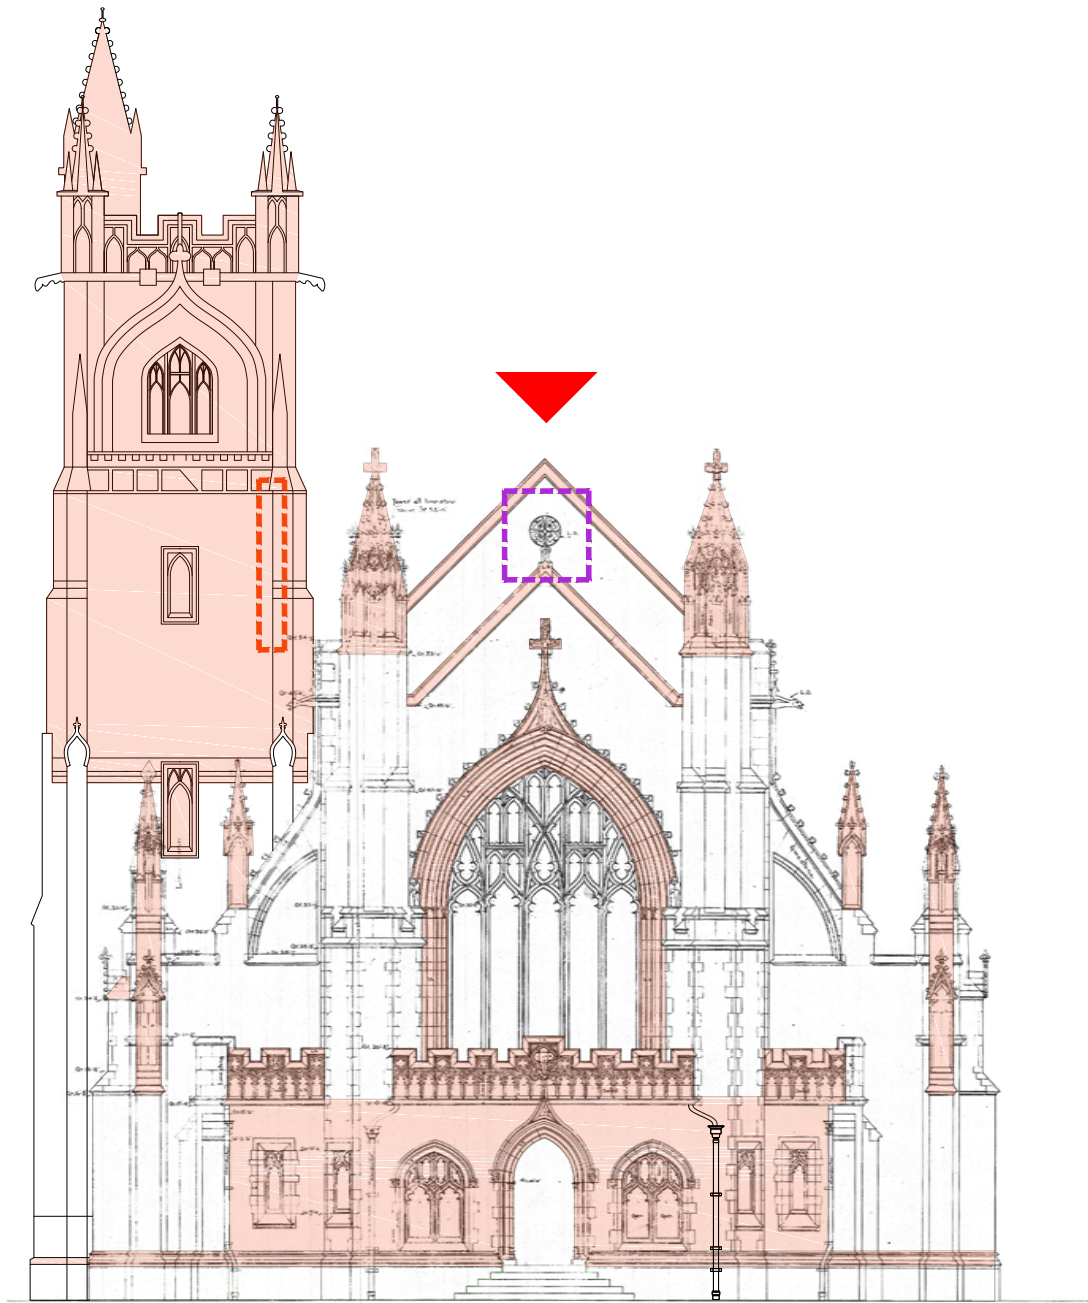
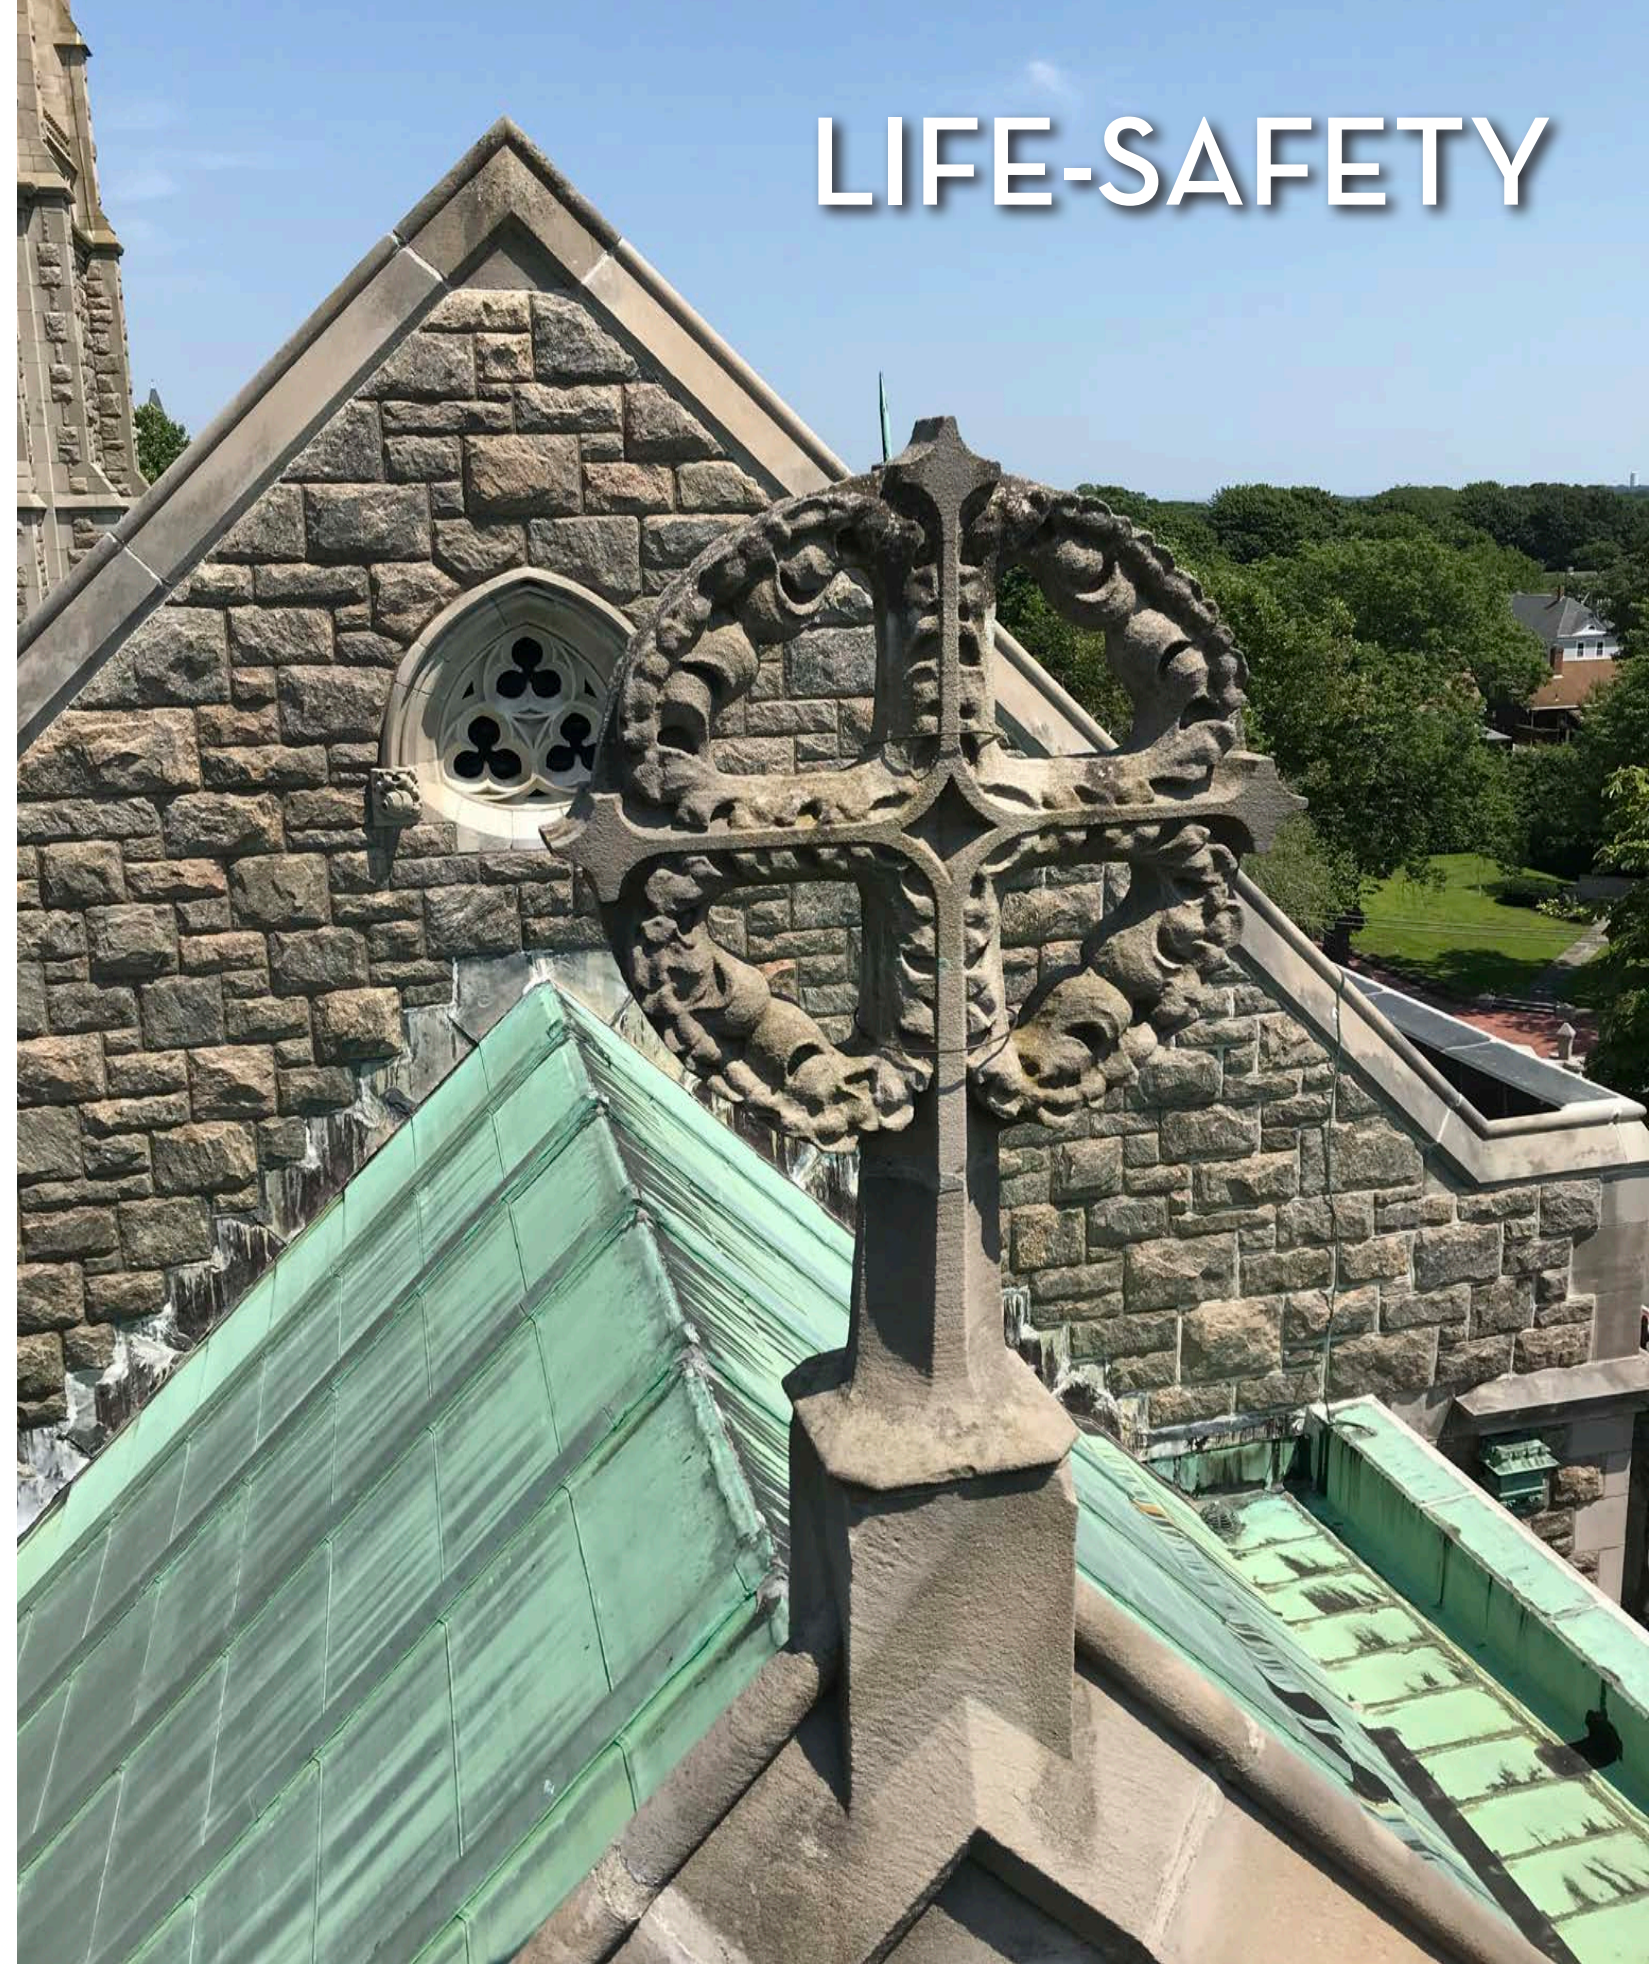
WEST ELEVATION - primary

LIFE-SAFETY

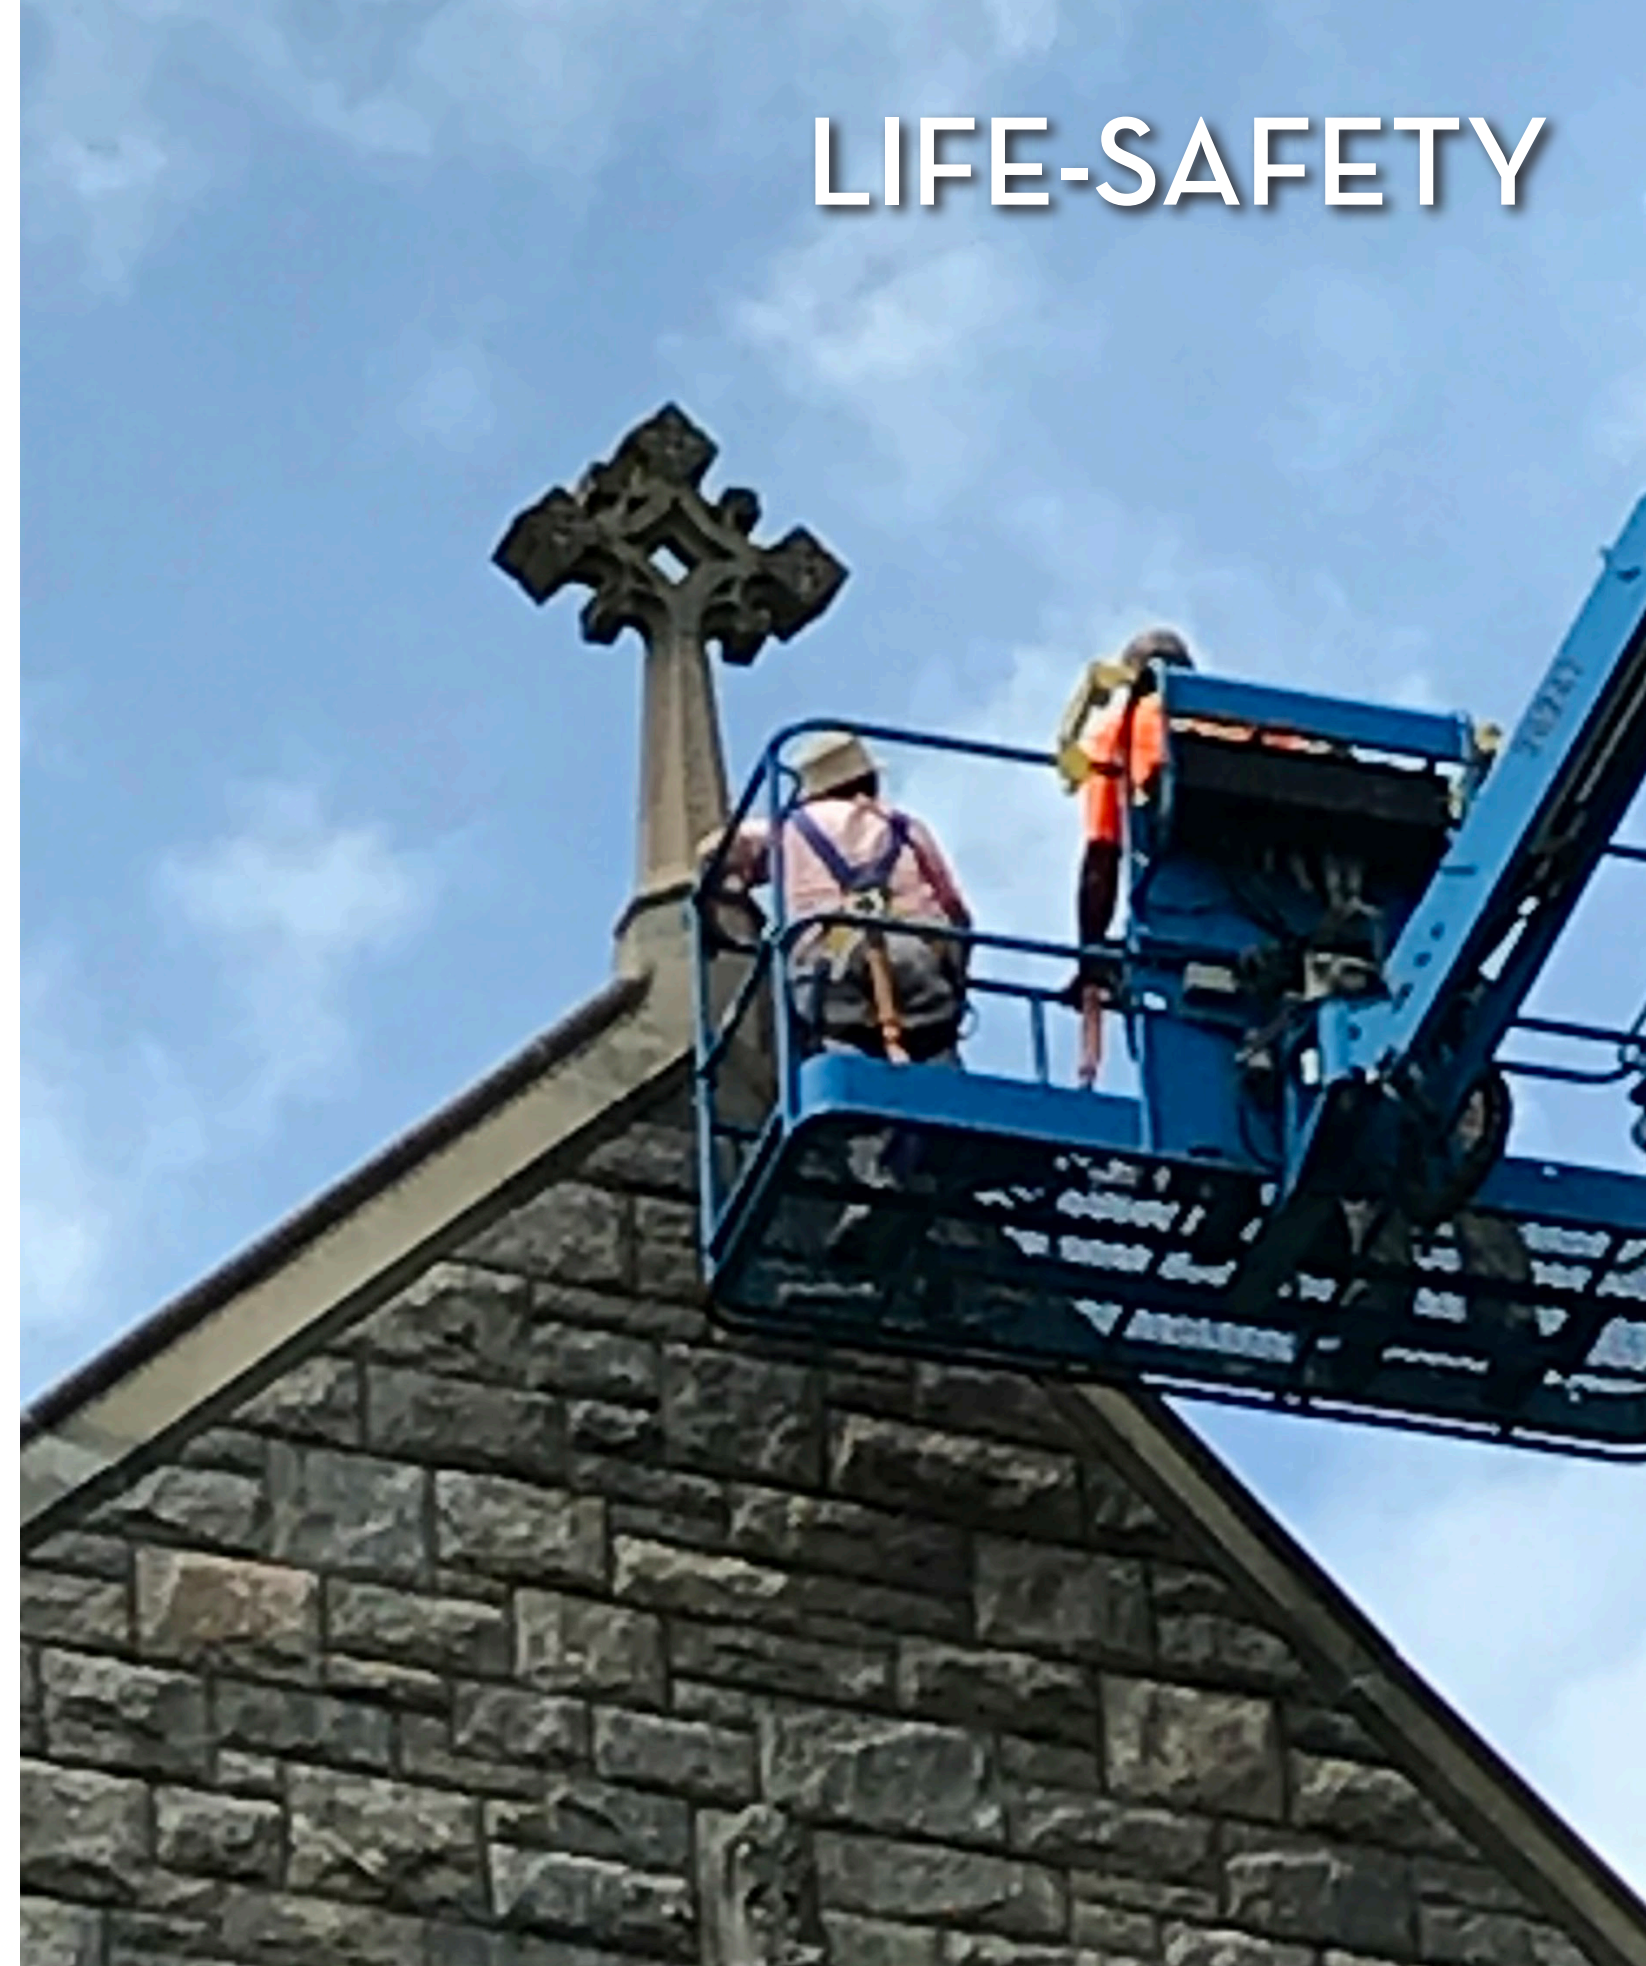
EAST ELEVATION - primary

LIFE-SAFETY
