UNITARIAN MEMORIAL CHURCH CONDITIONS ASSESSMENT

Unitarian Memorial Church | Fairhaven, Mass. | February 13, 2019

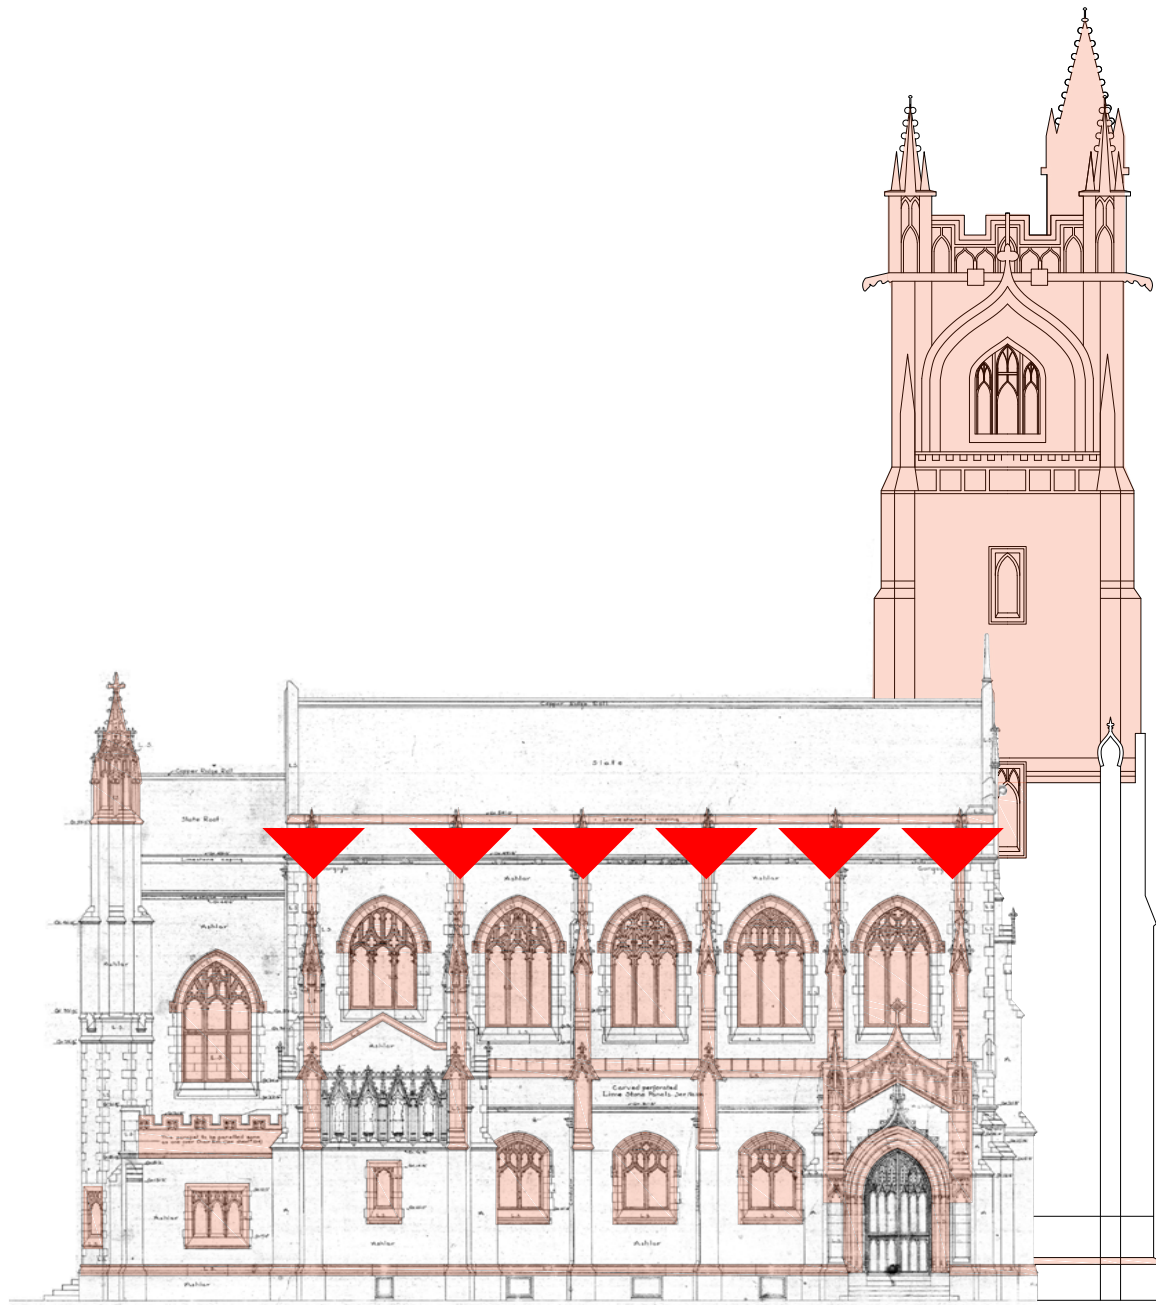
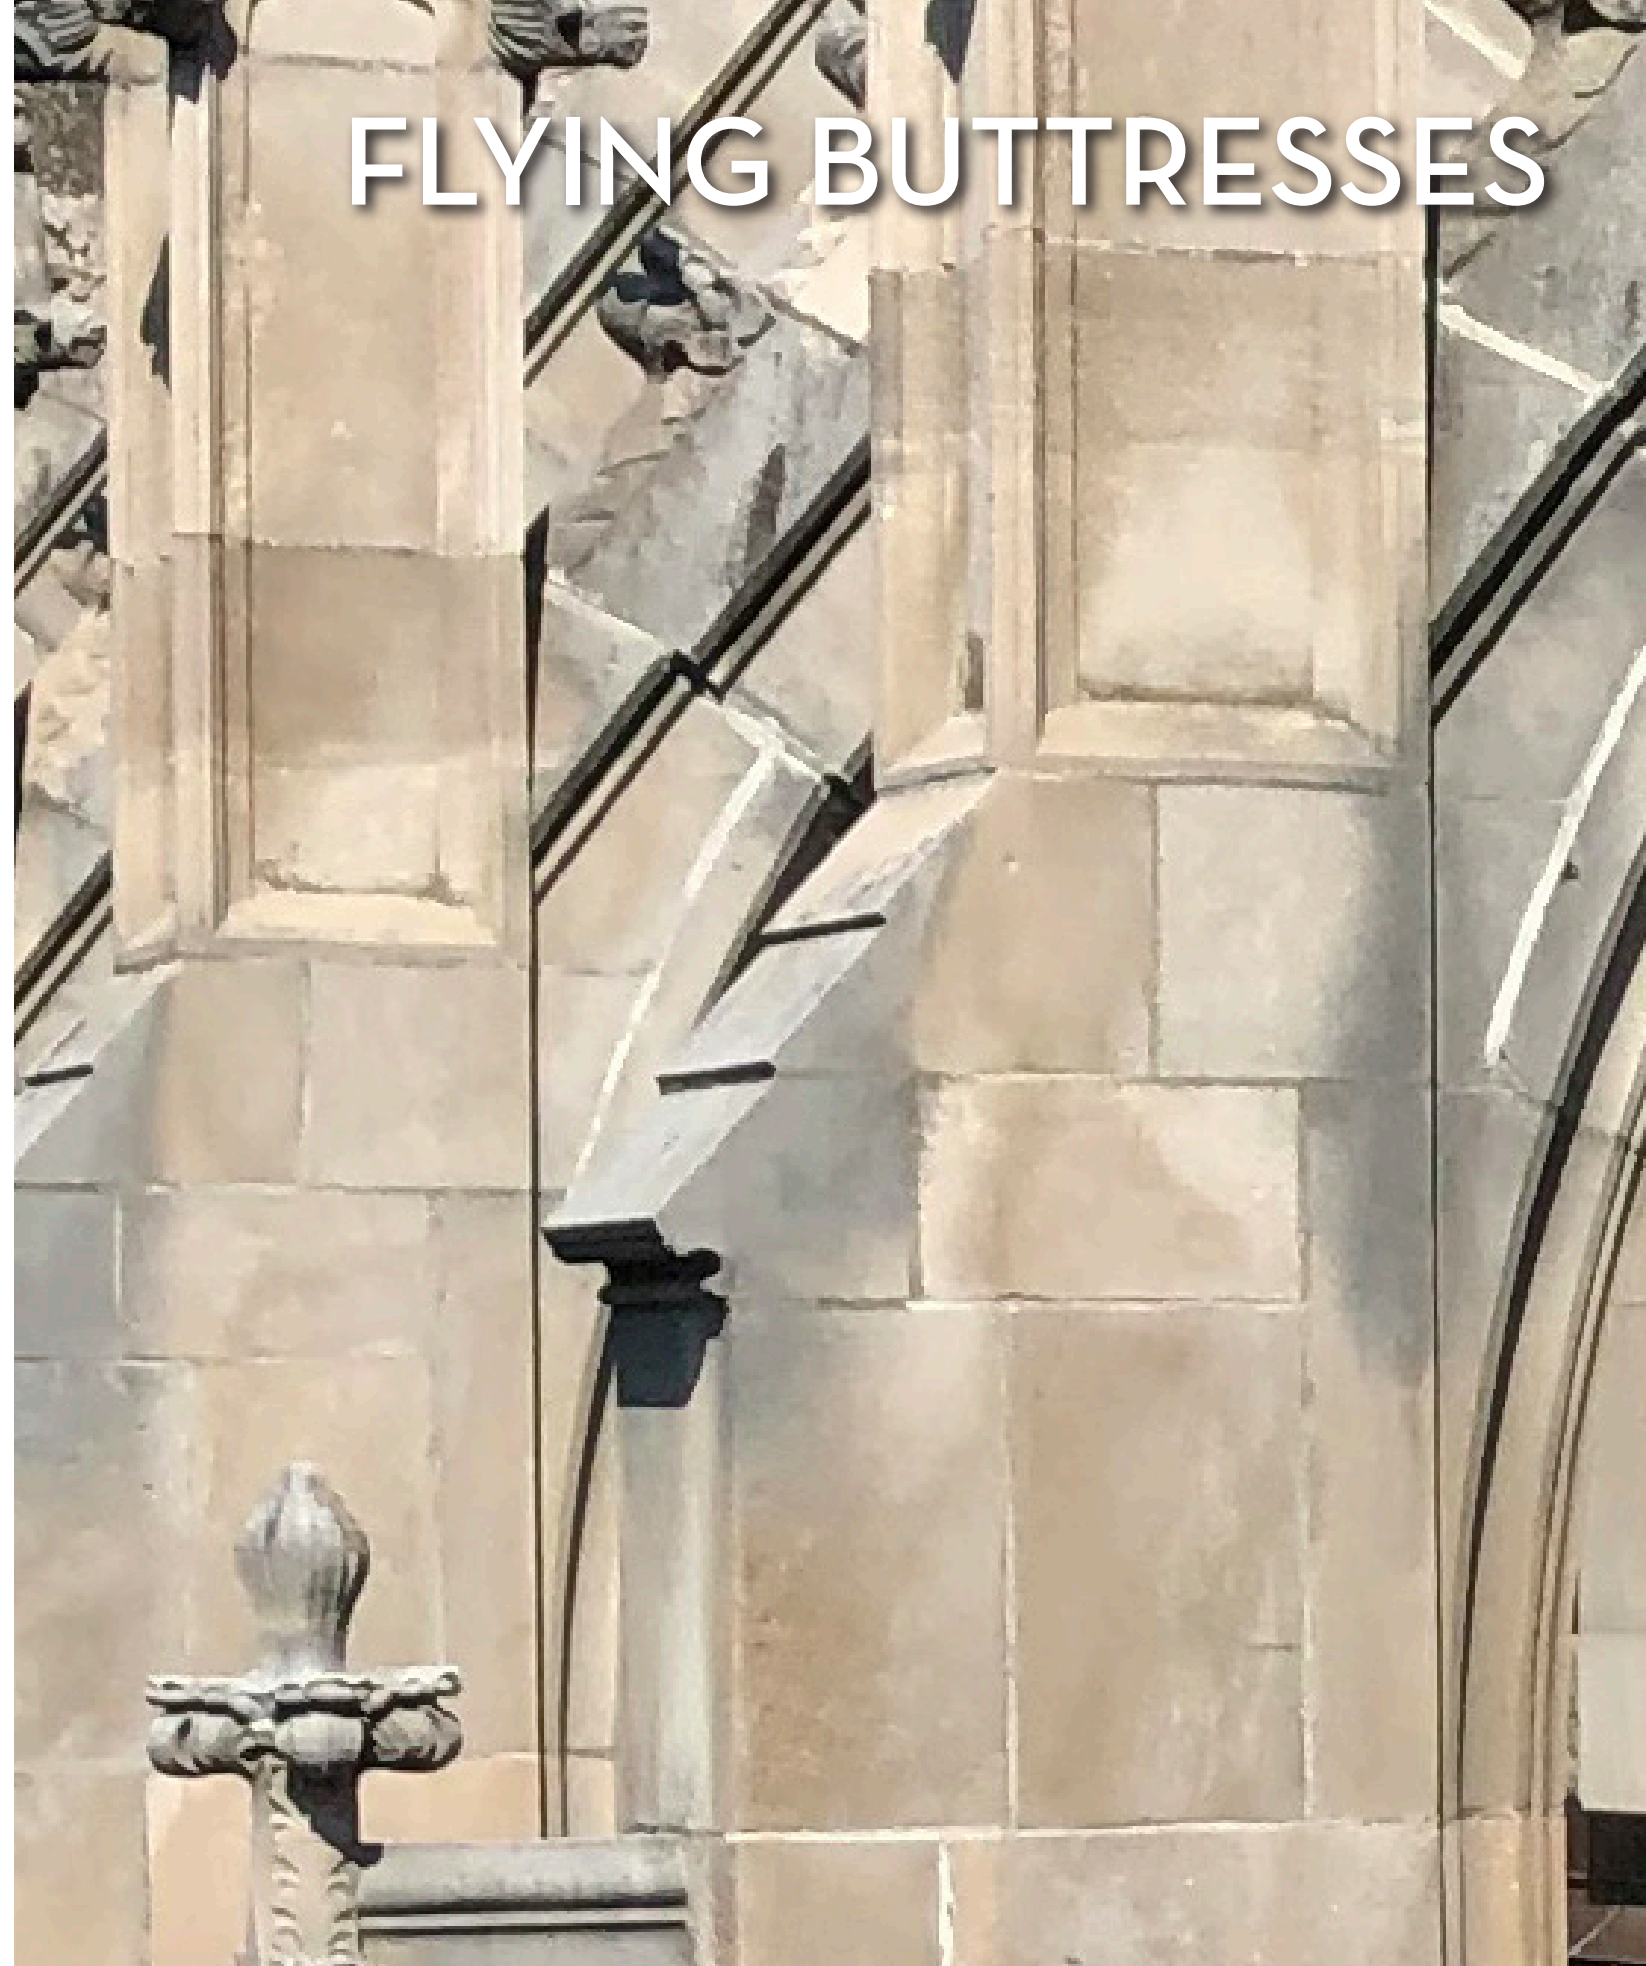
SOUTH ELEVATION - primary

FLYING BUTTRESSES
