Conditions Assessments and Treatment Recommendations for  
UNITARIAN MEMORIAL CHURCH

FAIRHAVEN, MASSACHUSETTS  
19 DECEMBER 2019

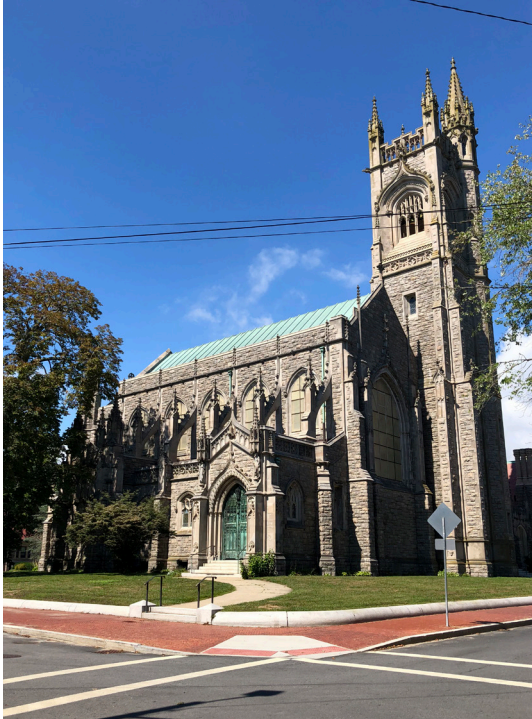
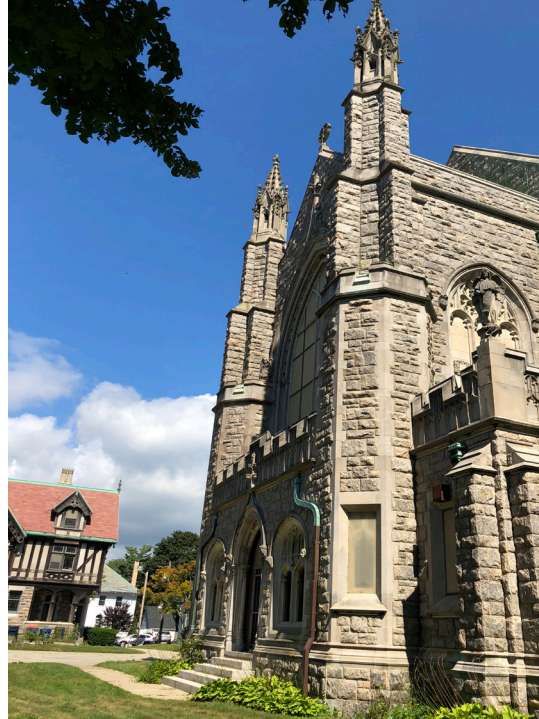
From any direction this is an extraordinary edifice: clad in locally quarried granite, trimmed in limestone, featuring truly unique stained windows and bronze doors. Yet the problems of preserving and maintaining such a complex structure pose a number of challenges.

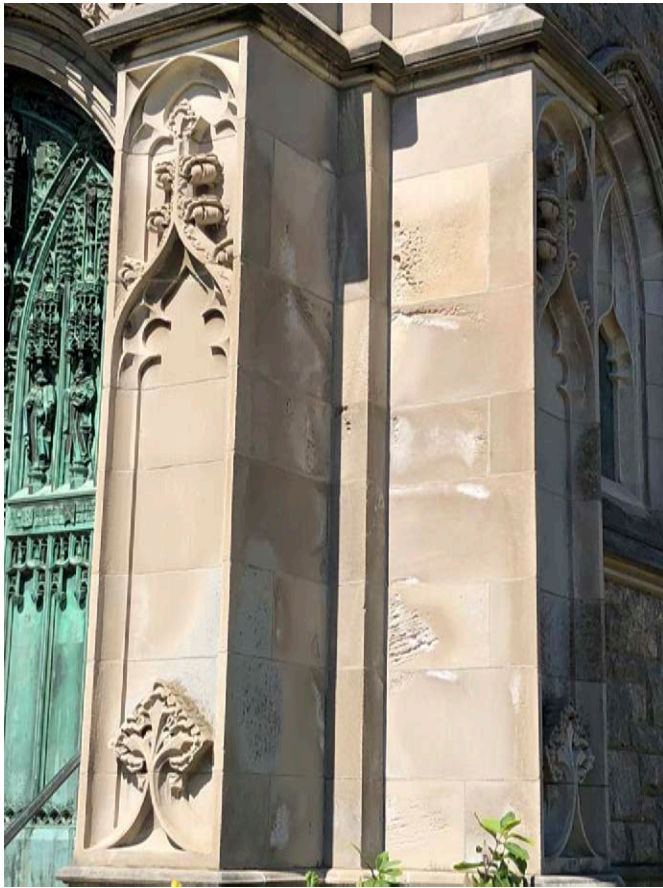
Erosion and staining of the limestone at the narthex entry may be an indication of water shedding exacerbated by the inherent qualities of the stone itself. In other situations, the moisture rich atmosphere of this seaside community fosters organic growth. And while many of the mortar joints in the ashlar granite walls appear intact, there are telltale signs of deterioration. An abiding concern is construction technology employed in the building of the church, which involves ferrous metal ties linking exterior granite veneer to the inner limestone veneer through the infill masonry.

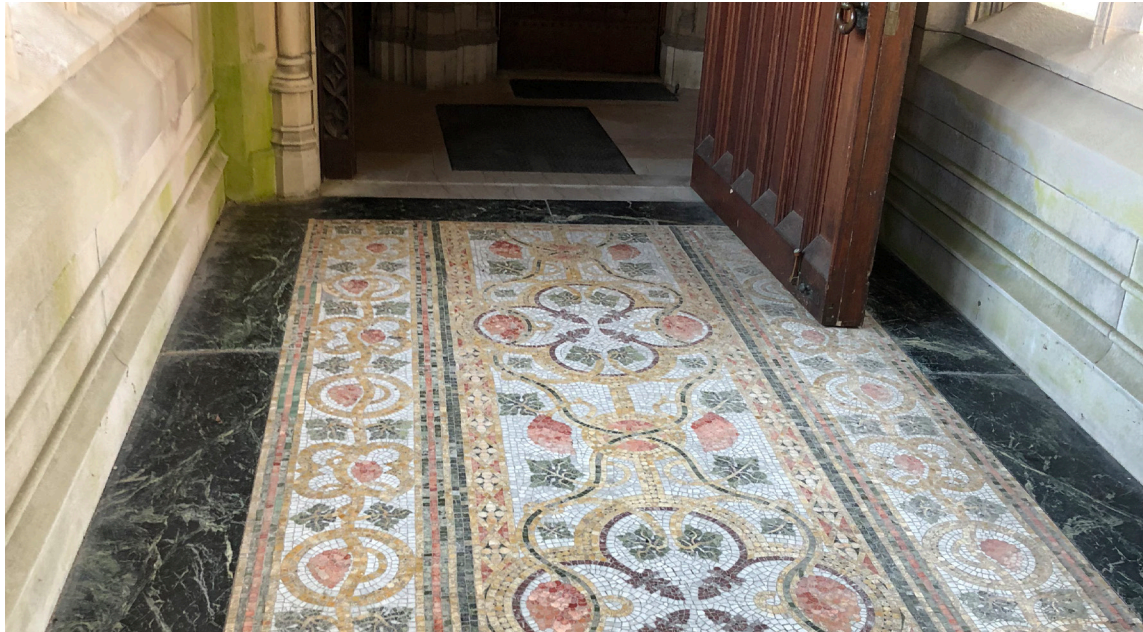
Linking the sanctuary to the Parish House is the cloister with its magnificent mosaic floor. Concerns about the slow rise of this floor may be related to steel or iron beams used in the original construction. The analytic skills of both structural engineer John Wathne and masonry consultant Ivan Myjer were called upon to determine what is at issue. Appropriately, Ivan has expertise in mosaic design and fabrication. With the analysis come treatment recommendations to arrest deterioration and preserve the entire architectural ensemble.

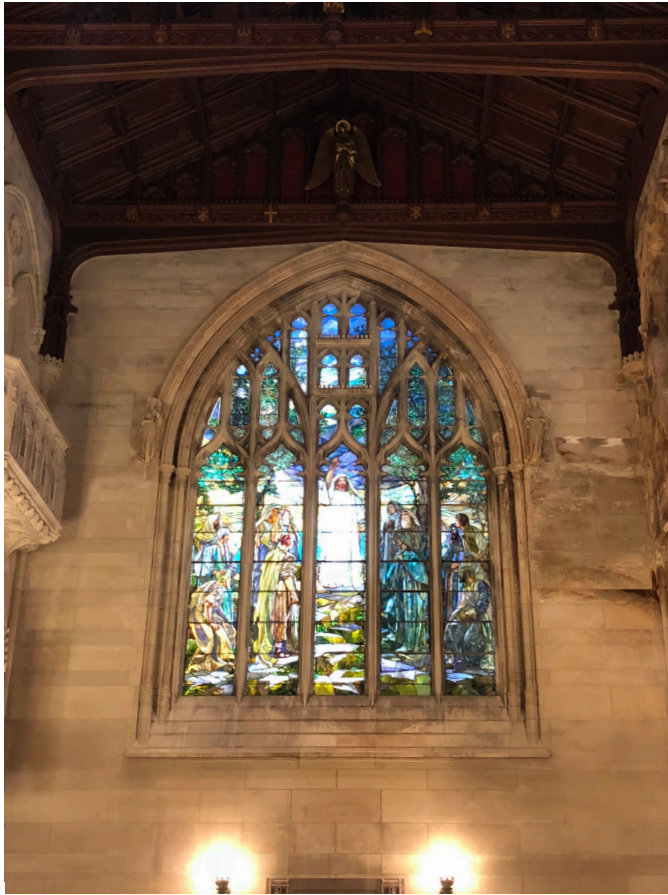
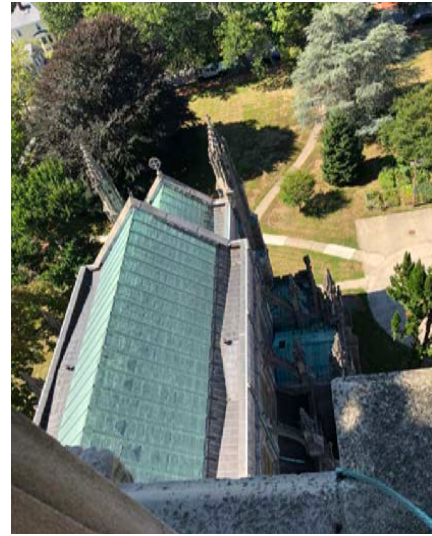
Perhaps the most glaring problems originate with roof and gutter issues. Staining on the interior limestone was observed as far back as the 1920s. Continued problems are writ large on the walls, obscuring the beauty and grace of this place. Even more troubling is spalling, where a section of stone literally pops off as a result of water penetration and rusting ferrous ties.

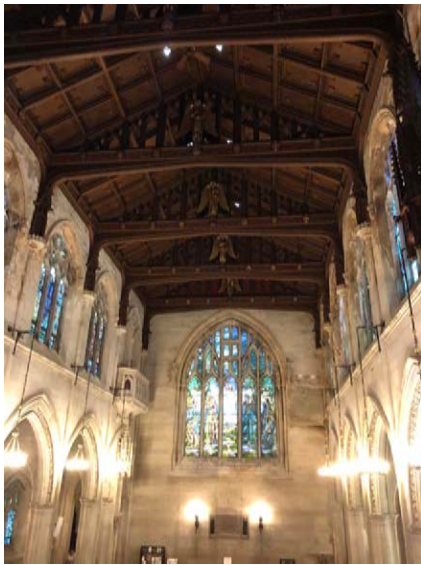
The beauty of the Sanctuary is both its intricate design and craftsmanship and the quiet grace it embodies. The Baptistry with its carved oak baptismal font, molded plaster, radial fan-vaulted ceiling, and marble flooring is a complex ensemble. Original chandeliers and sconces, vaulting and ribbing, pews and pulpit all radiate the highest level of craftsmanship and the need to keep the water out!

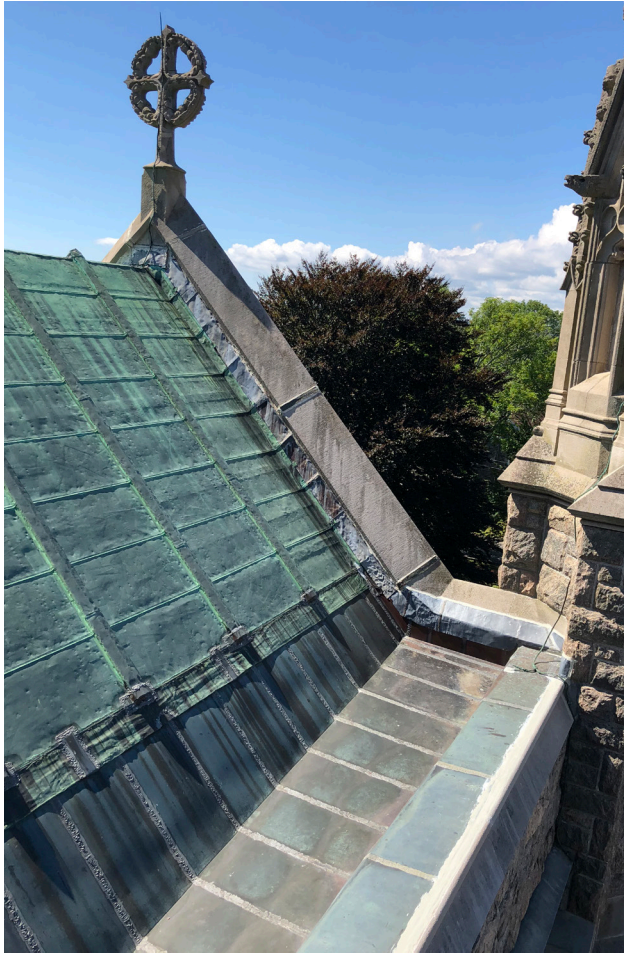
Keeping water out (and heat within) has been an ongoing and at times agonizing challenge for the stewards of this church. A 2004 roof project replaced the copper gutters, leaving the Sanctuary pitched roofing intact. Drainage is provided by piping to collector boxes and downspouts. It is unclear where water goes once underground, nor is it absolutely certain that leaking into the sanctuary has been eliminated. Although water problems in the basement may be limited to some rising damp as seen on the brick piers, getting a better understanding of drainage may be analyzed by video cameras in one or two locations. Other sections of roof appear to be aged. Examination by SSV along with Jon Bates of Titan Roofing evaluated conditions and best treatment methods.

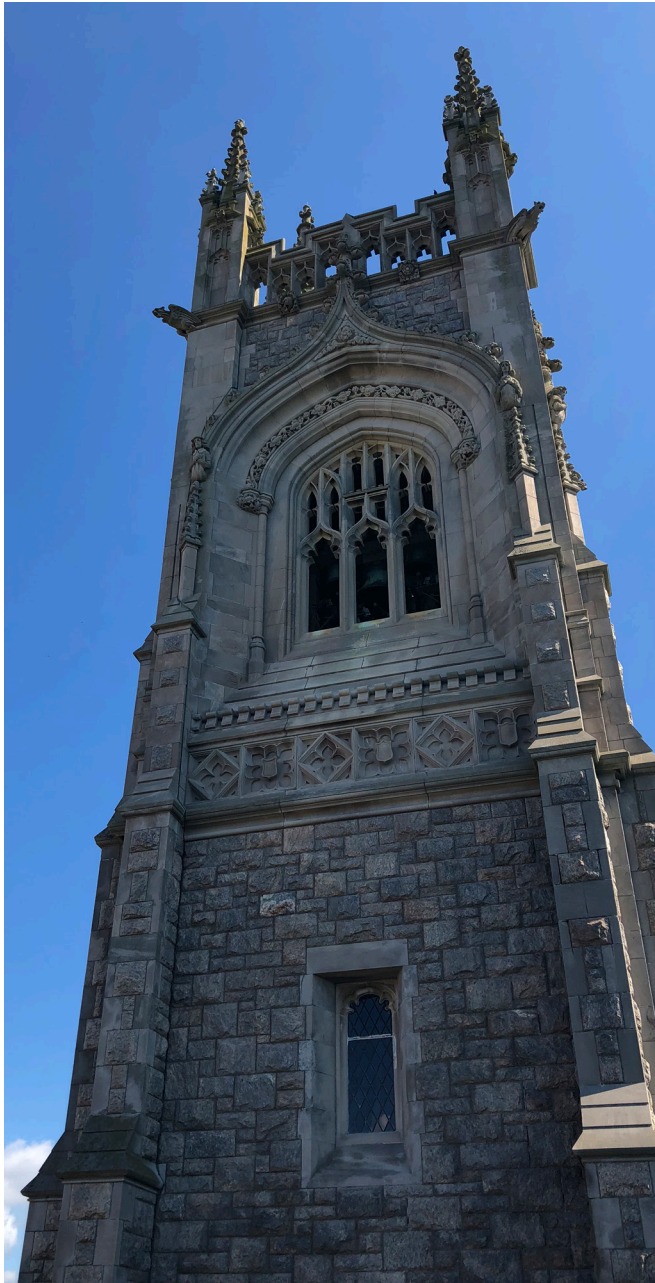
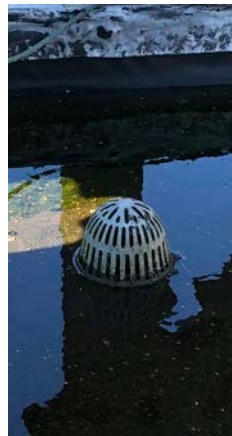
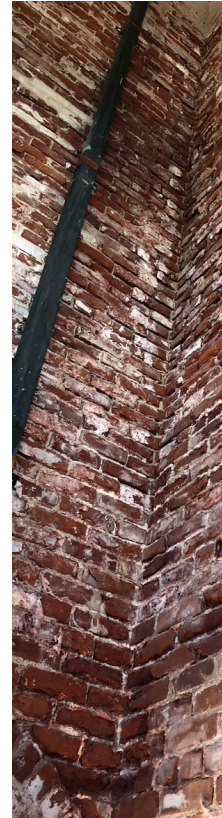
The tower is a significant concern as it shelters eleven magnificent bells. Deteriorated mortar joints, spalled brick, and efflorescence all indicate problems, including standing water and cracked stones. The lightning rod system is generally well anchored, and the grounds adequate.

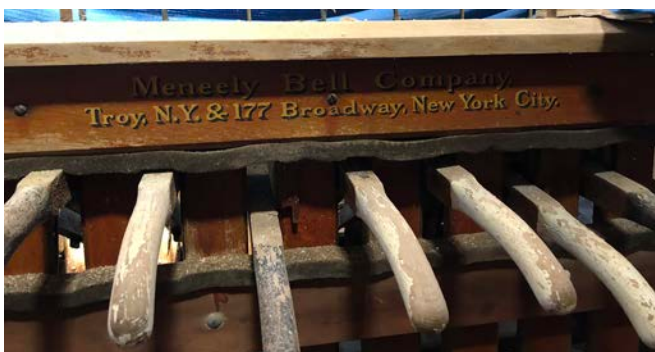
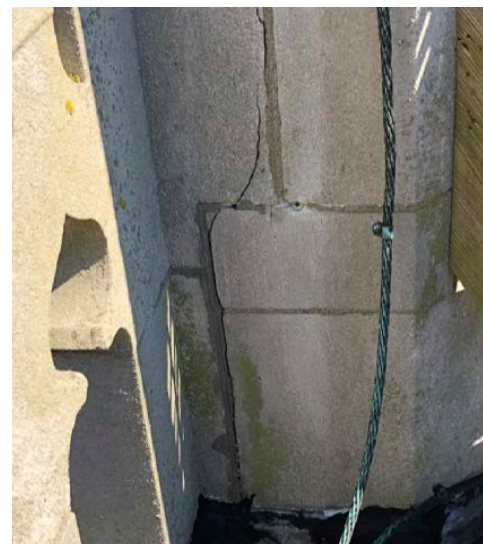
The stained glass windows feature truly unique glass painting by Robert Reid, apparently the first and only time this impressionist painter applied his talent to stained glass. The yellowing polycarbonate panels were removed to alleviate potential problems, including water penetration at the jambs and heat build-up which can accelerate deterioration of the lead comes. This revealed the original slightly rippled outer glazing. We understand that the stained glass has been previously assessed. This study is benchmarked by a new assessment by Roberto Rosa at Serpentino Stained Glass.

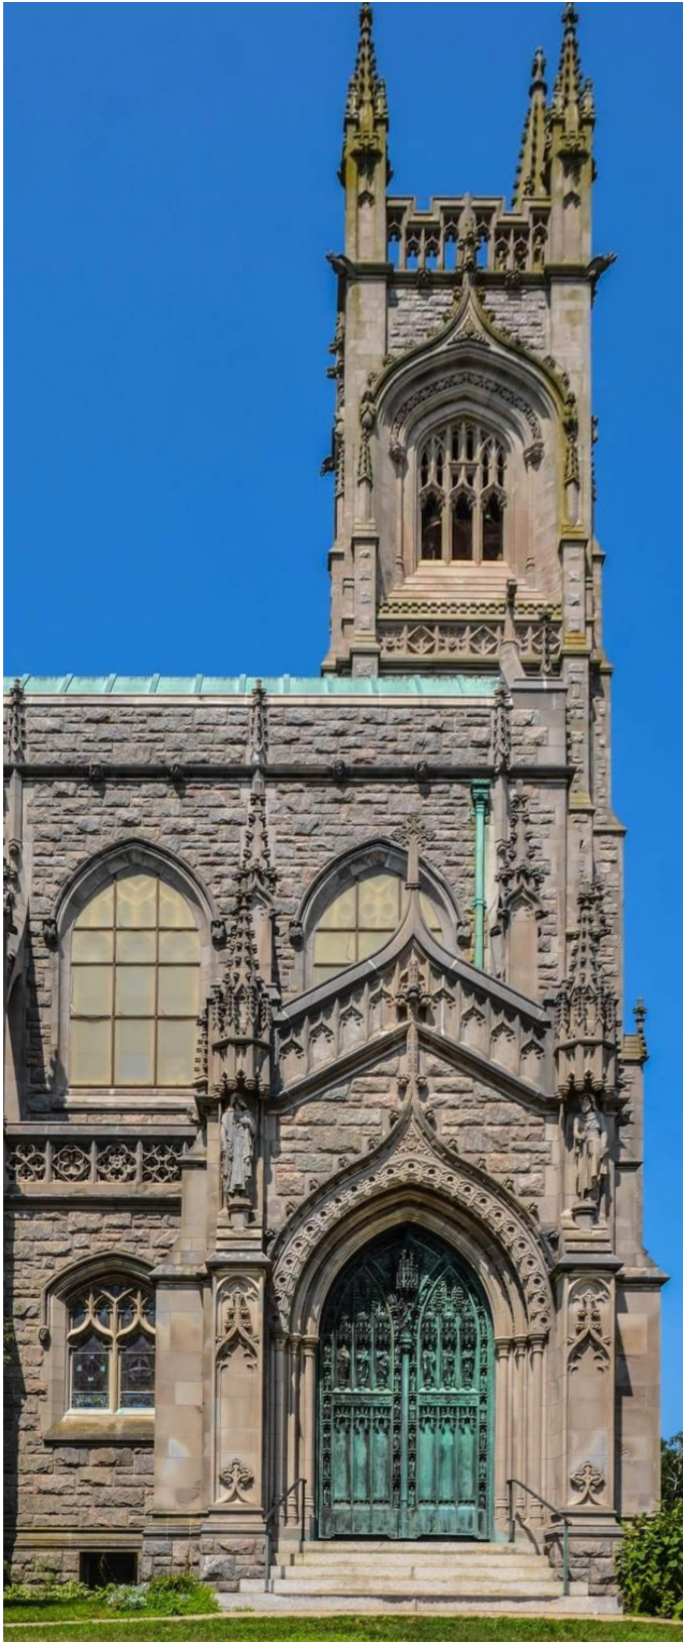
(pinterest.com, © Lyme/Vance)

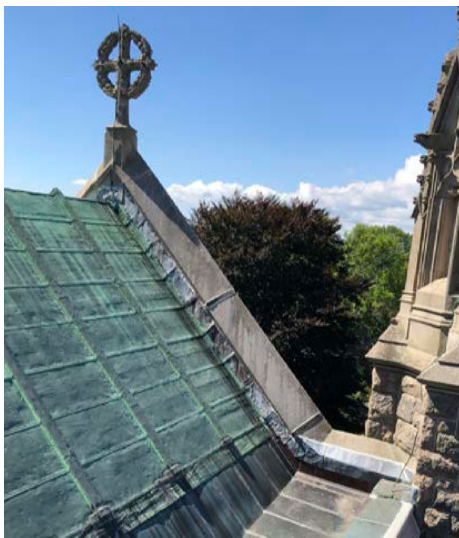
- Gable-ended copper roof intersected by transepts and with lower roofs covering the aisles.
- Tower with flat roof.

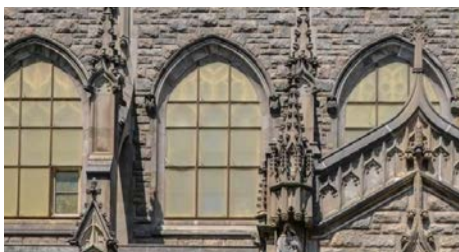
- Monumental bronze double doors on south entry porch.
- Monumental bronze entry gates at cloister.
- Wood door to enter sanctuary from cloister.
- Wood doors in west elevation.
- Large arches in tower for bells.
- Large ogee windows, symmetrically arranged in five bays, on north and south elevations with stained glass by Robert Reid.
- Monumental ogee windows on east and west elevations with significant stained glass by Robert Reid.
- Additional smaller openings at aisles and lower levels of east and west elevations, all with stained glass by Robert Reid.

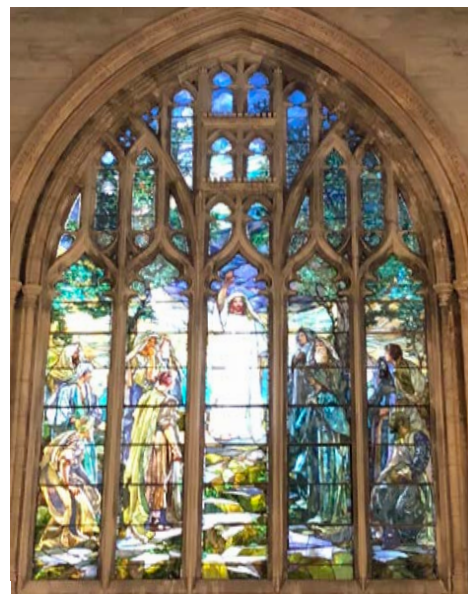
Interior, typical level of elaborate detail

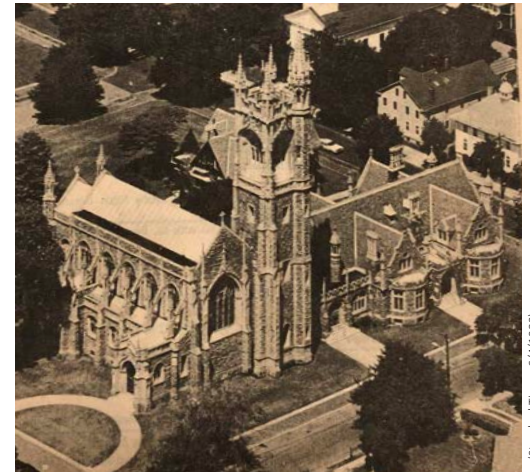
Aerial view of church.

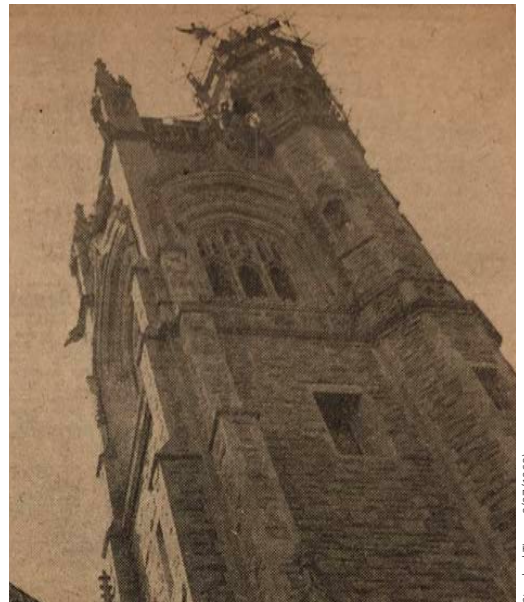
Scaffolding for repair of spire after lightning strike.

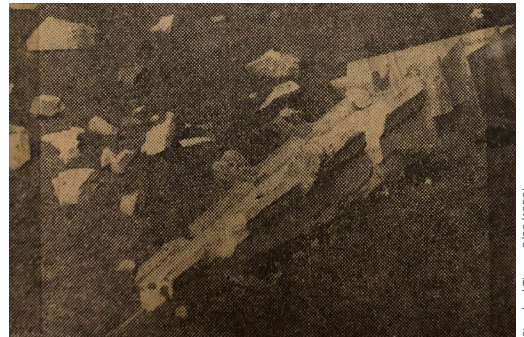
Spire after lightning strike.

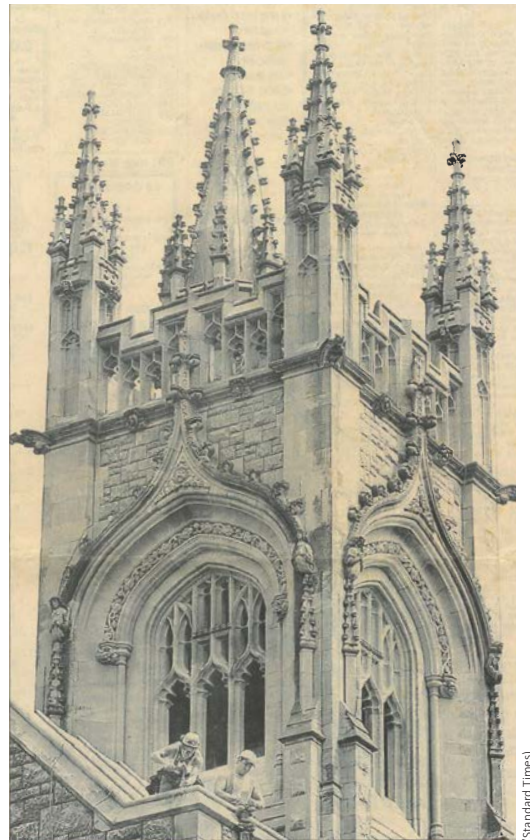
Workers from Flagship Roofing making repairs in 2002.

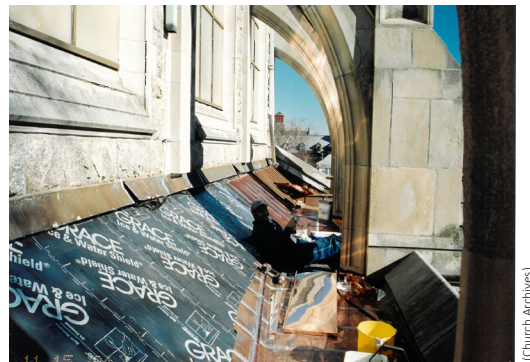
2004 gutter and roof repairs.

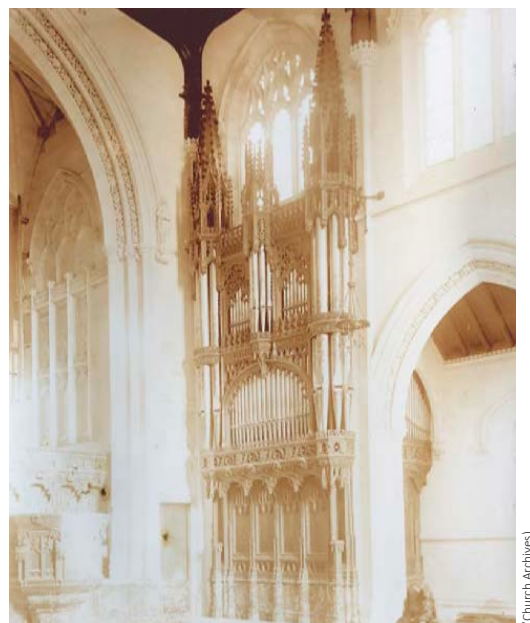
Organ with original set of 3 pinnacles (center removed)

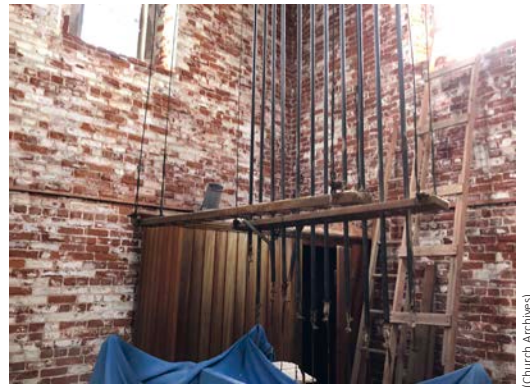
The bell ringing room has extensive deterioration of the walls due to moisture infiltration.

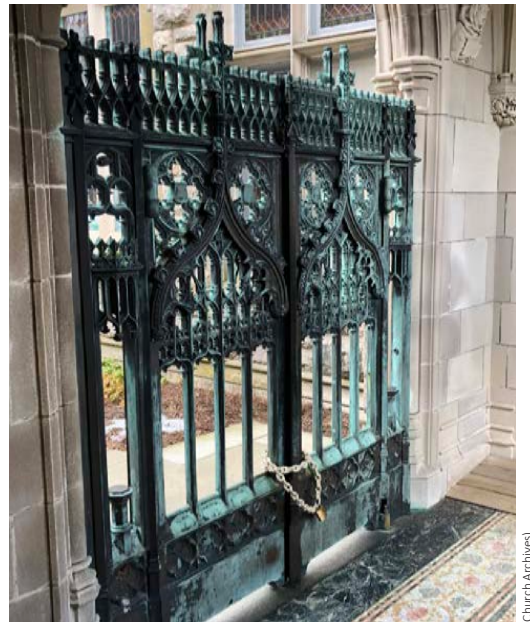
The heavy weight of the beautiful church gates is weakening the attachments to the stone at their hinges.

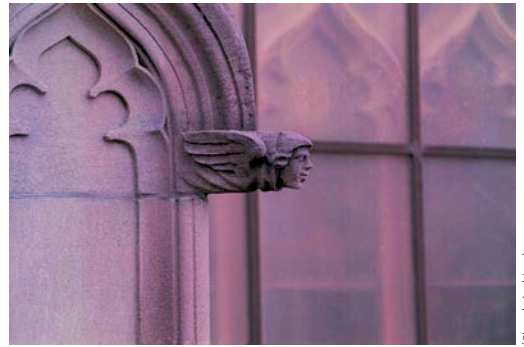
Church windows with Lexan.

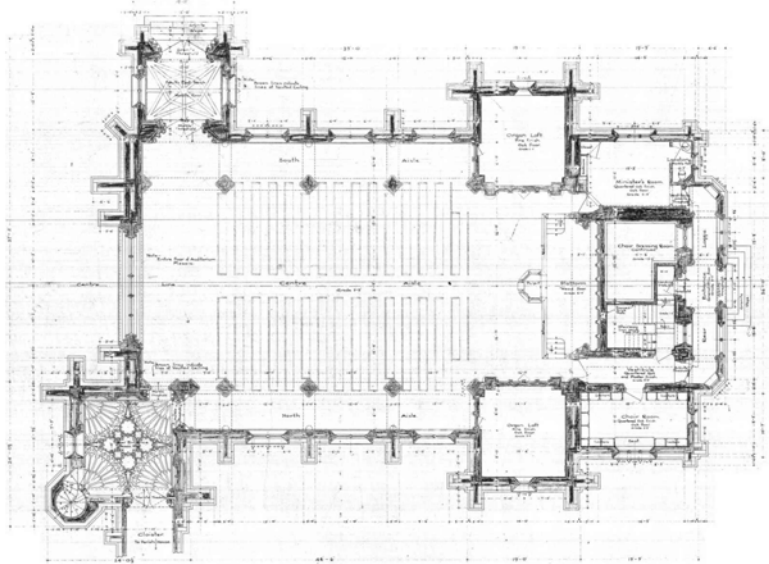
EXISTING FIRST LEVEL PLAN

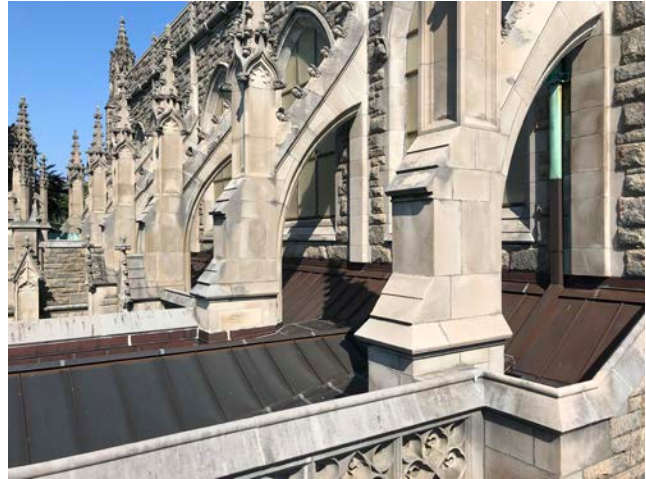
Newer copper replacement roof over west ambulatory and porch.

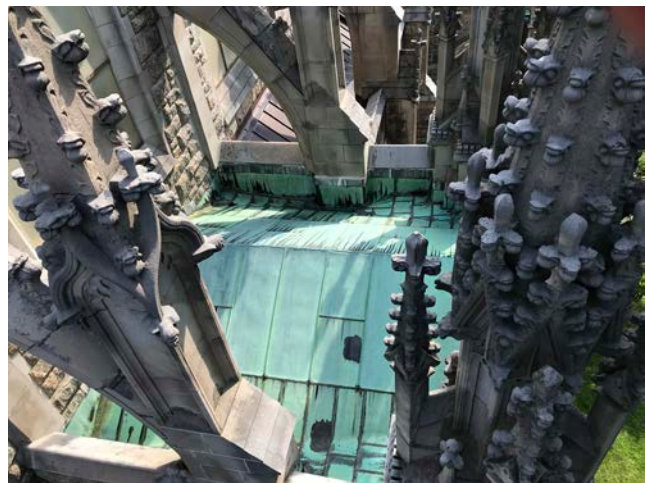
Older copper roof with numerous patches at west transept.

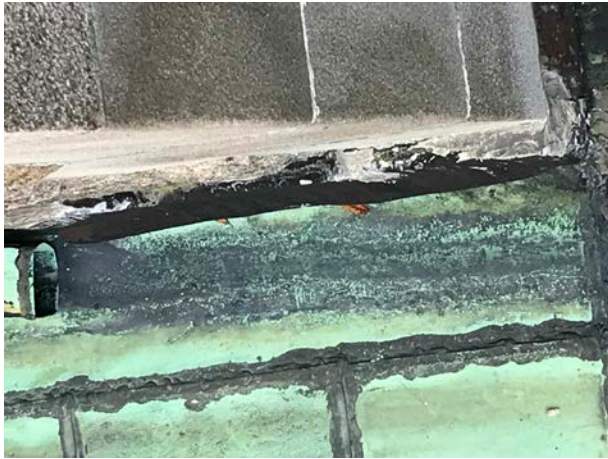
Detailed view at southeast corner roof shows many campaigns of repairs to open seams with mastic.

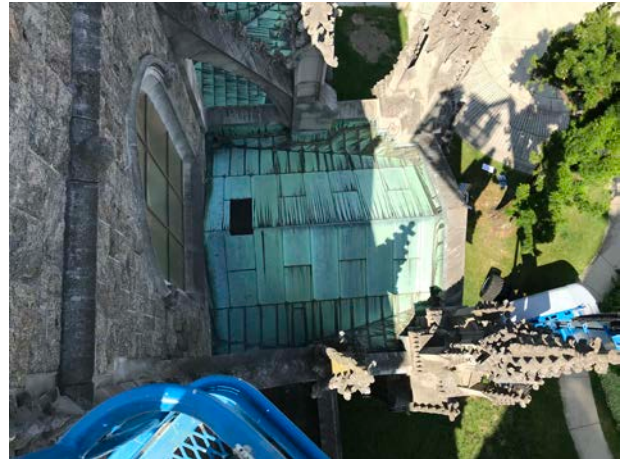
Original copper roof beyond its life expectancy.

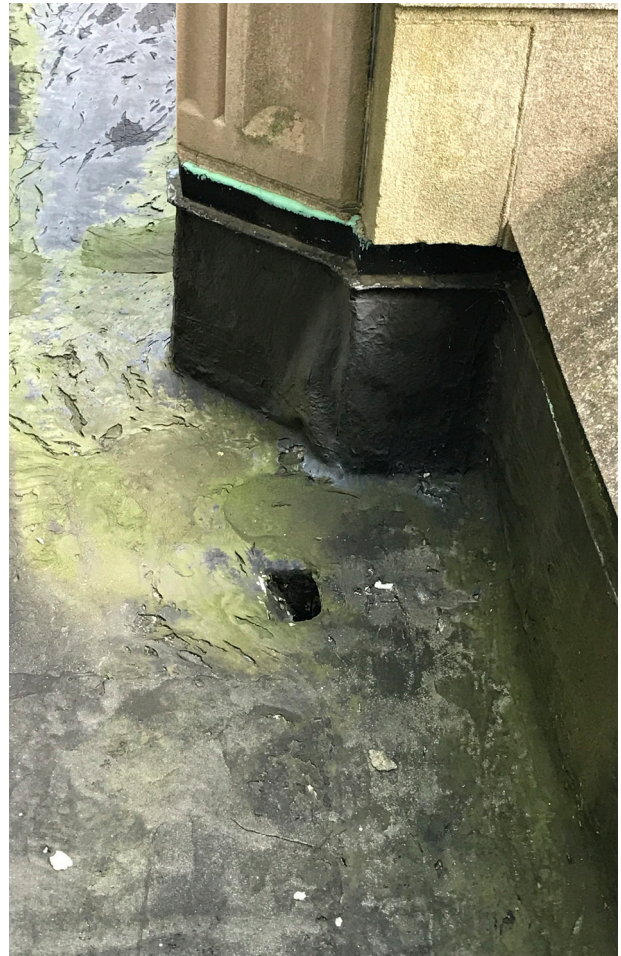
Rain leaders enter the building and are the suspected cause of interior damage.

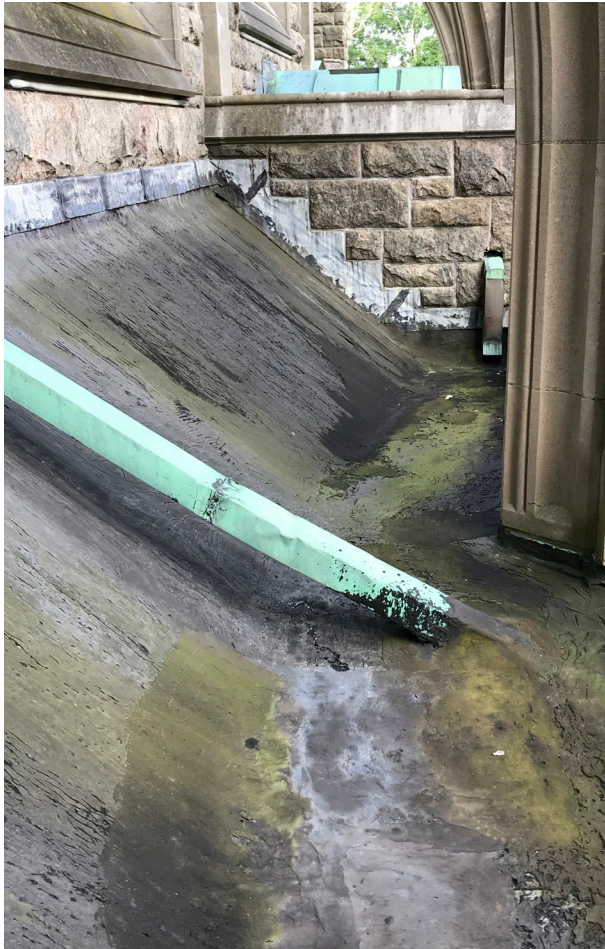
Downspouts from the nave roof drop to the aisle roof then enter the building briefly to then go to external collector boxes.

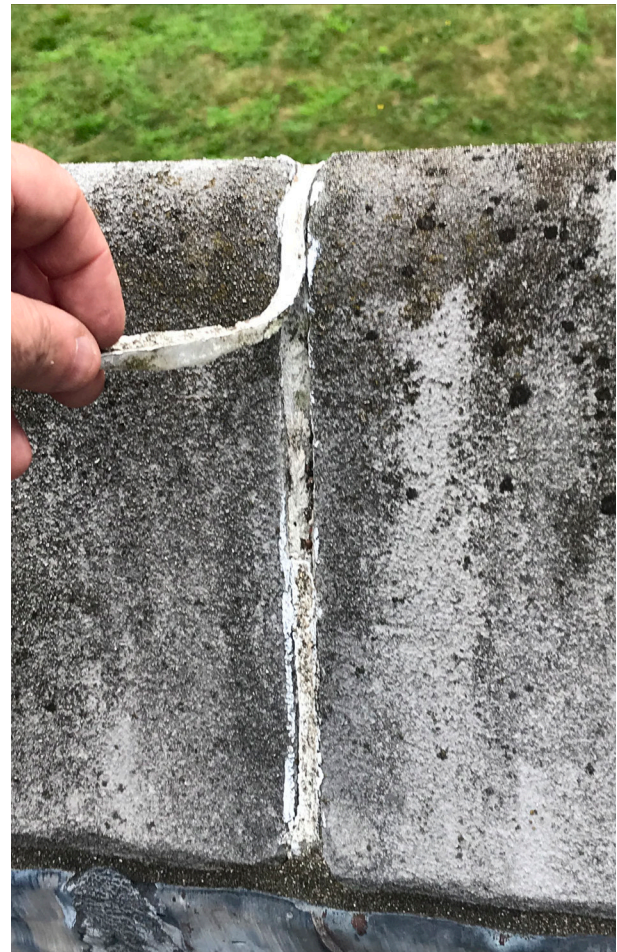
Caulking at coping stones has failed. Note that the caulking has tested positive for asbestos.

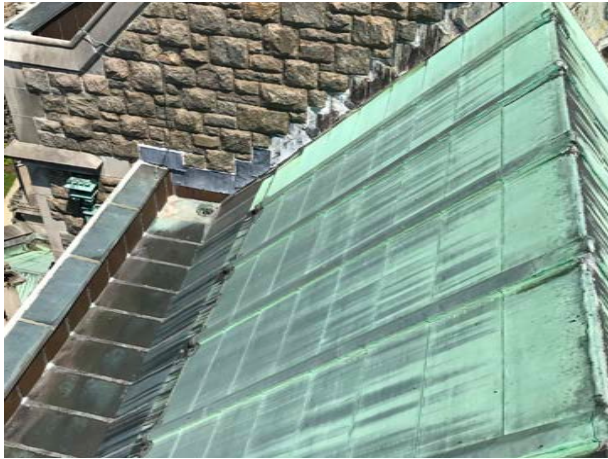
Older copper roofing with numerous patches over choir at west end of building.

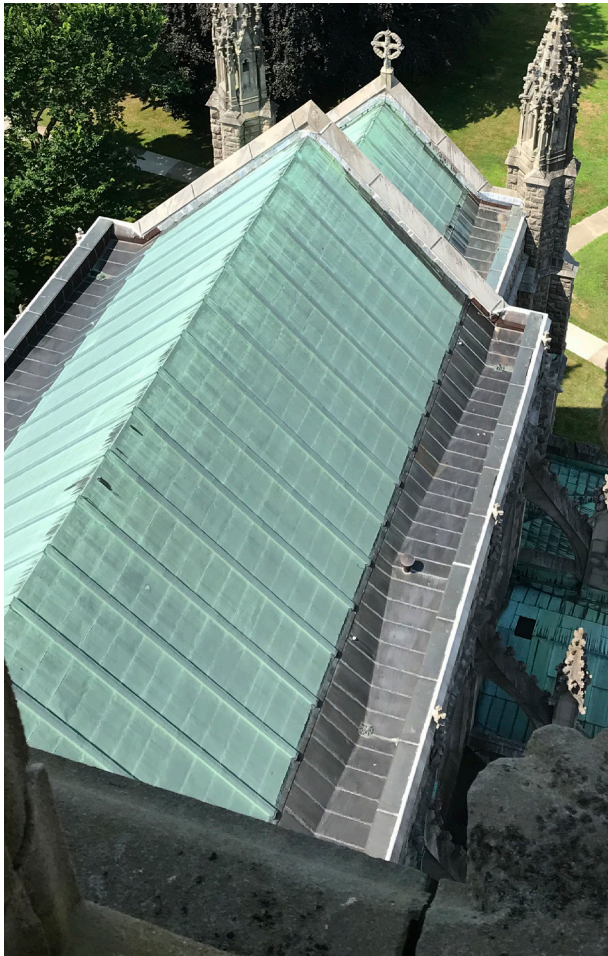
Newer replacement copper at nave roof valleys, and older copper roof at nave peak, possibly completed in 2004.

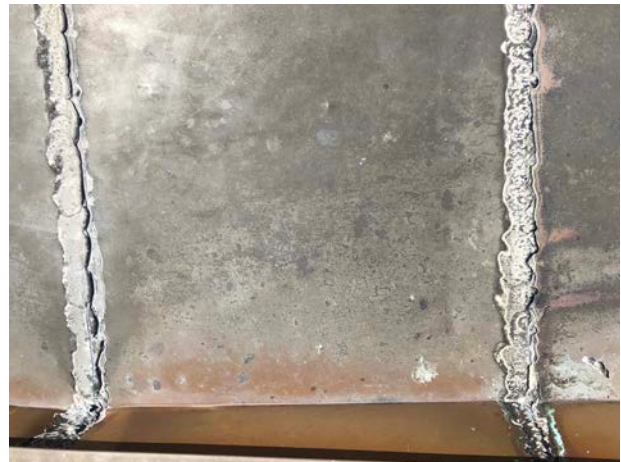
Newer replacement copper at north side of nave roof. While this is relatively recent work (2004), there is evidence of cracked solder.

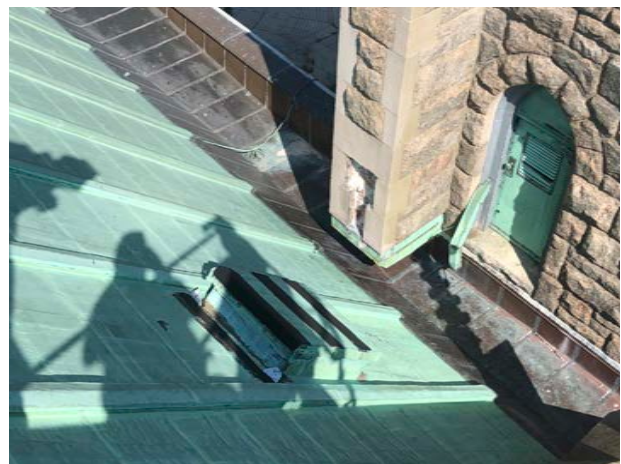
Hatch cover has mastic patching along its upper edge, an indication of leaking.

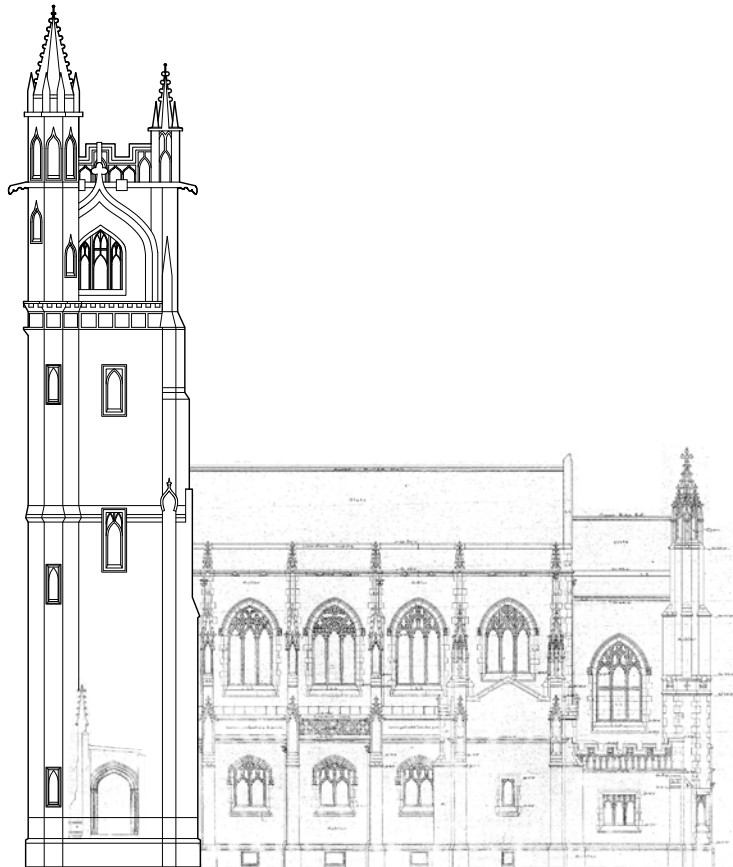
EXISTING NORTH ELEVATION

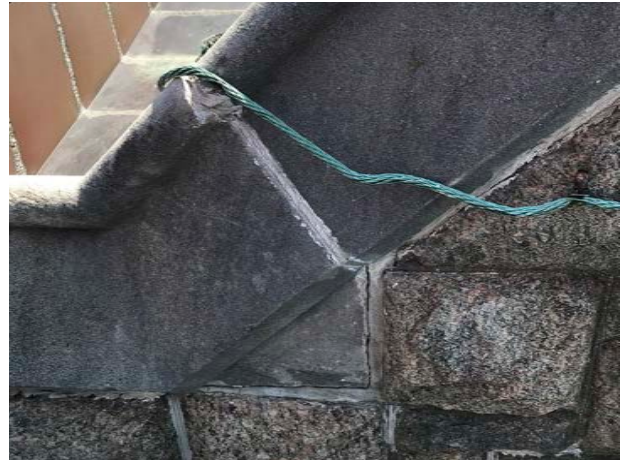
Stone movement, asbestos-containing caulk, open joints.

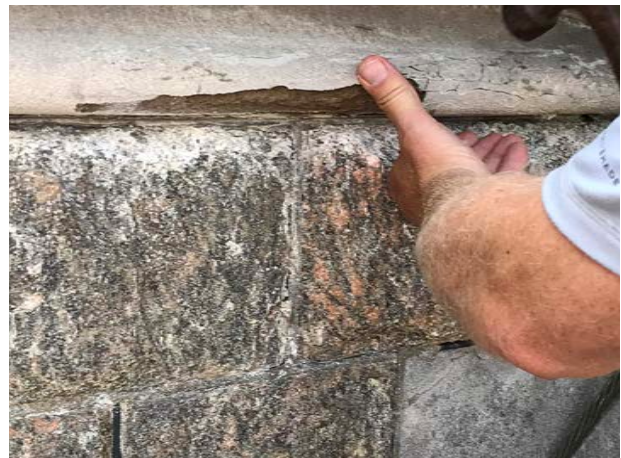
Frost-damaged trim stone.

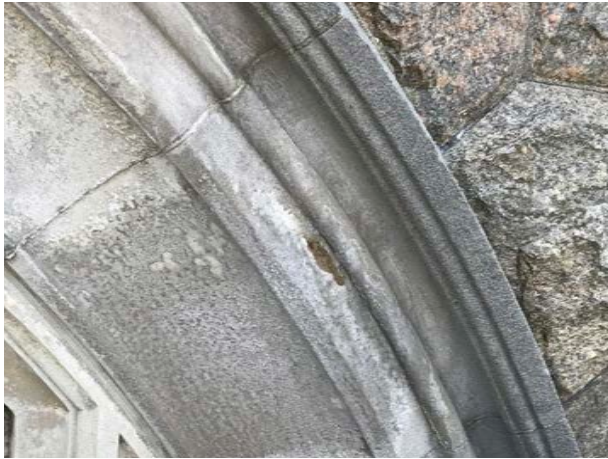
Frost-damaged trim stone.

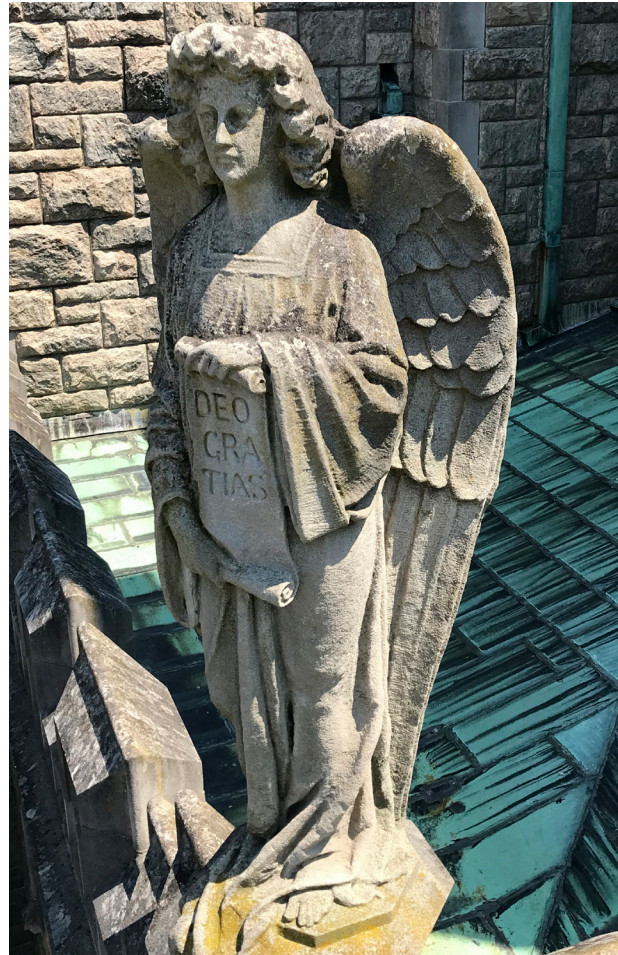
Angel at this location has had cracked wing repaired with epoxy (and appears to be holding).

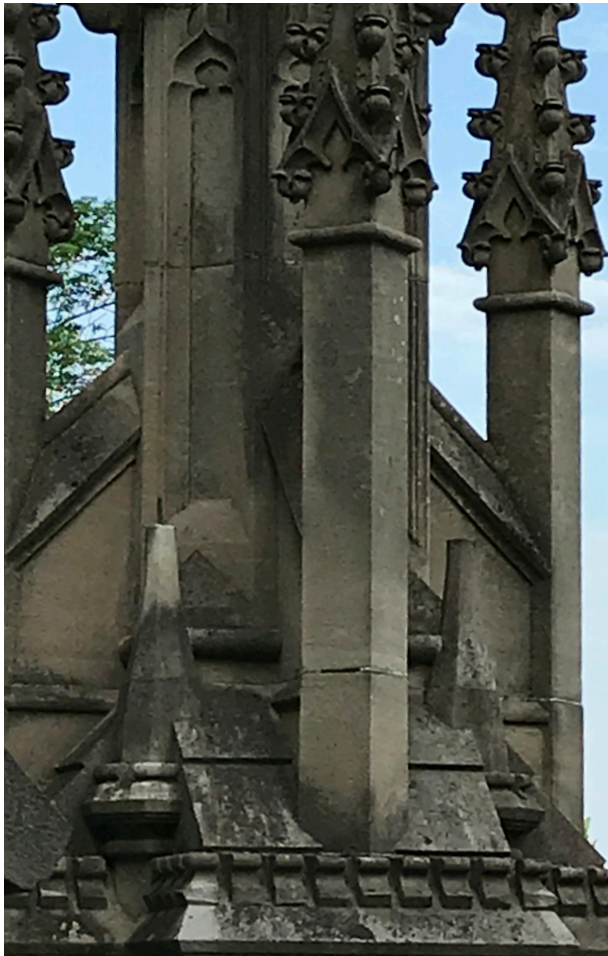
Missing and cracked finials and defective mortar joints.

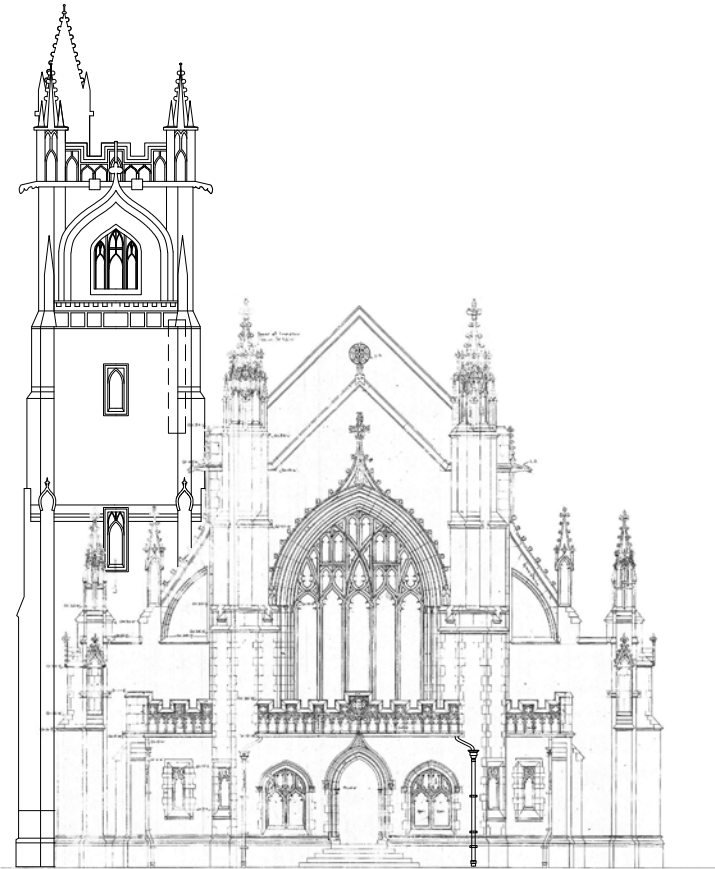
EXISTING WEST ELEVATION

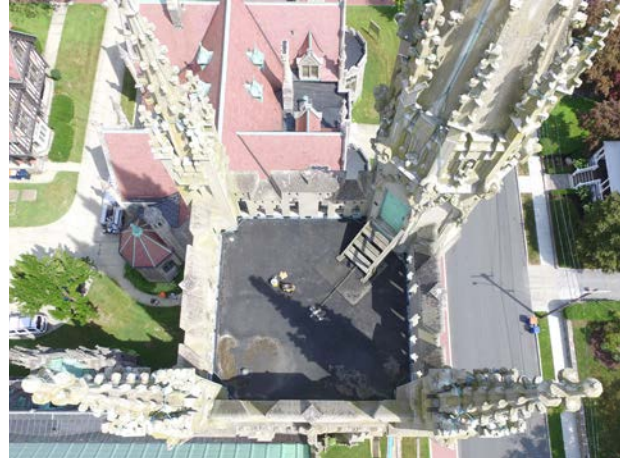
EPDM roof was patched during assessment and should be replaced.

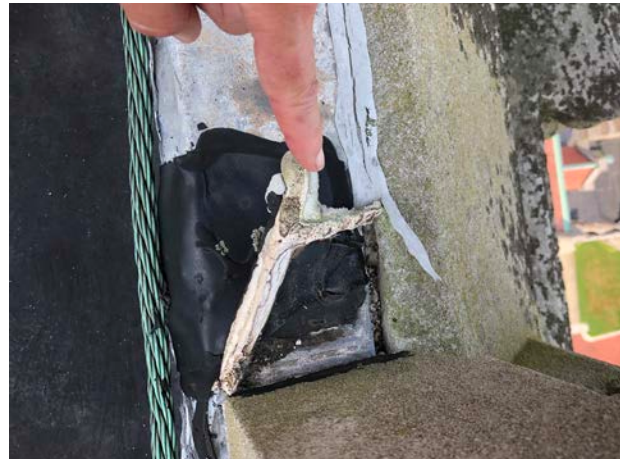
Tower roof has many failures of flashing and caulking on this roof. Note that white caulking was determined to be asbestos-containing.

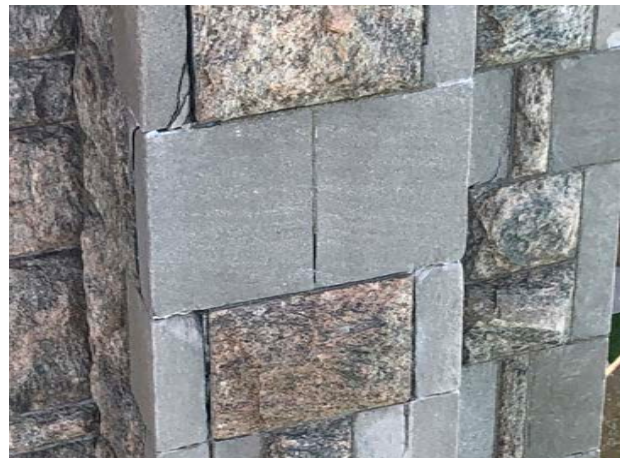
Cracks at buttress stone.

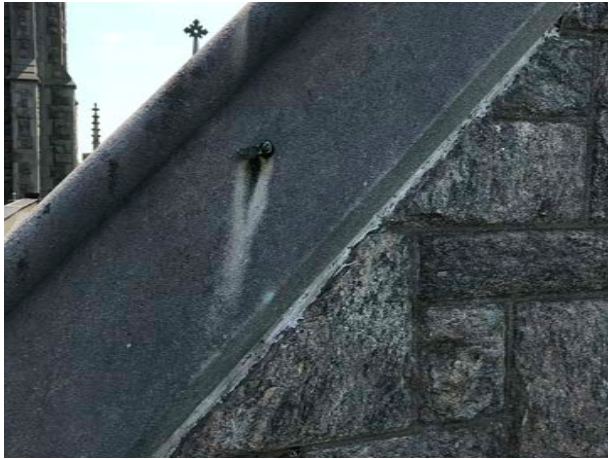
Failed caulk at gable coping. Note: This caulk contains asbestos.

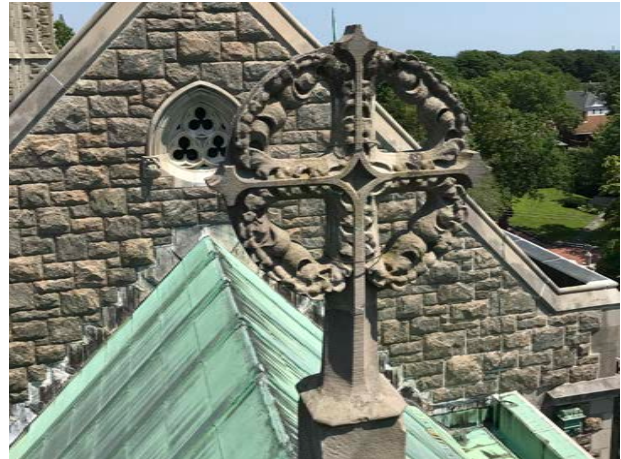
Cross at peak of roof is loose and cracked.

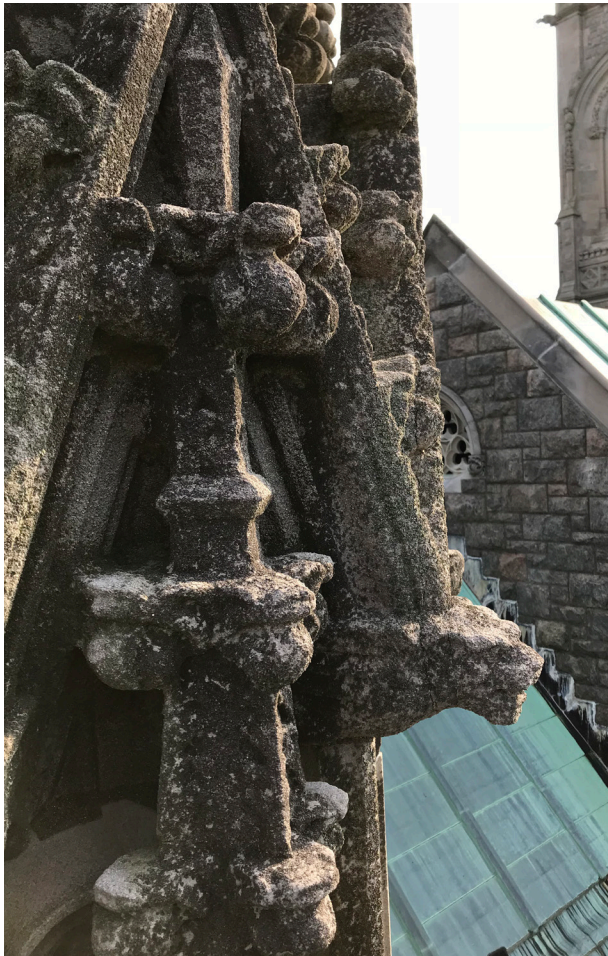
Finials on pinnacles have organic growth that should be removed followed by a careful inspection for loose elements to be re-installed with non-ferrous pins.

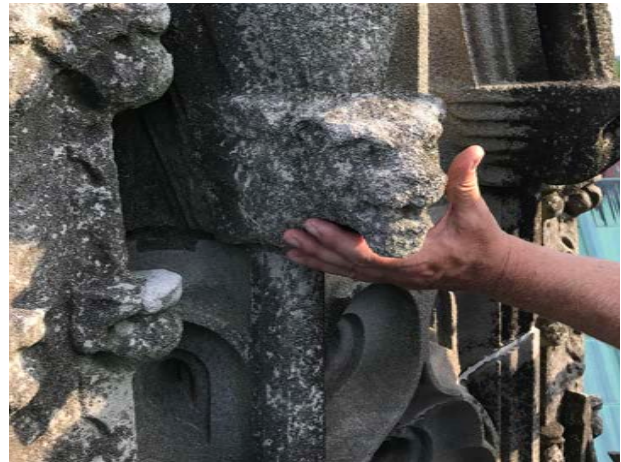
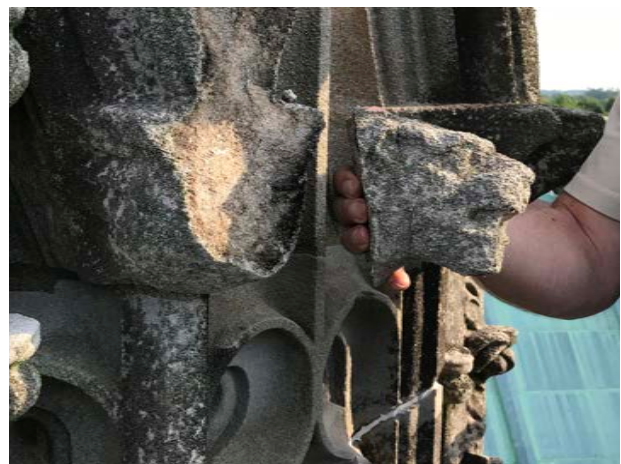
Inspection team removed a figure's head at the right pinnacle that showed severe evidence of weathering due to a crack that had been there a long time.

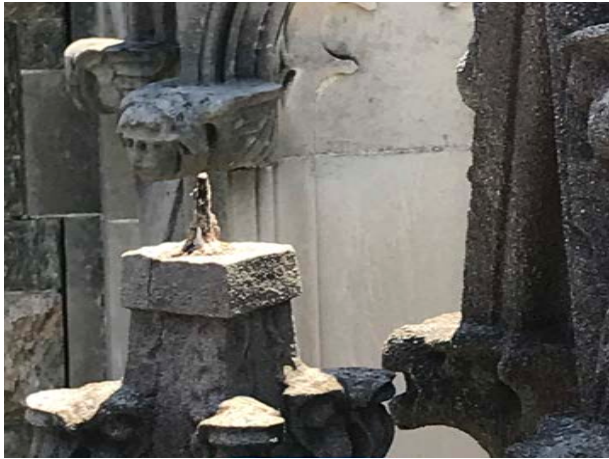
At the south side of the west elevation, the inspection team removed a precarious finial.

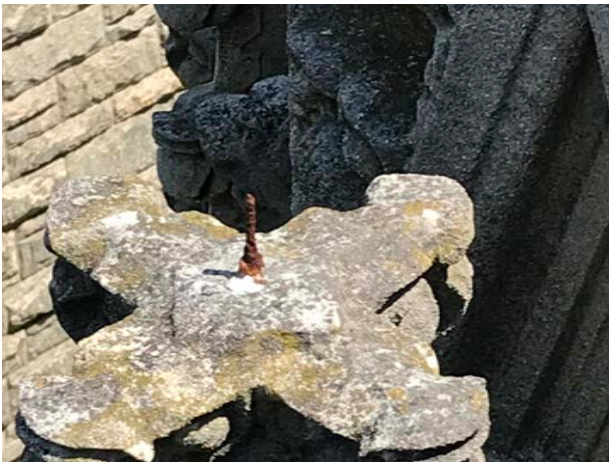
Lost and cracked finials due to corroded steel pins at north side of west elevation.

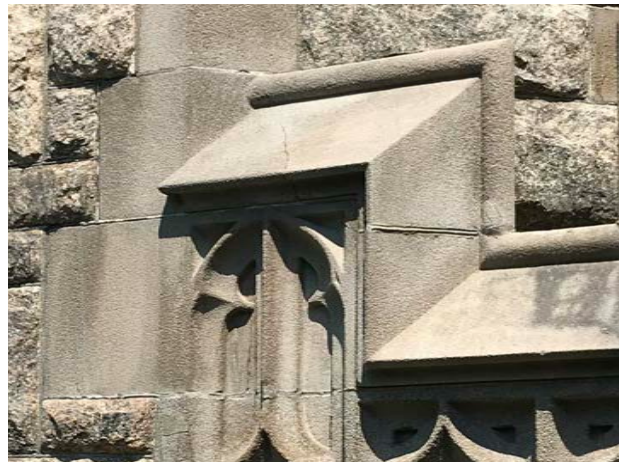
Cracked stones at parapet above porch.
