Conditions Assessments and Treatment Recommendations for  
UNITARIAN MEMORIAL CHURCH

FAIRHAVEN, MASSACHUSETTS  
19 DECEMBER 2019

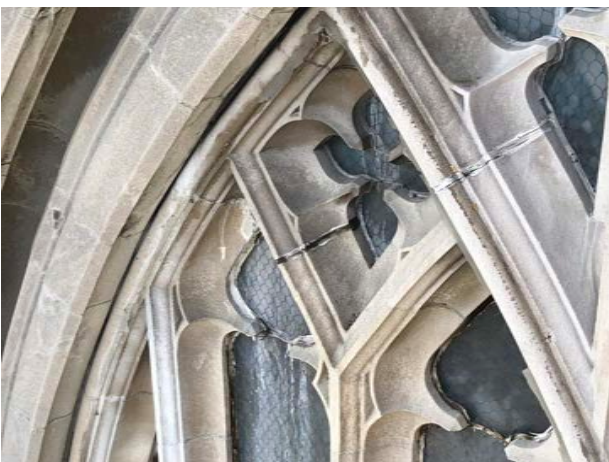
Note: Typically most of the glazing compounds at stained glass windows were found to be asbestos-containing.

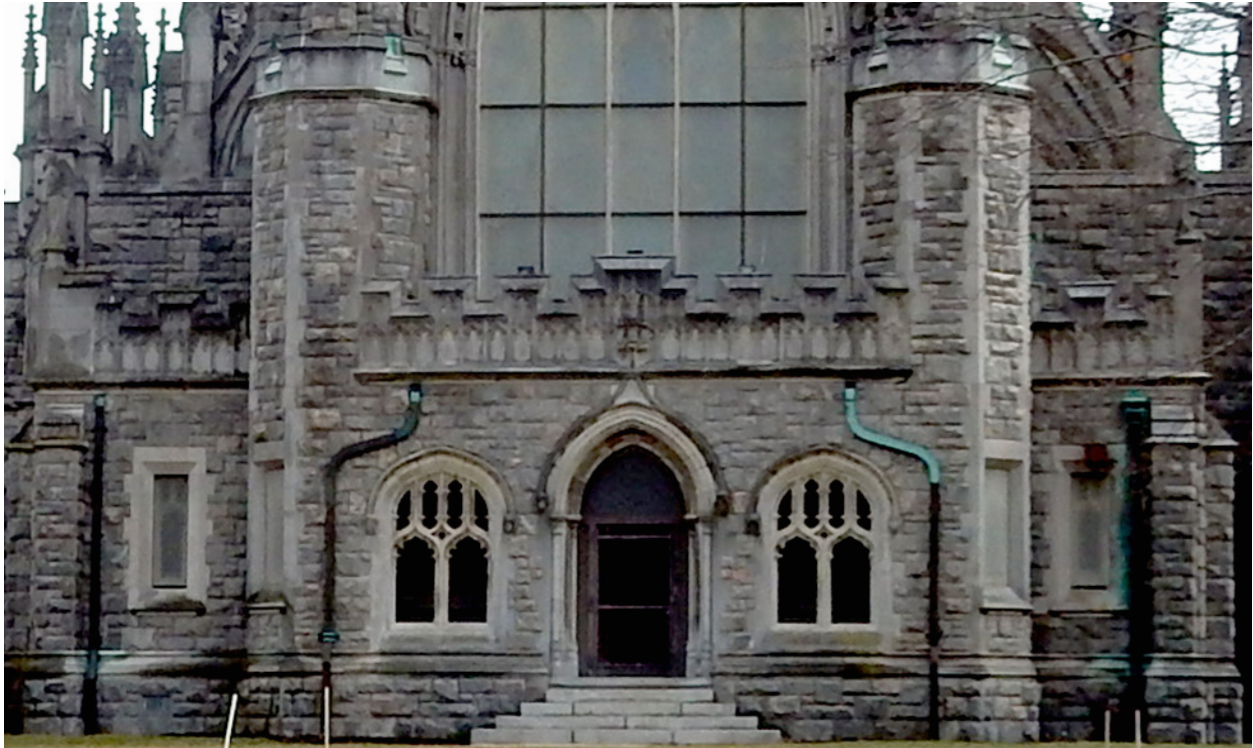
Downspouts and metal box above window.

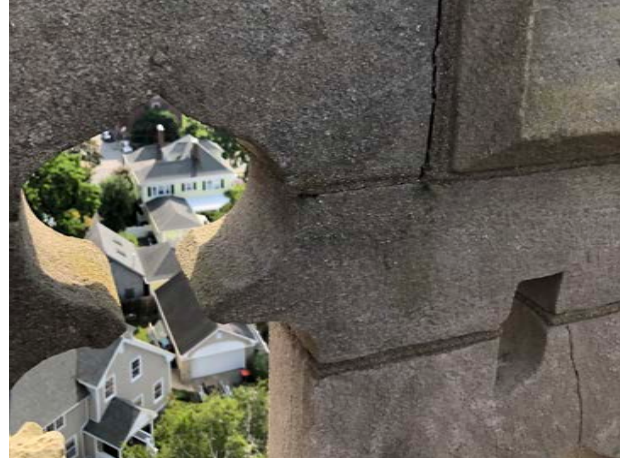
There are many open joints and cracks in limestone tracery parapet above the tower roof.

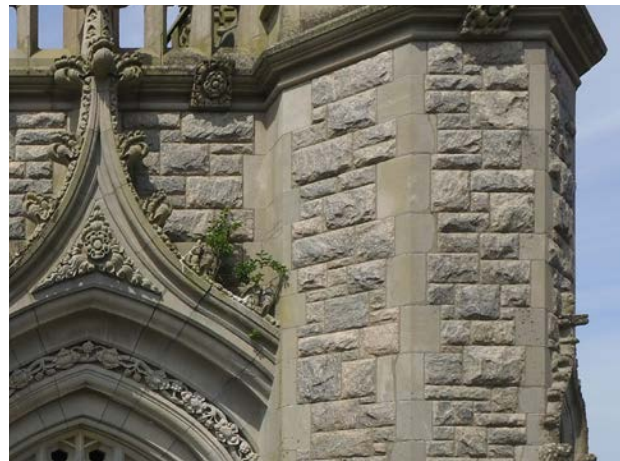
Remove small tree growing nearly at top of tower.

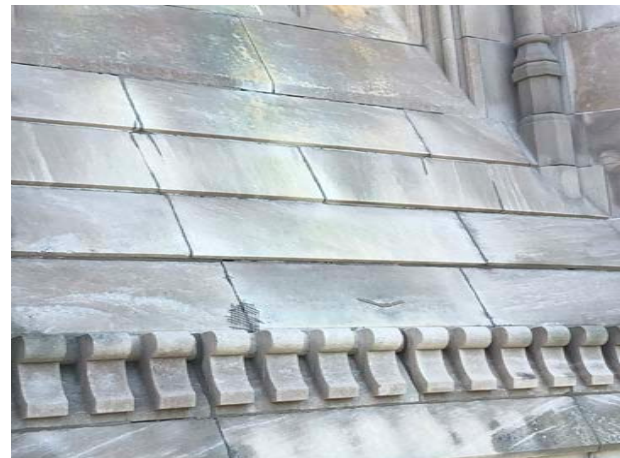
Shingle stone sills have open joints causing water infiltration.

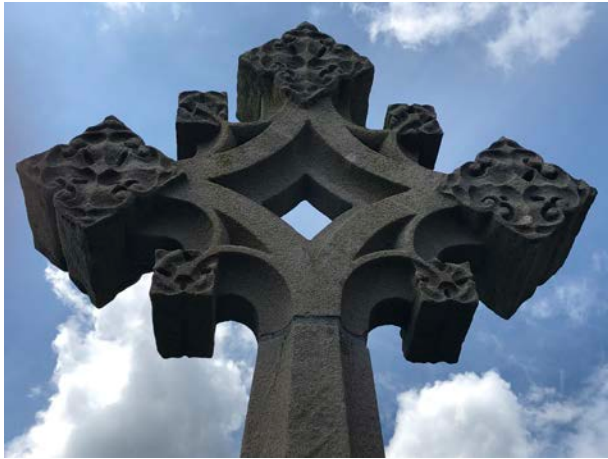
Stone cross at gable peak is cracked and loose.

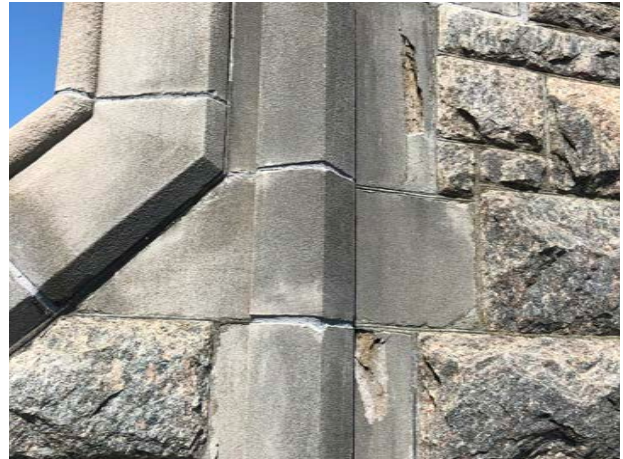
Spalled limestone at gable coping.

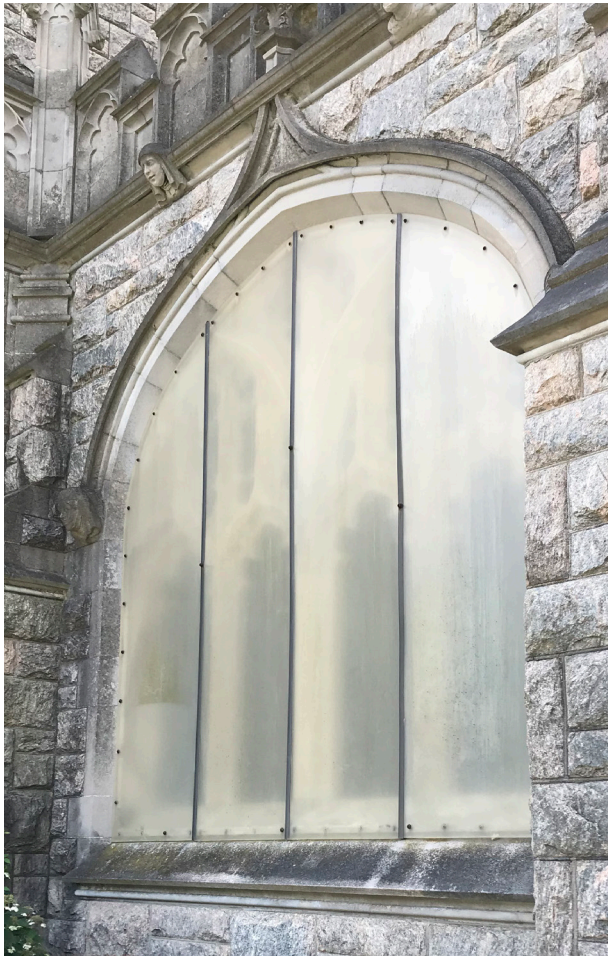
Yellowed Plexi-glas security panels at the cloister should be replaced with material and methods to improve aesthetics while maintaining security

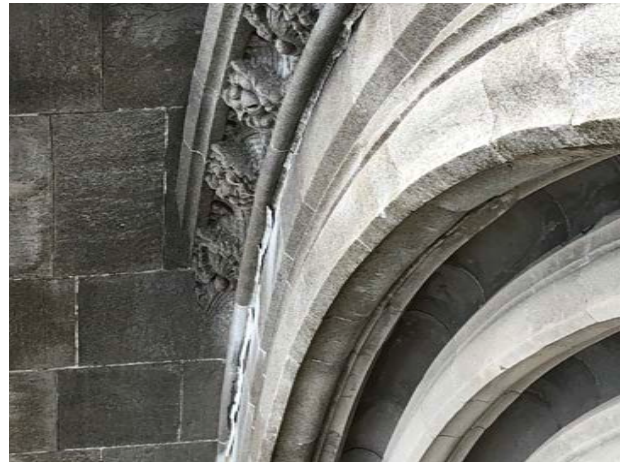
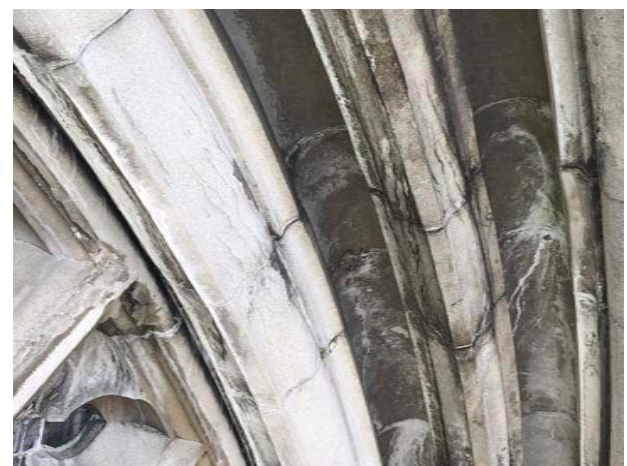
Deteriorated stone at arch over main window is evidence of water infiltration and movement of stone.

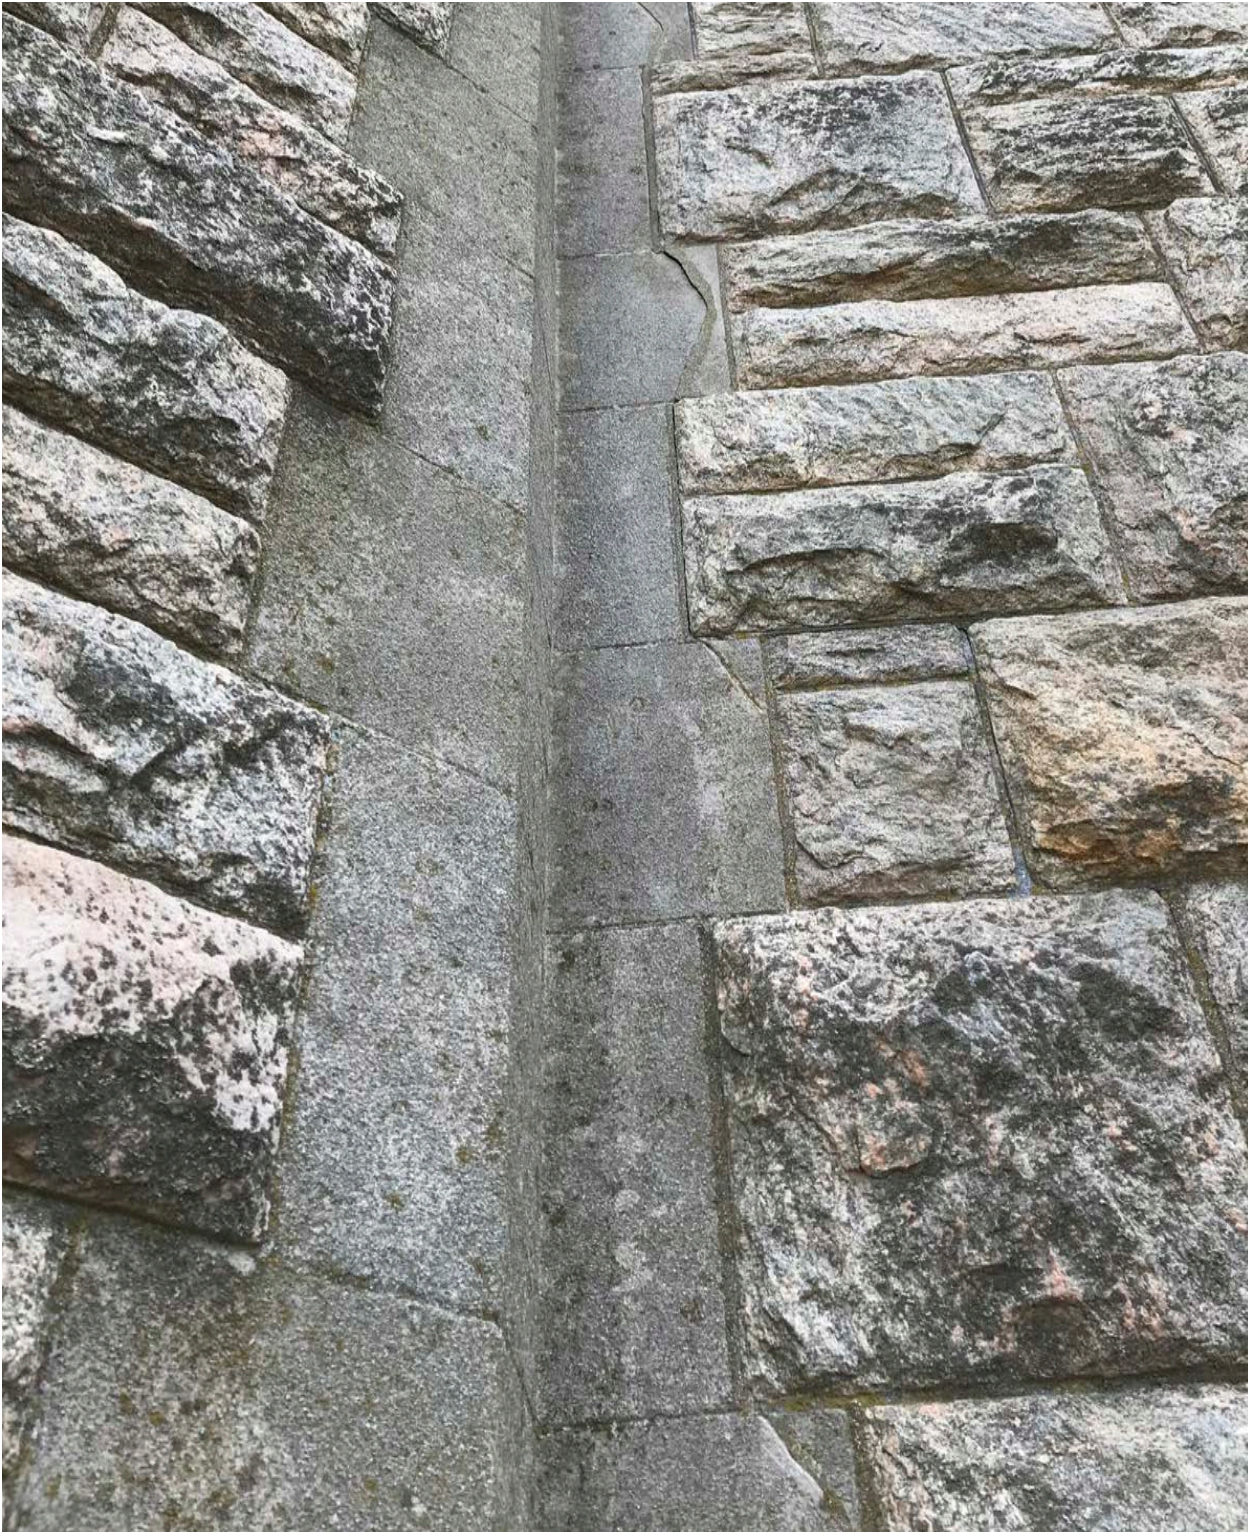
Vertical crack at mid-level of tower.

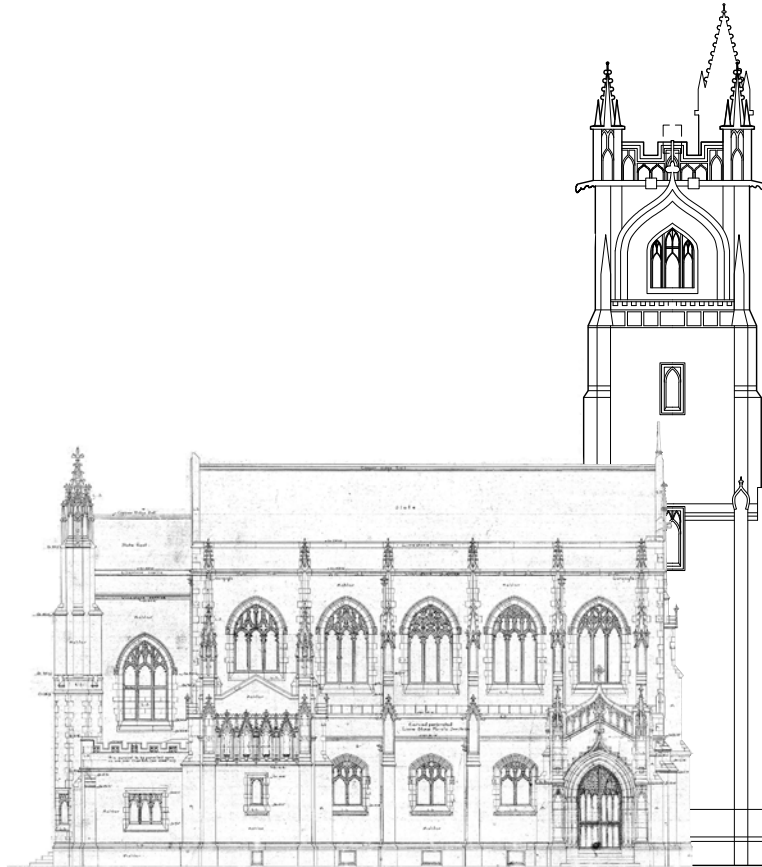
EXISTING SOUTH ELEVATION

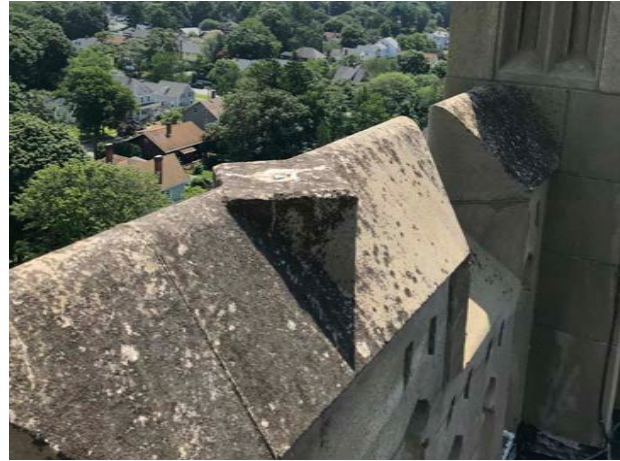
Evidence that there may have originally been finials here at all four elevations.

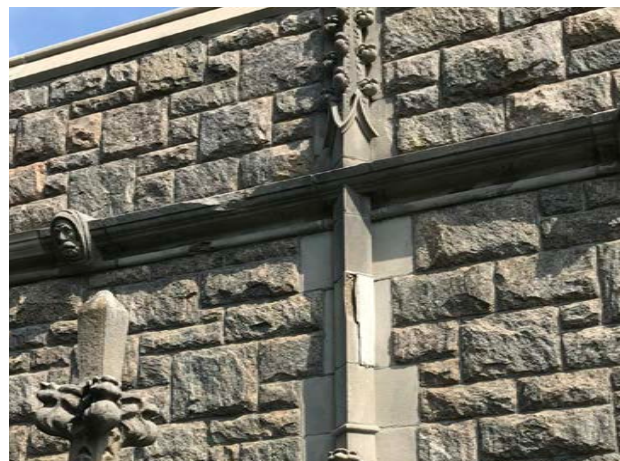
Deteriorated and broken stone.

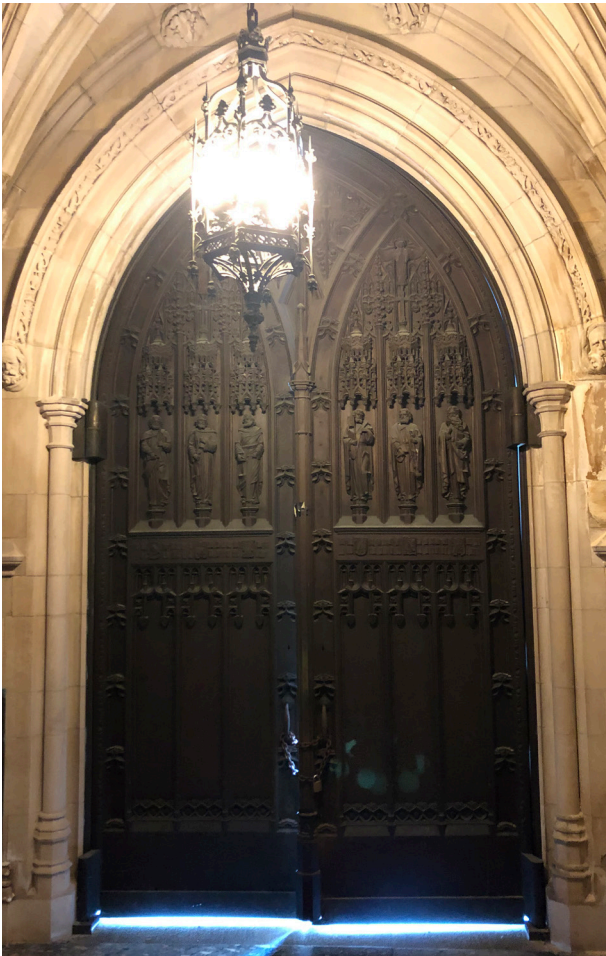
Existing bronze doors are difficult to operate due to a combination of factors: A slipped arch stone, a compressed rubber shim at the hinge, and perhaps an undersized pintel hinge. See Structural Assessment on page 79.

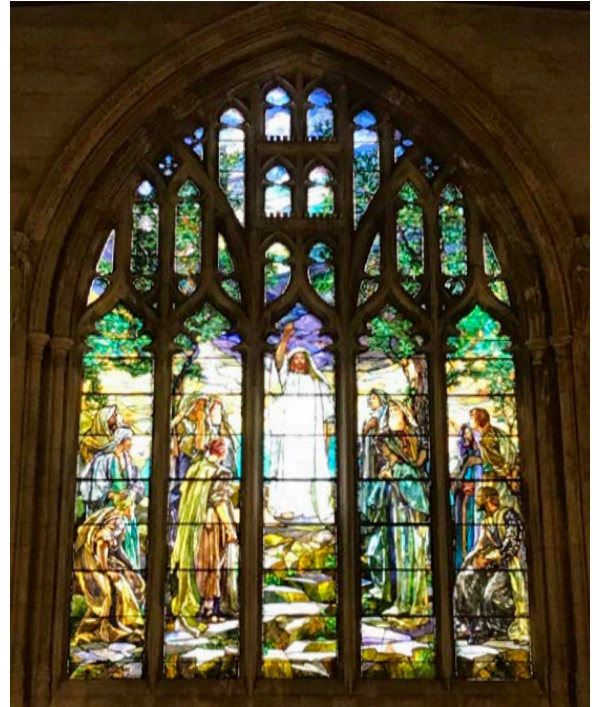
Water damage at the stone around the east window presents serious problems that had also affected the space between the window and the Plexi-glas. During the on-site investigation and lift survey, the Plexi-glas was removed from this window because it was doing more harm than good. This image shows the window after removal of the Plexi-glas, which now permits the full beauty of the window to shine forth both on the interior and exterior of the building. Similar treatment is recommended for all the Plexi-glas covered windows except those in areas requiring protection from vandalism.

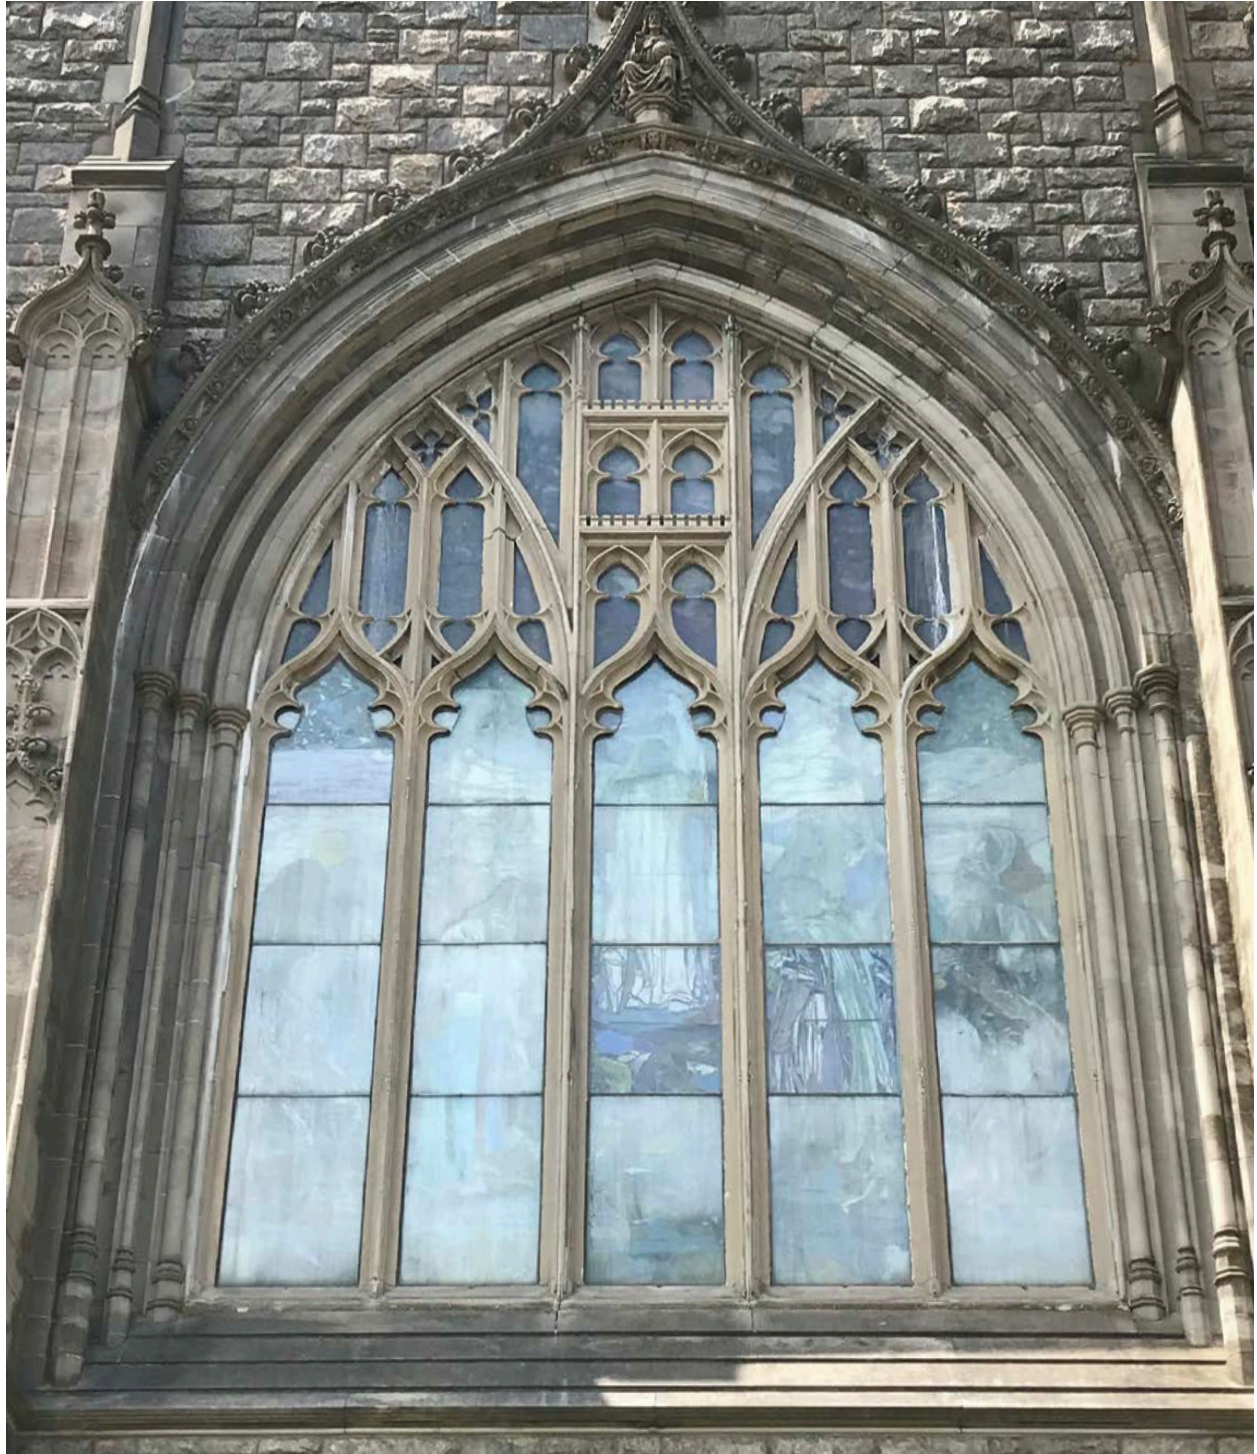
East window that has benefited from Plexi-glas removal during the lift inspection to allow original glass's beauty to be visible and also remove a condition that is causing excess moisture against the glass. The outermost layer of the original glass (visible here) is a ripple texture.

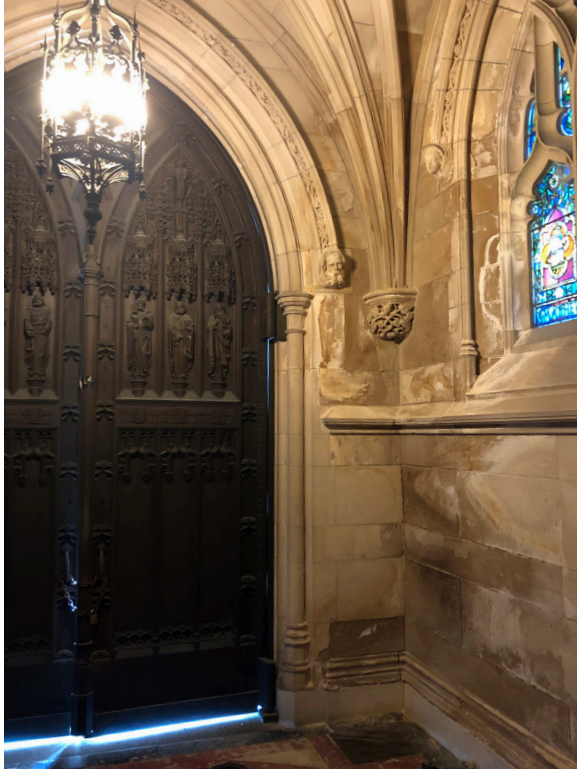
Moisture effects on southwest entry portico. The moisture issues at the building's interior sweep from the east window around the south side and through the choir to the northwest corner. All areas show the effects of moisture penetration that has caused leaching of colored oxides, rust, and other materials.

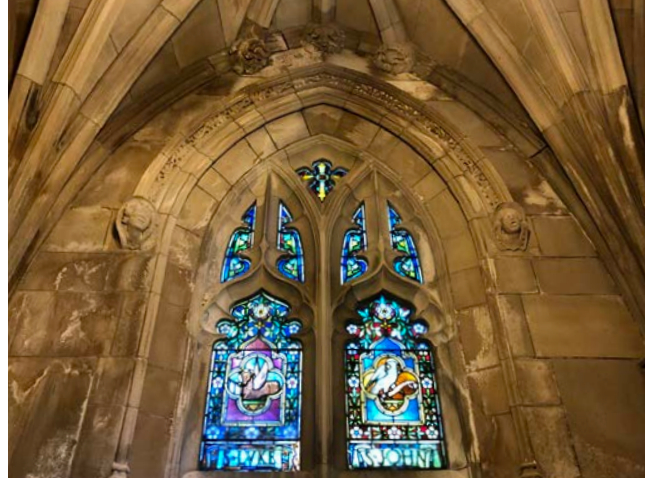
Southwest entry portico moisture effects.

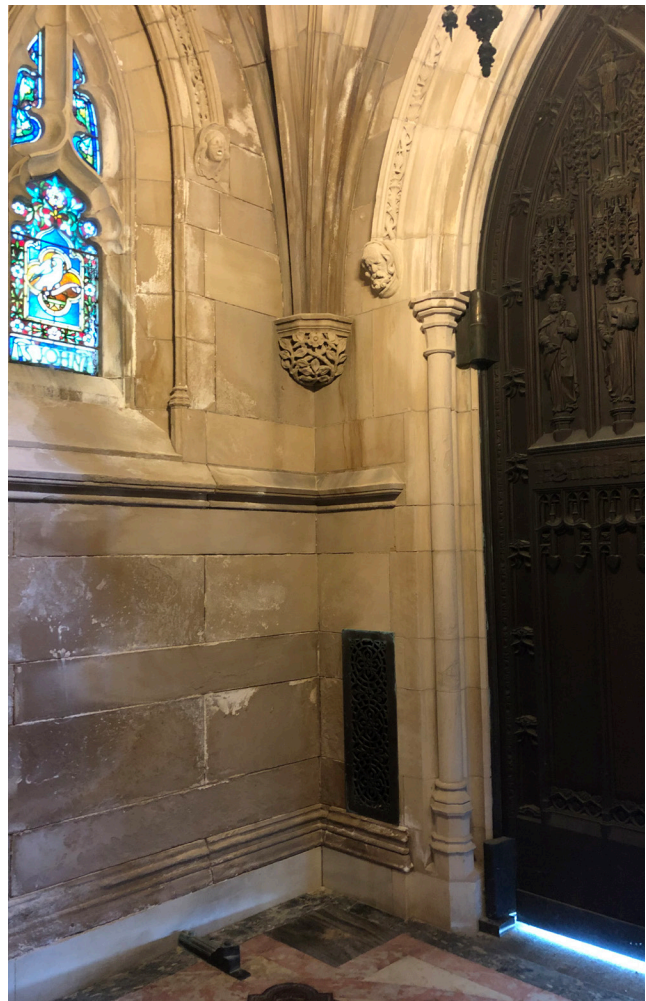
Southwest entry portico moisture damage.

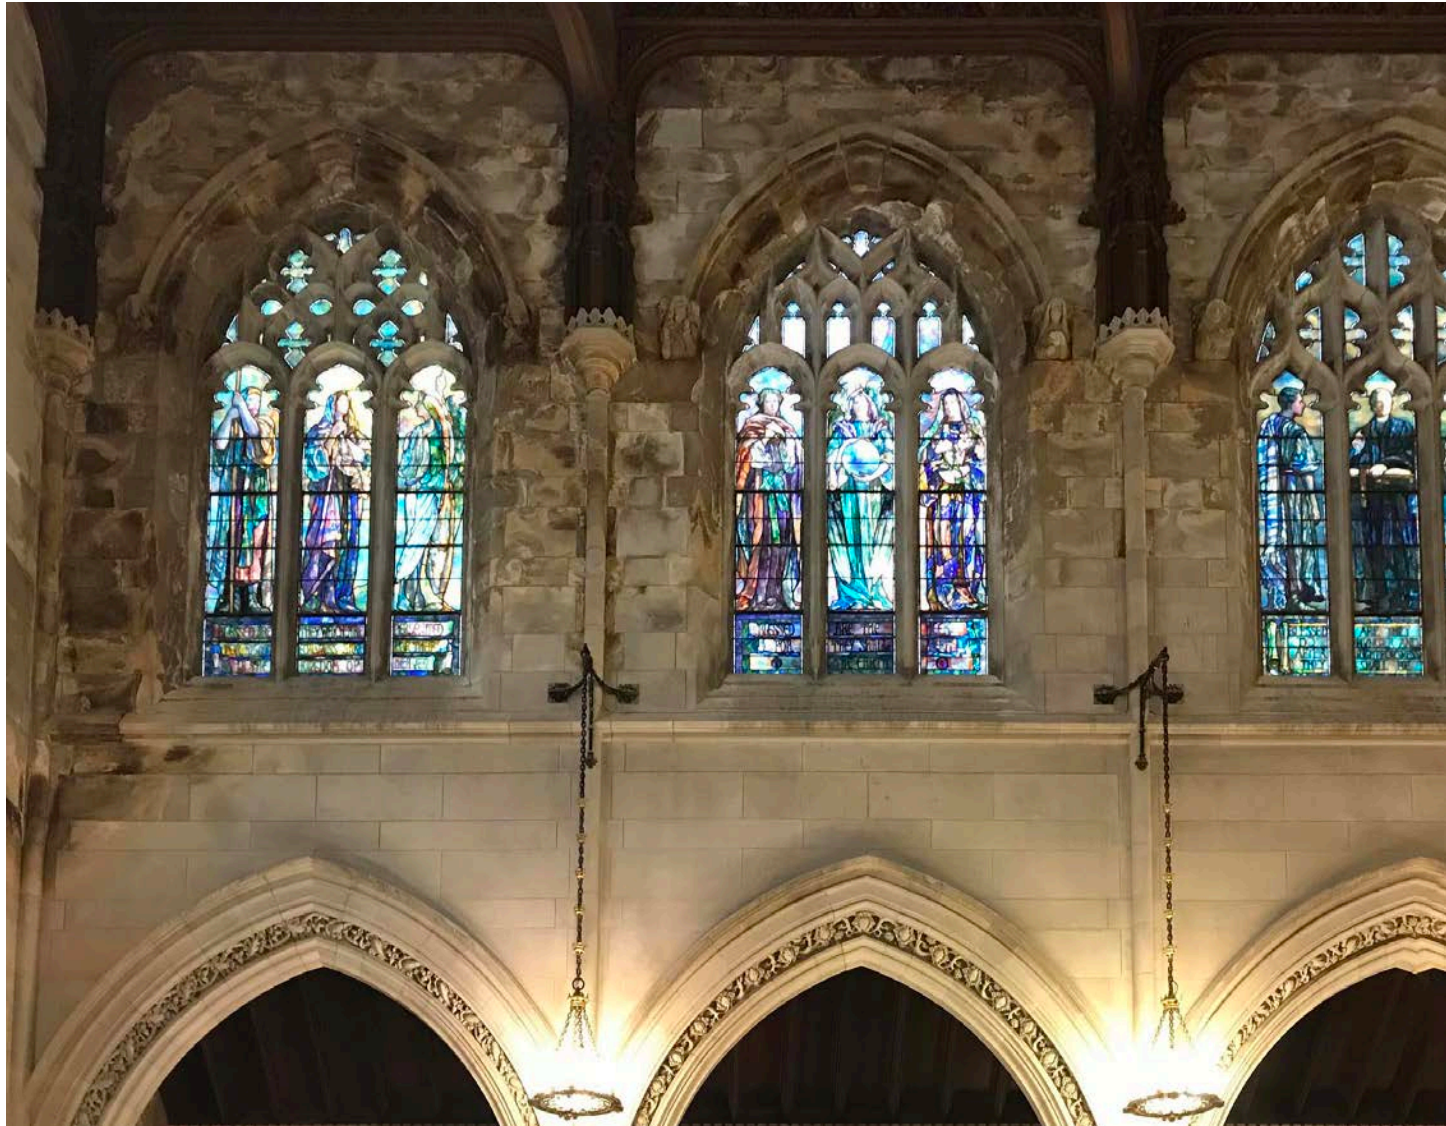
The south wall presents particularly pronounced moisture damage between the windows that is apparent across the entire face of the wall.

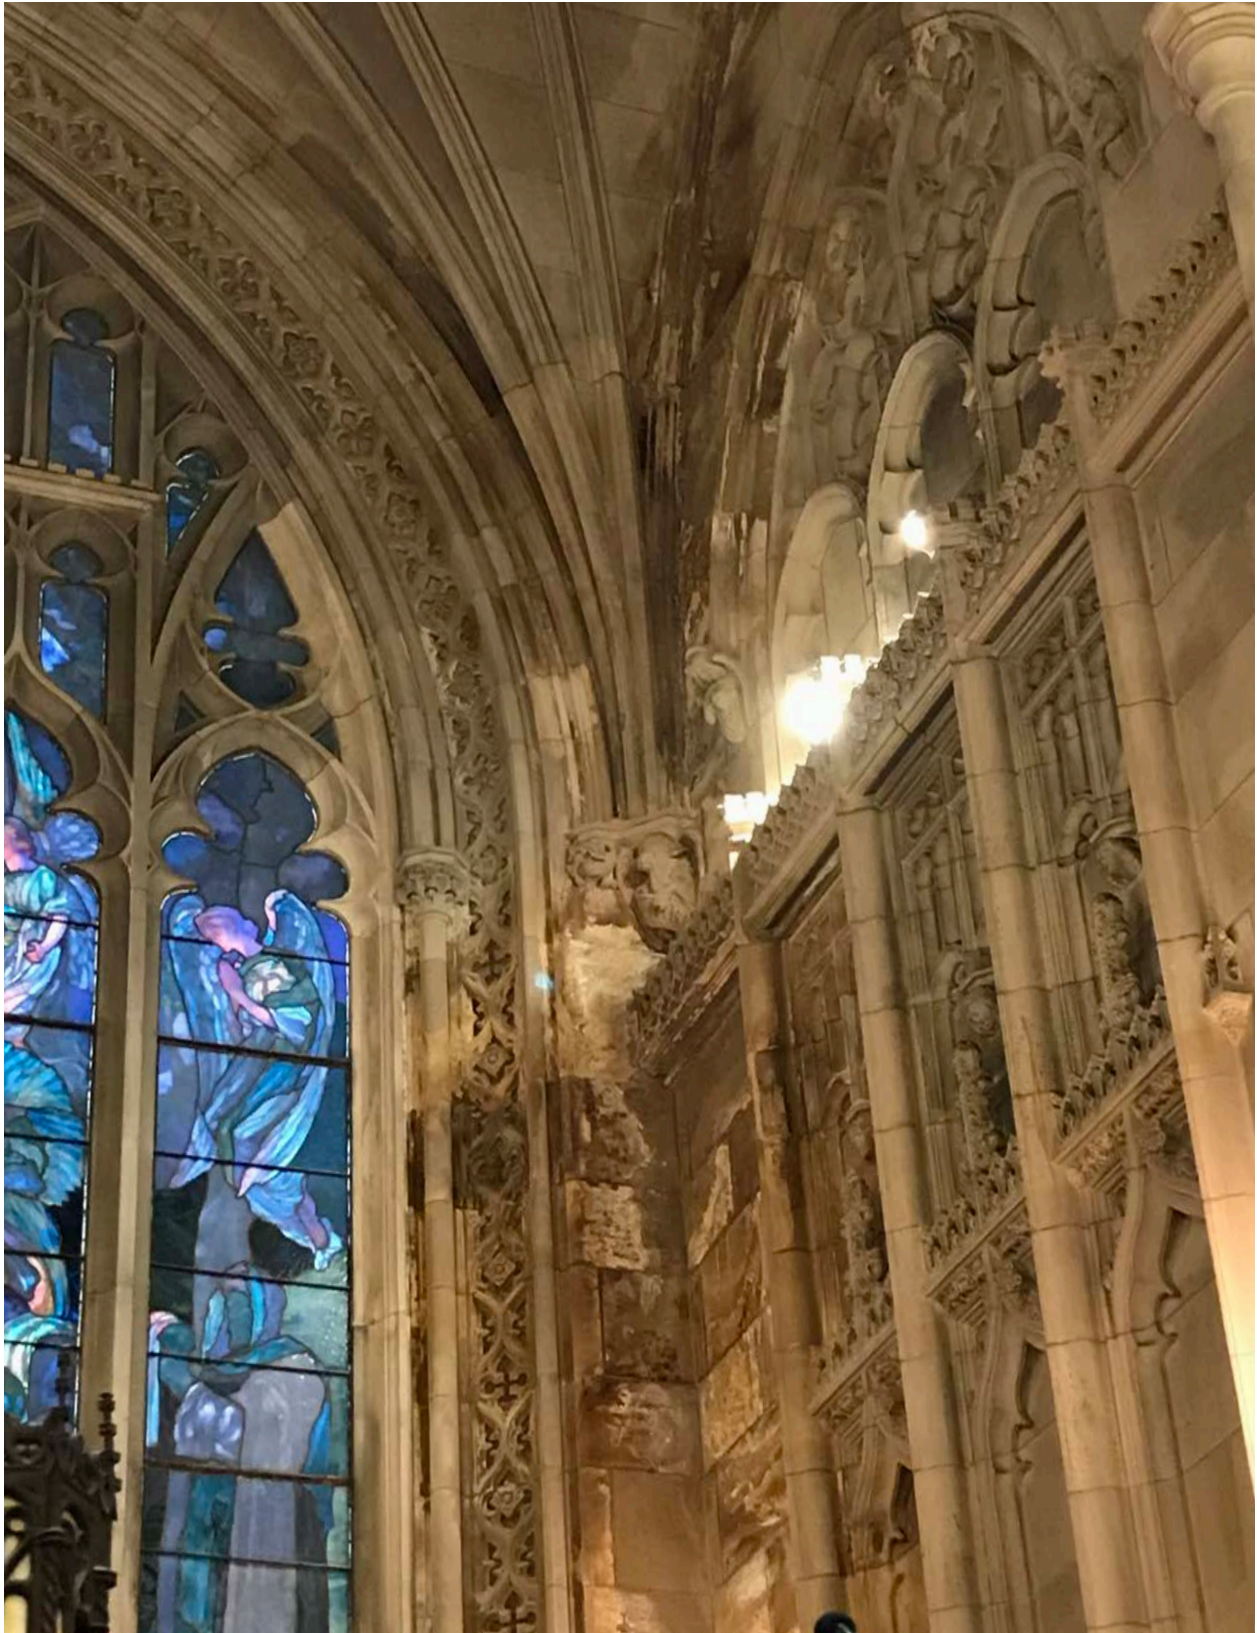
Moisture damage continues around the back of the choir and is particularly severe at the northwest corner.

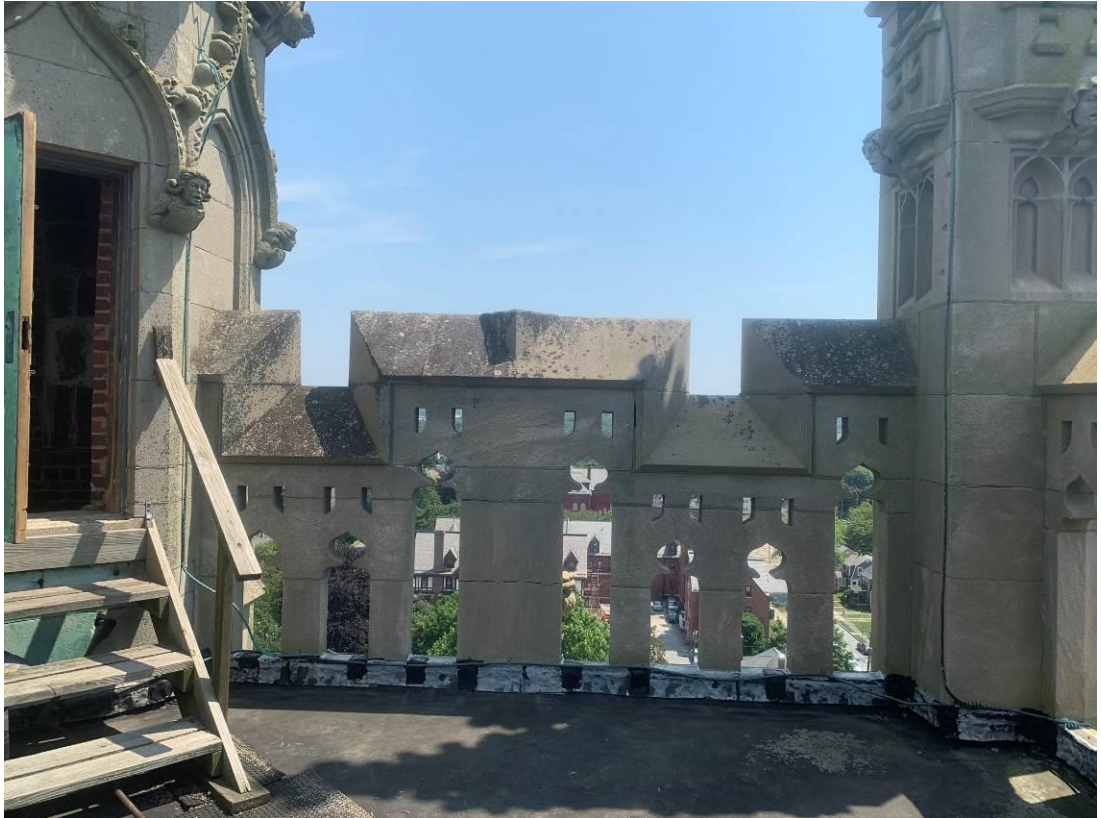
- A major portion of the mortar joints in the complex stonework in the upper parapets between the pinnacles atop the tower, where a small centered finial at each tower face is actually missing.

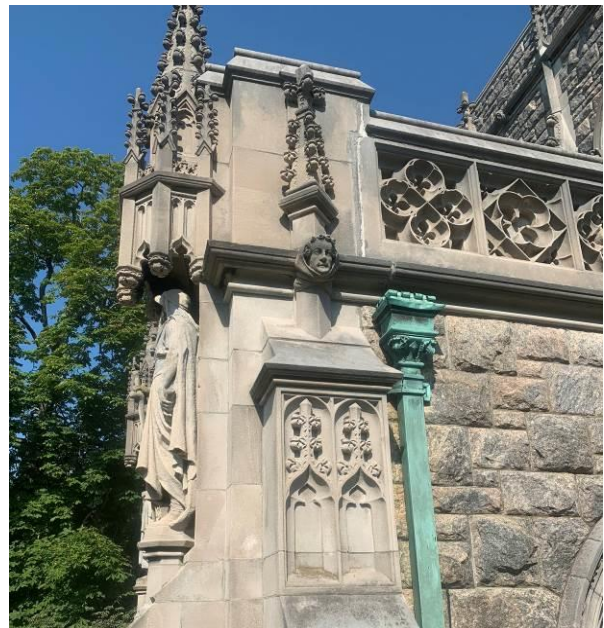
- Diagonal step cracks radiating upward to the south from the main window head arch at the east transept, and vertically below the center of the window.
- At the upper right corner of the northernmost ground-level window of the west elevation.
- At most of the head joints of the limestone string courses on the north and south clerestory walls and limestone coping above.

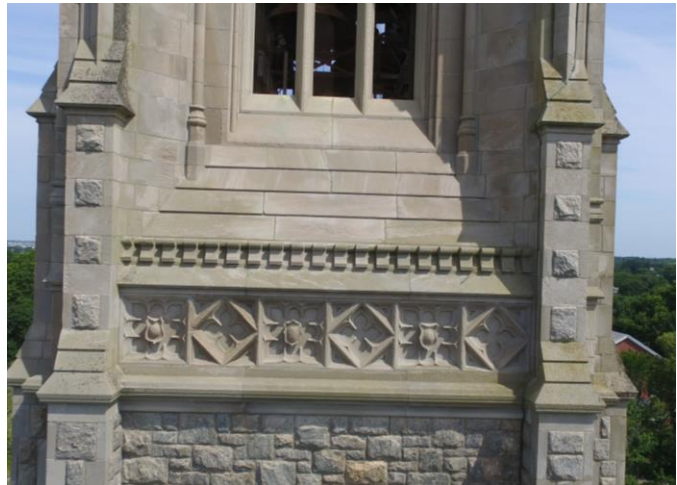
*These cracks should be accessed and inspected, and structurally investigated on a case-by-case basis and repaired appropriately. Repair may involve stitching, pointing and/or grouting.*

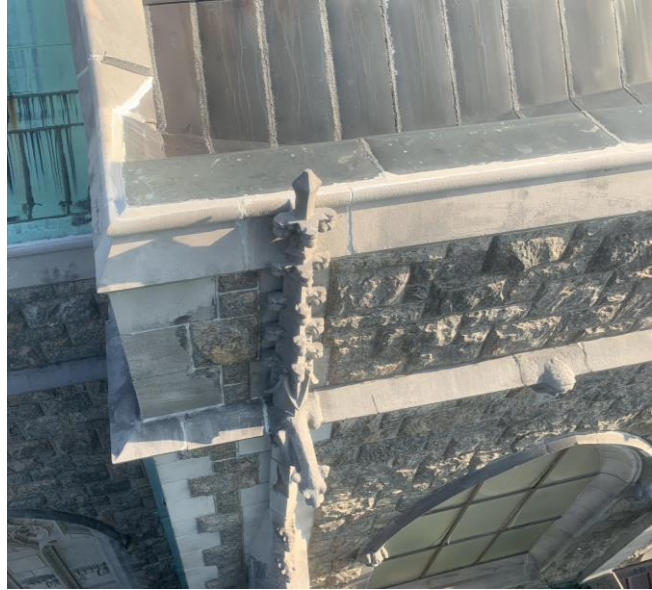
- There is a wide crack below the coping capstone at the apex of the west lower gable, and the capstone is loose and shifting upward. The carved limestone Celtic cross, which is atop this stone, has also lifted and can be wiggled by hand. *The shaft of the cross is fastened to the capstone with an embedded metal rod, which limits its movement, and provides sufficient resistance to prevent the cross from falling over.*

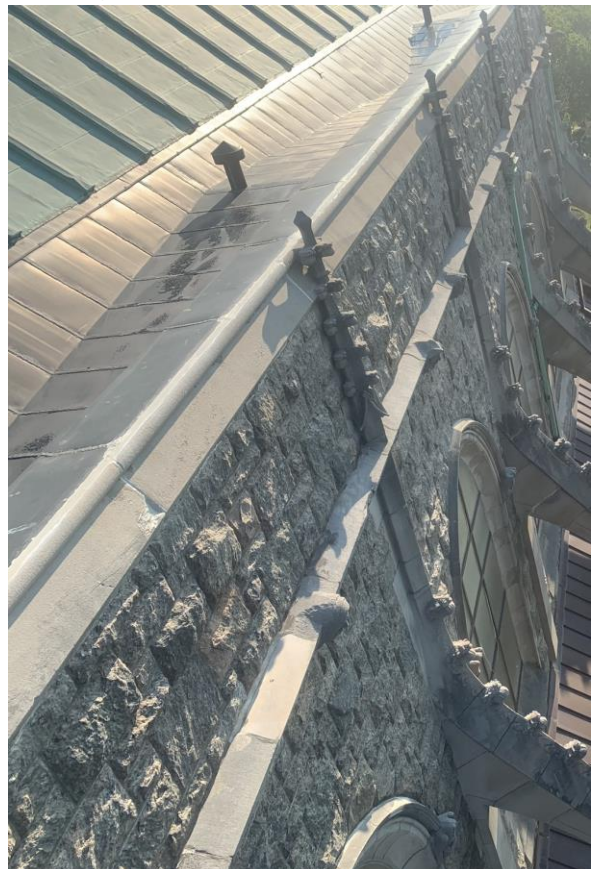
crocketed ornaments over the head of the window are likely also absorbing significant water, seeps downward.

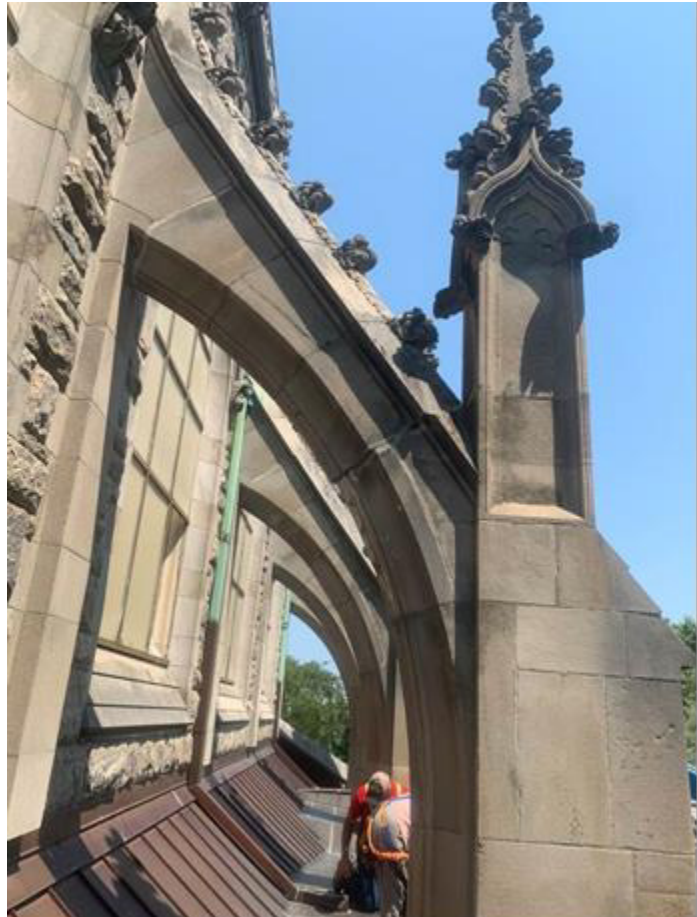
across the debonded joints in so that the stones can be suspended, rather than wedged in place. This would relieve the lateral thrusting forces within the arches and prevent further movement.

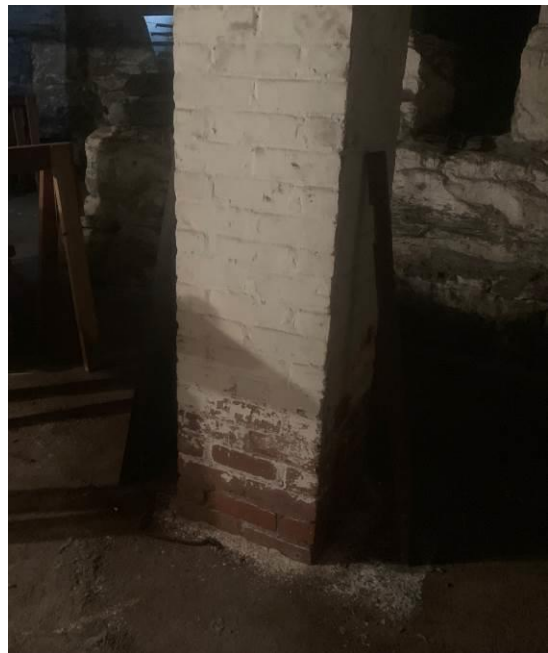
- B1:** Most of the brick piers that support the sanctuary level framing and three of the piers that support the side aisle columns have a minor to moderate amount of damage at the bottom due to the effects of rising dampness. This occurs when moisture from below the basement floor wicks up through the masonry and evaporates in the mortar joints and sometimes the bricks. The evaporation can enable water-laden mineral crystals to form within the masonry surfaces, causing the mortar surface to crumble and the brick surfaces to spall. Unfortunately, short of a major intervention such as pier replacement or through-pier flashing, this is a slow acting process that has taken 100 years to reach this point with little serious structural effect. We recommend repointing the joints and replacing the most damaged bricks as the damage slowly continues.

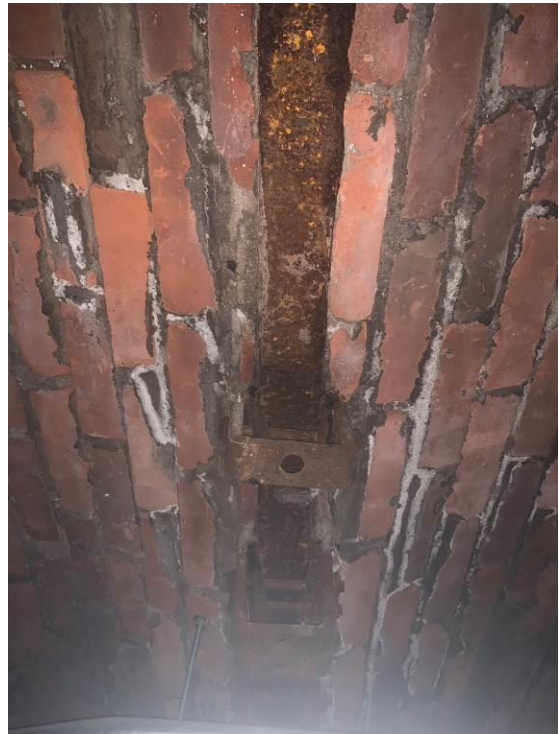
### ***Interior/ Sanctuary Level-***

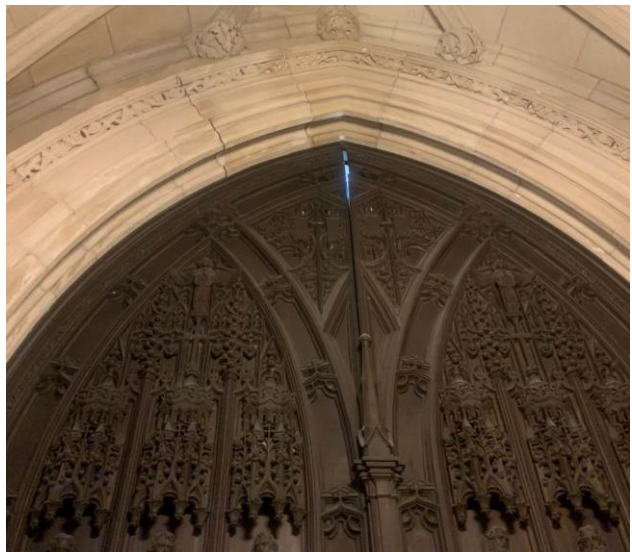
be repaired by chinking and grouting the mortar bed joints, then the surround and/or the head of the door should be trimmed in order free the leaf from its compressed-in-place condition.

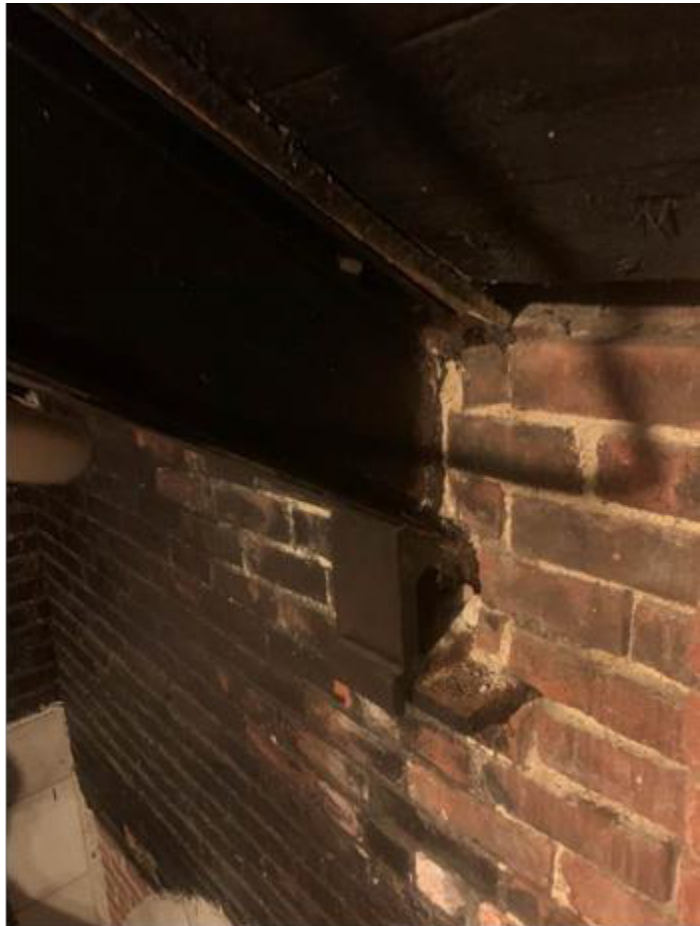
cleaned of all rust and reinforced with welded or bolted steel attachments, then painted with a rust inhibitive undercoat and an epoxy based top coat, and then the brick replaced.

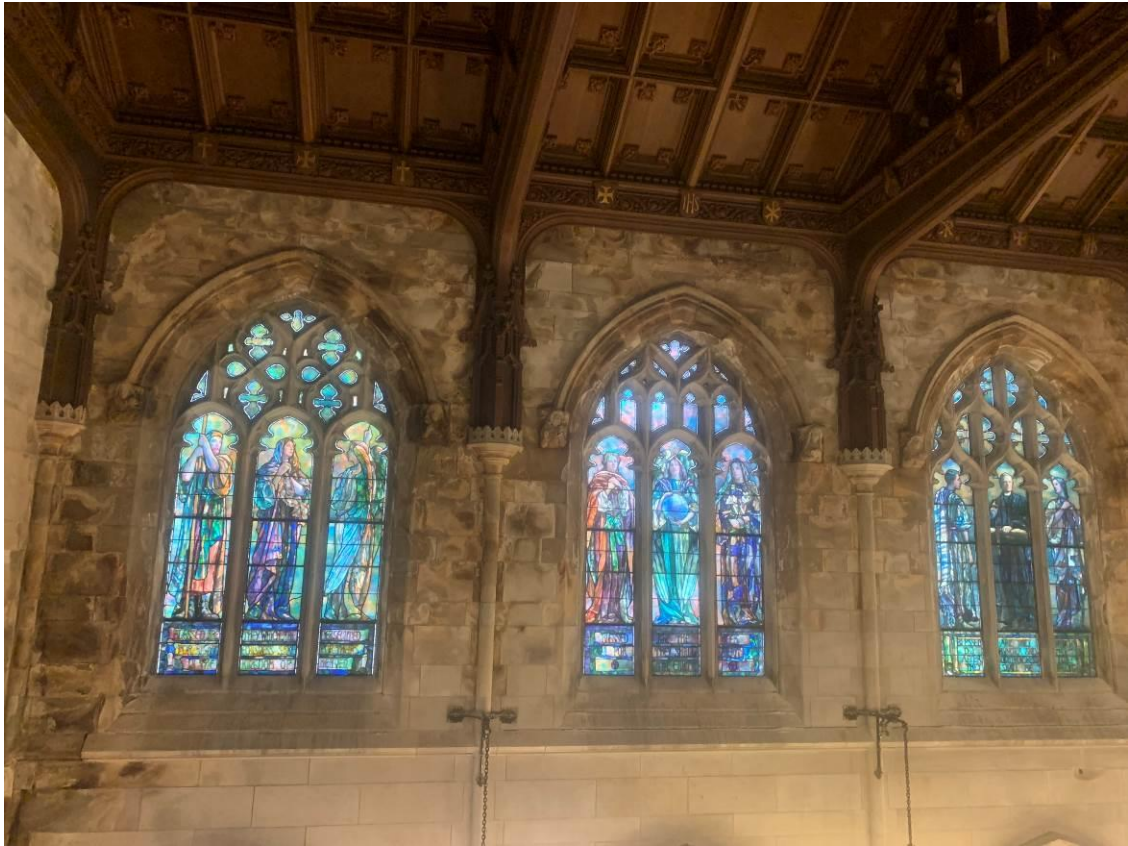
### ***Interior/ Tower-***

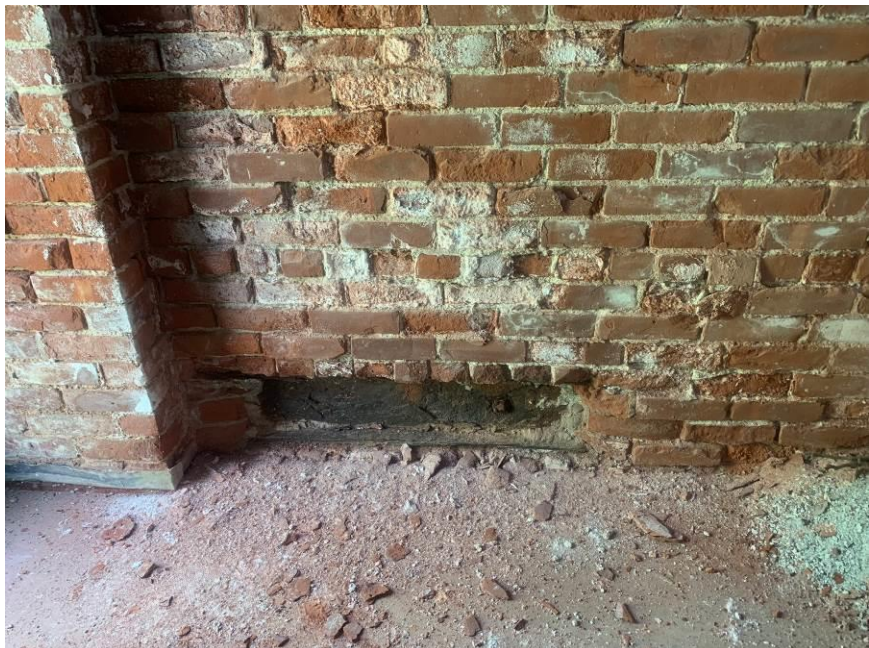
*removed and replaced with new steel. The adjacent door opening would need to be filled in or shored during this work, which will temporarily weaken the corner.*
