Conditions Assessments and Treatment Recommendations for  
UNITARIAN MEMORIAL CHURCH

FAIRHAVEN, MASSACHUSETTS  
19 DECEMBER 2019

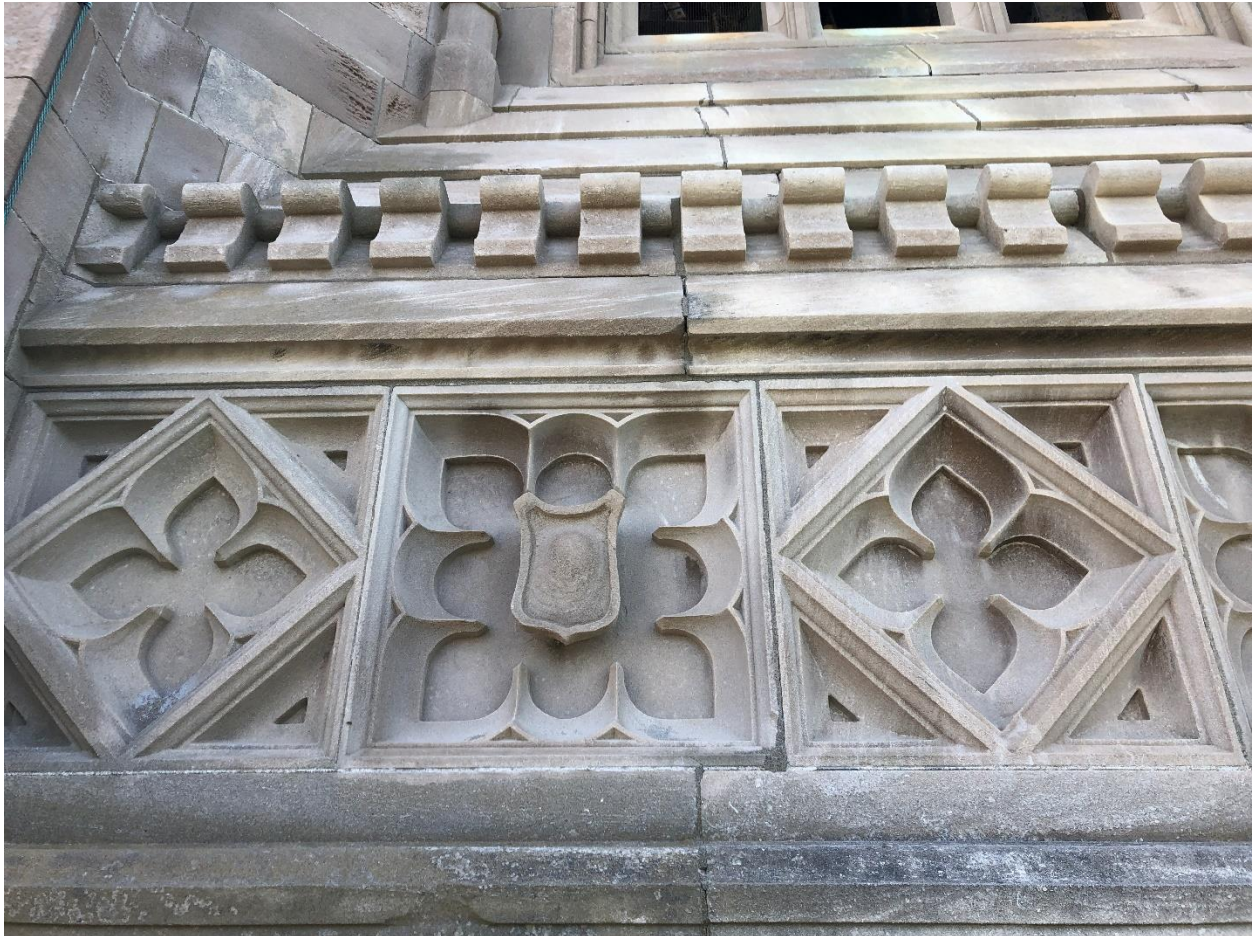
Open upward facing mortar joints near the top of the tower. Erosion from wind and water as well biological films and efflorescence are visible on the limestone.

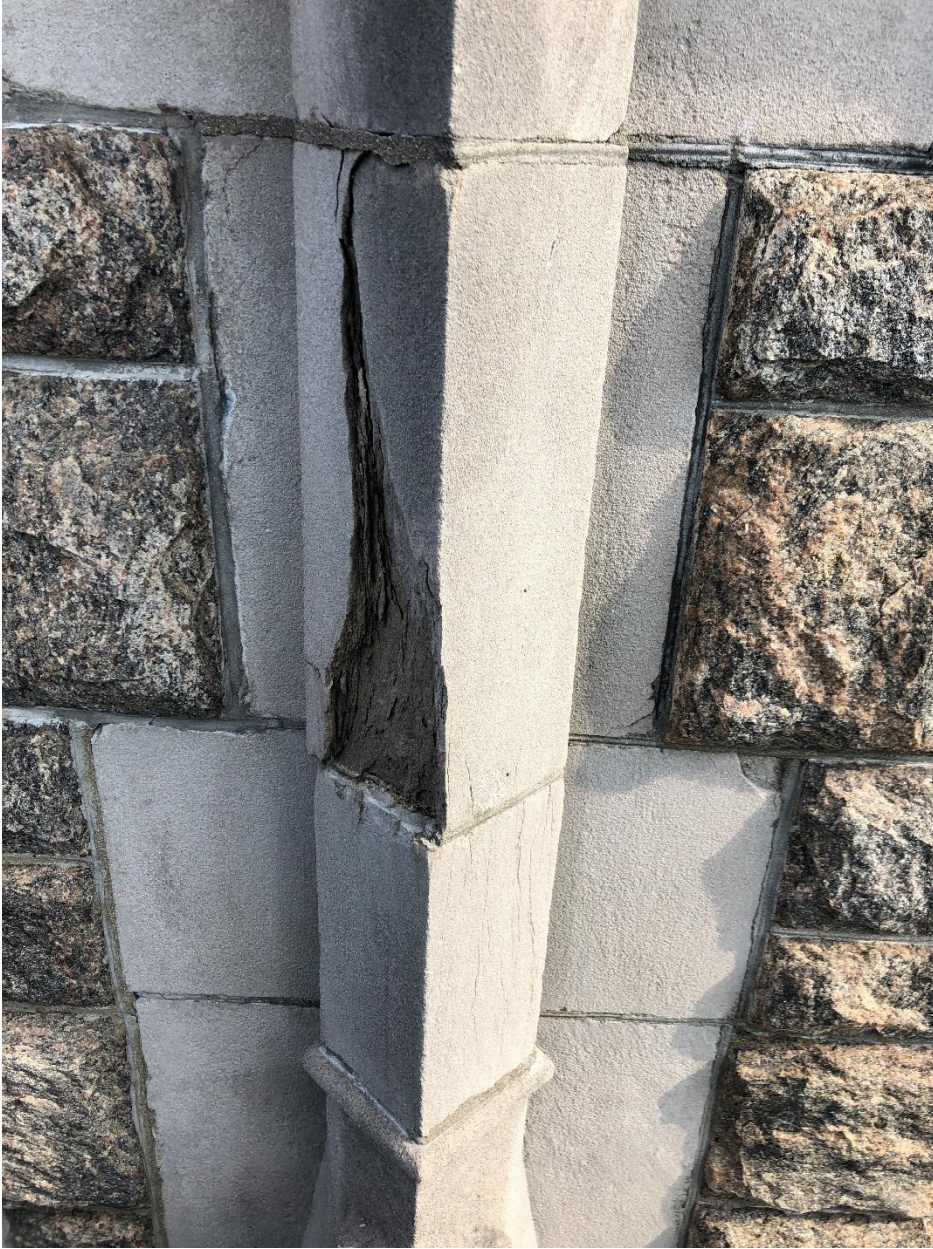
The cracking and delamination of the limestone units engaged in the granite wall is primarily due to frost damage. Water that enters the granite wall is saturating the limestone in these locations. In the winter, when the temperatures drop quickly, ice forms within the pores of the saturated units.

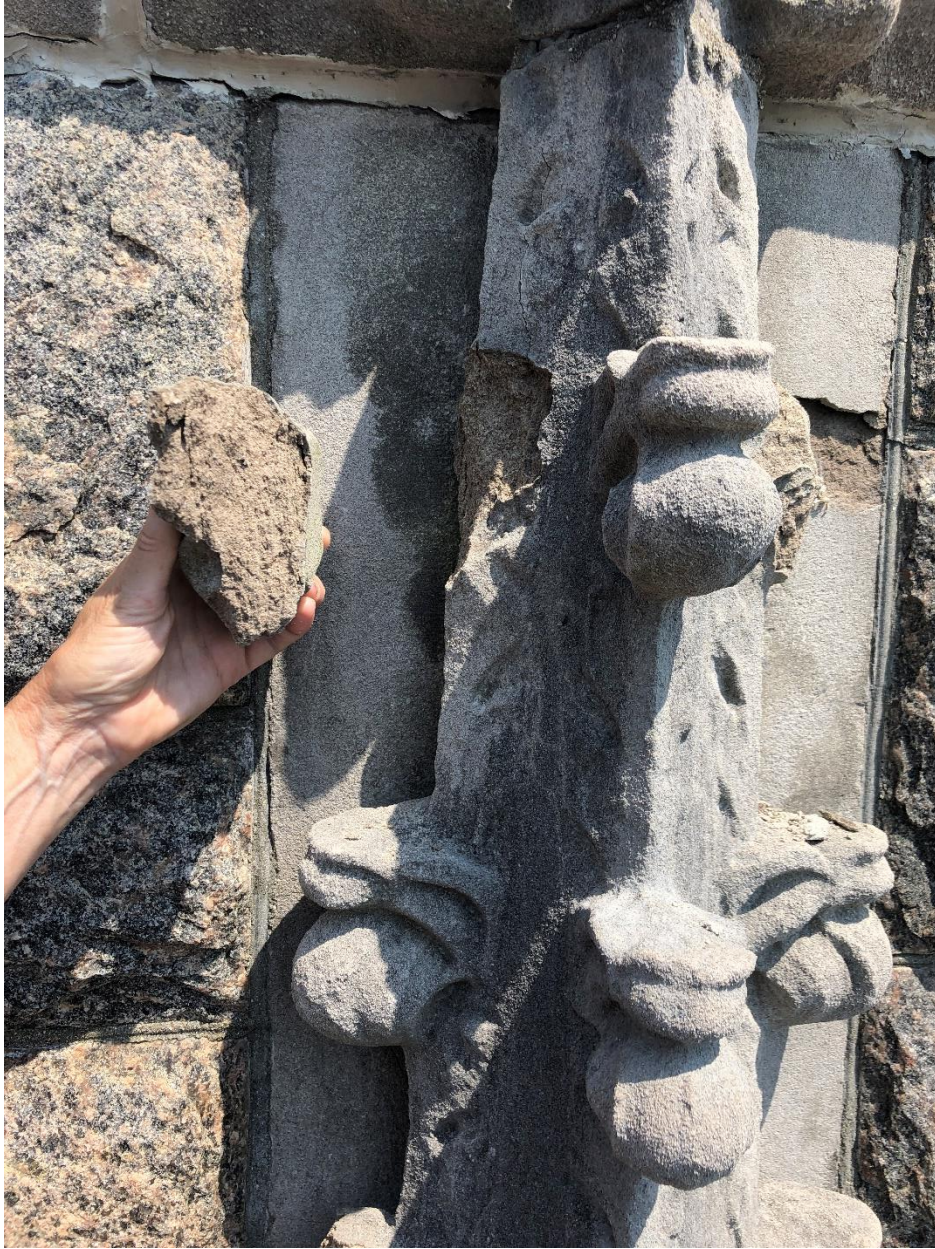
The mortar joints repaired with sealant have accelerated the frost damage by trapping moisture within the wall. Properly formulated mortars allow moisture to exit the wall at the joints. Sealants are completely impermeable and do not allow moisture to exit.

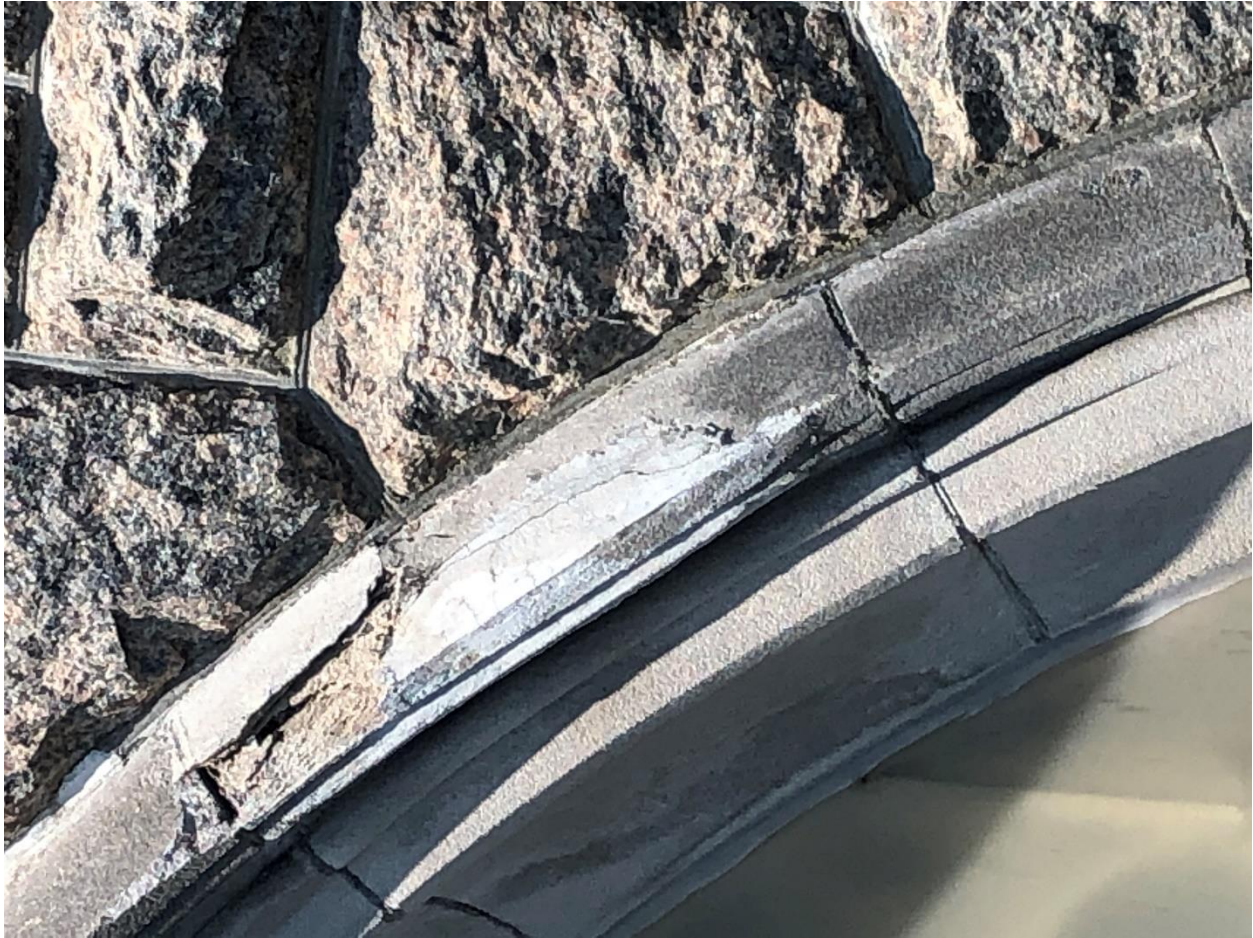
Many of the limestone units that make up the window arches along the north and south elevations are damaged from frost. Some of these units have been repaired with mortar but the repairs have failed because the underlying water infiltration problems were not addressed before the repairs were made.

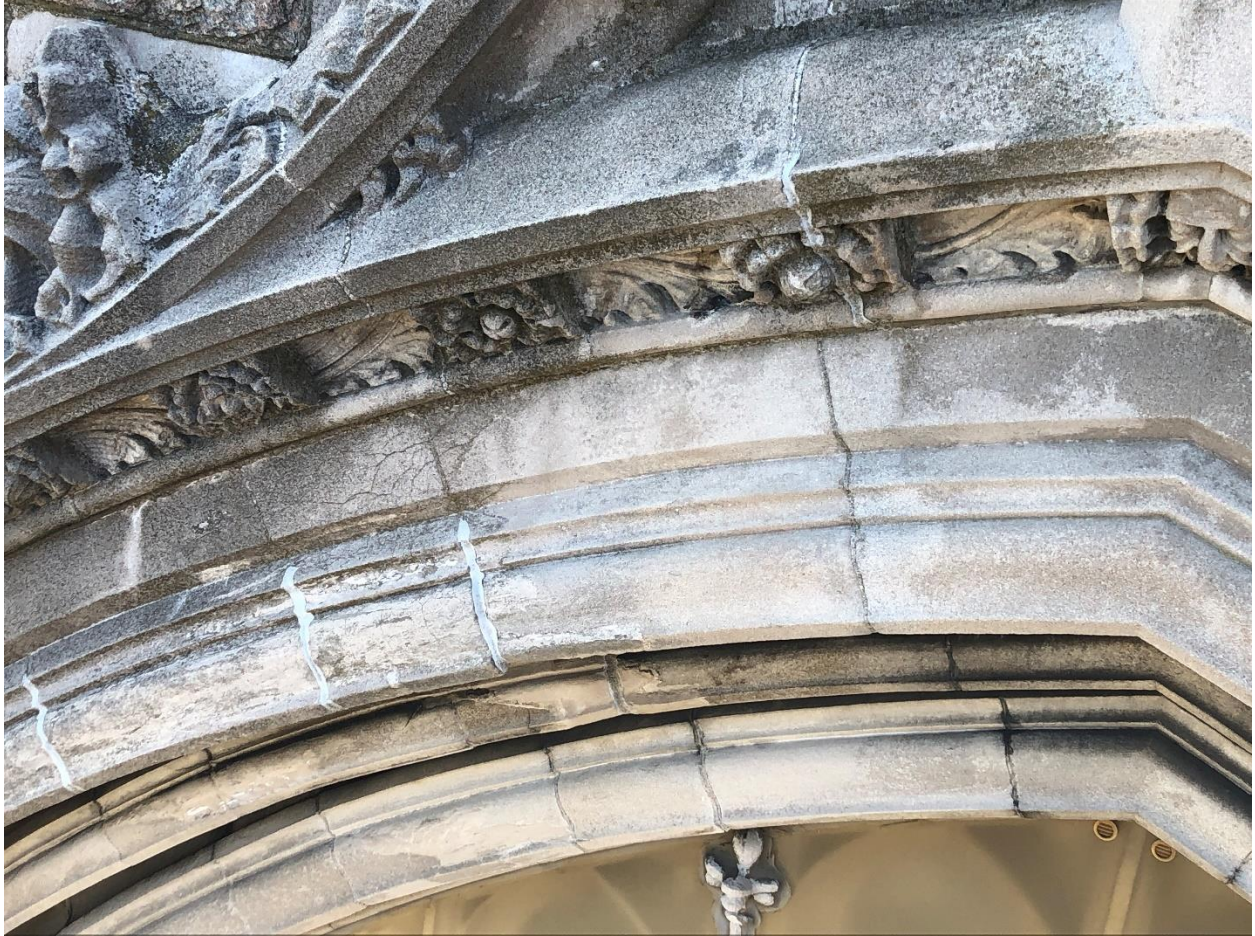
The limestone units at the large arch on the east elevation are cracked as a result of frost jacking. The network of thin cracks visible in the photograph above are the early signs of advancing frost related damage. These units are particularly important because they protect the tracery below which holds the stained glass. Left unchecked, the deterioration of the arch units will eventually undermine the stability of the stained-glass window on the east elevation.

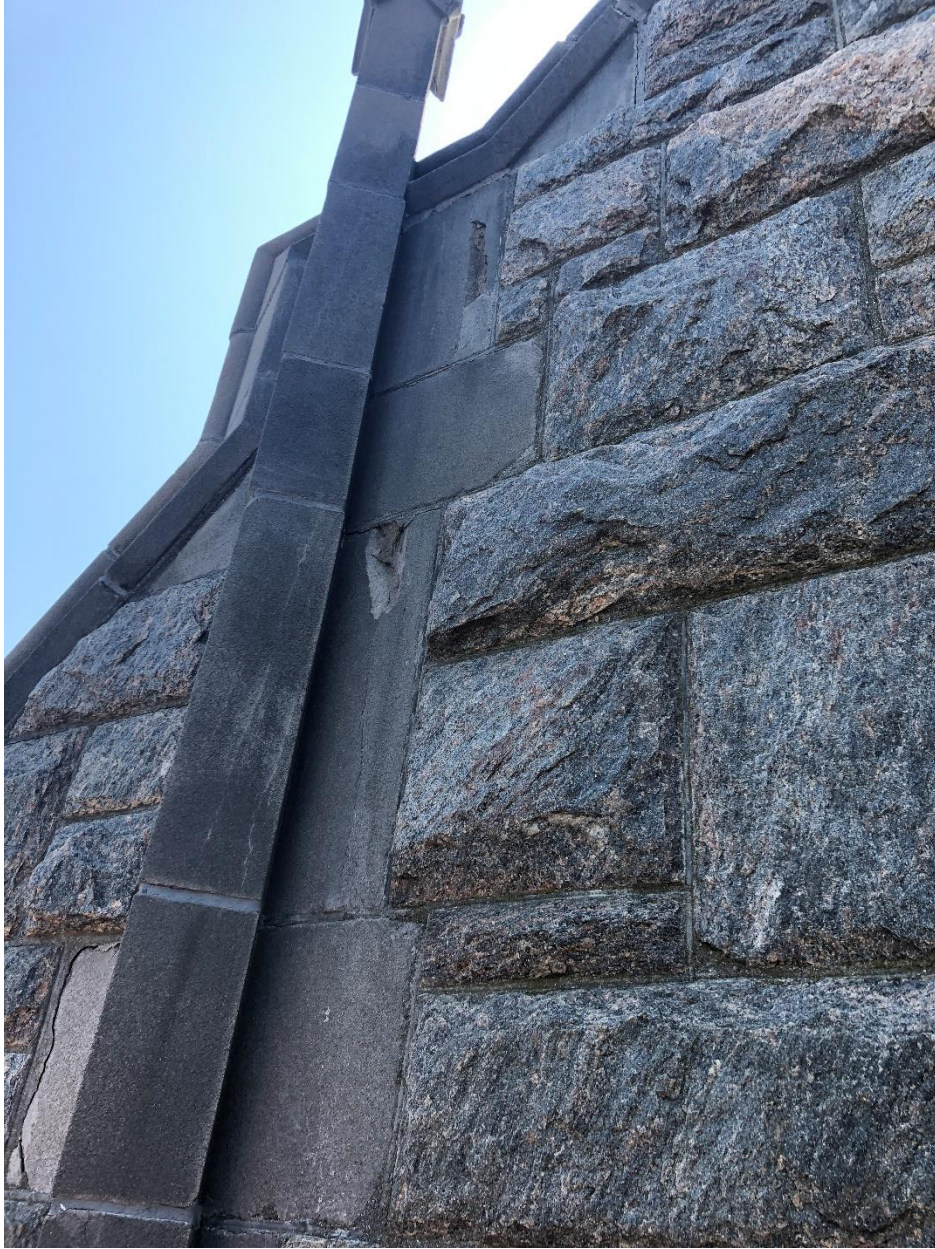
The engaged limestone units on the east elevation gable in the photograph above are cracked as a result of water infiltration into the wall through open joints and the lack of flashing under the coping stones at the top of the wall.

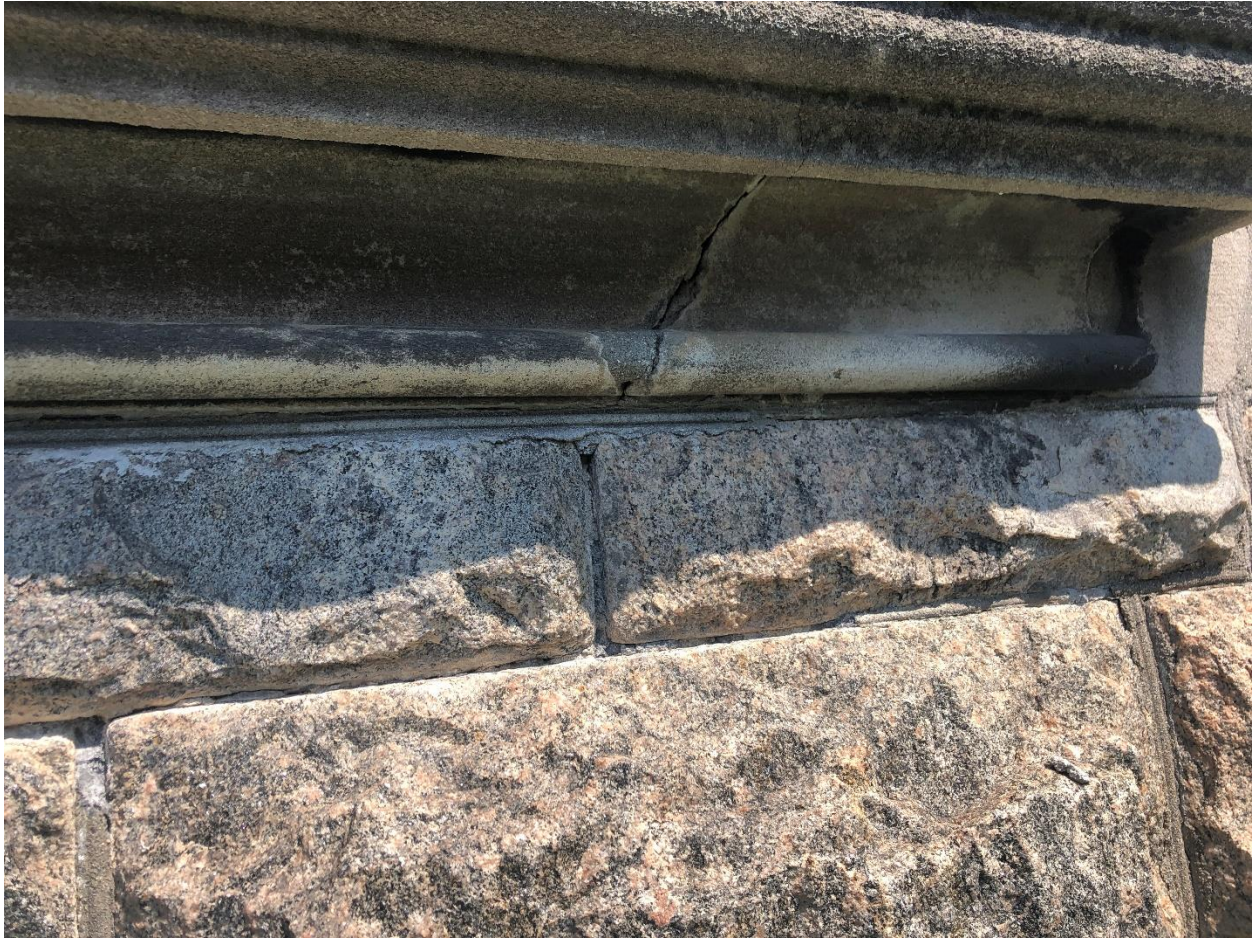
Water infiltration through open vertical joints in the limestone bands is responsible for the deterioration of the mortar between the granite ashlar units located below the open joint.

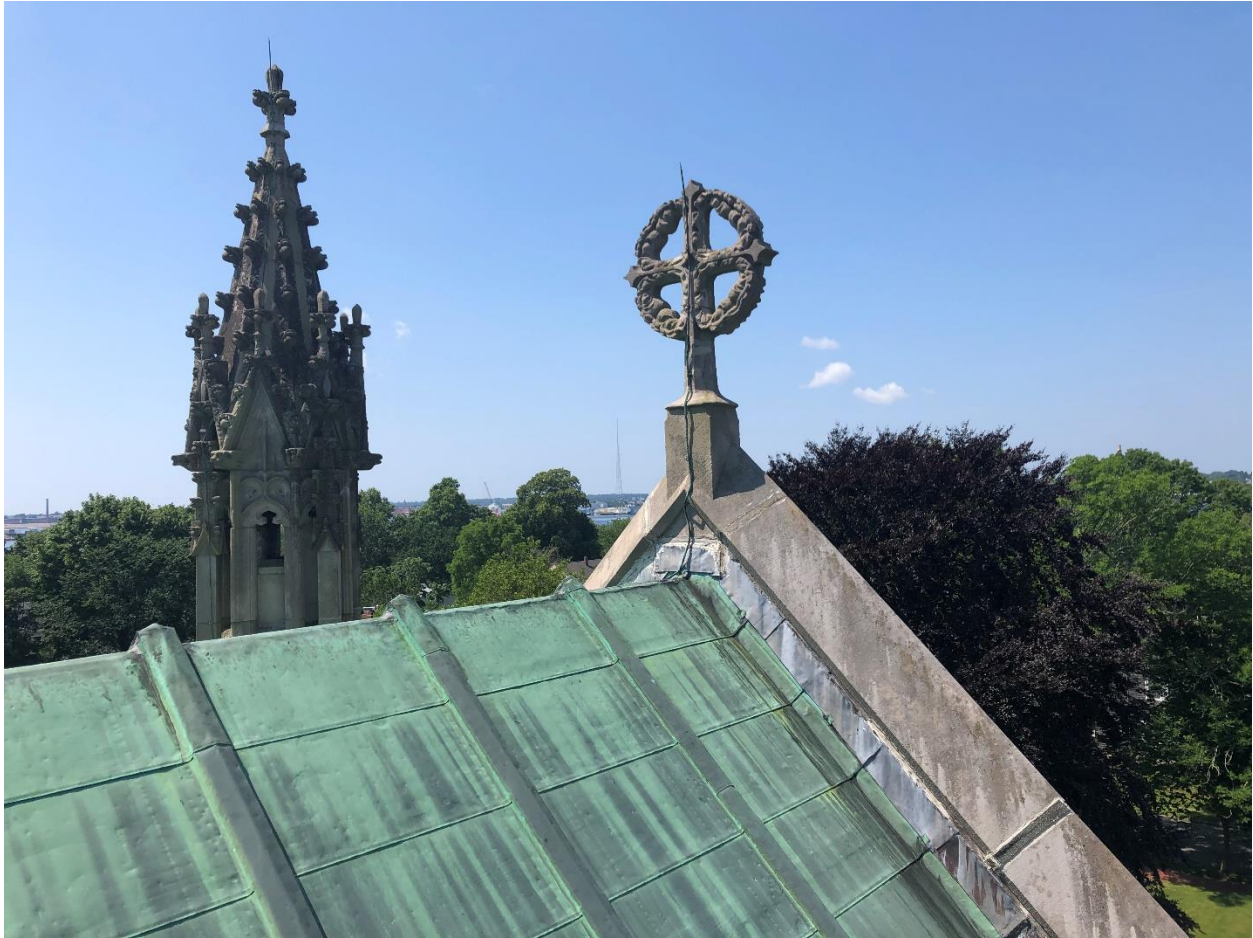
The Celtic Cross on the top of the west gable is loose due to the deterioration of the setting mortar. The cross is bearing on the dowel between the units not directly on the unit and moves visibly in the wind. Currently, the cross is restrained by the lightning rod that bridges the upper and lower units of the assembly.

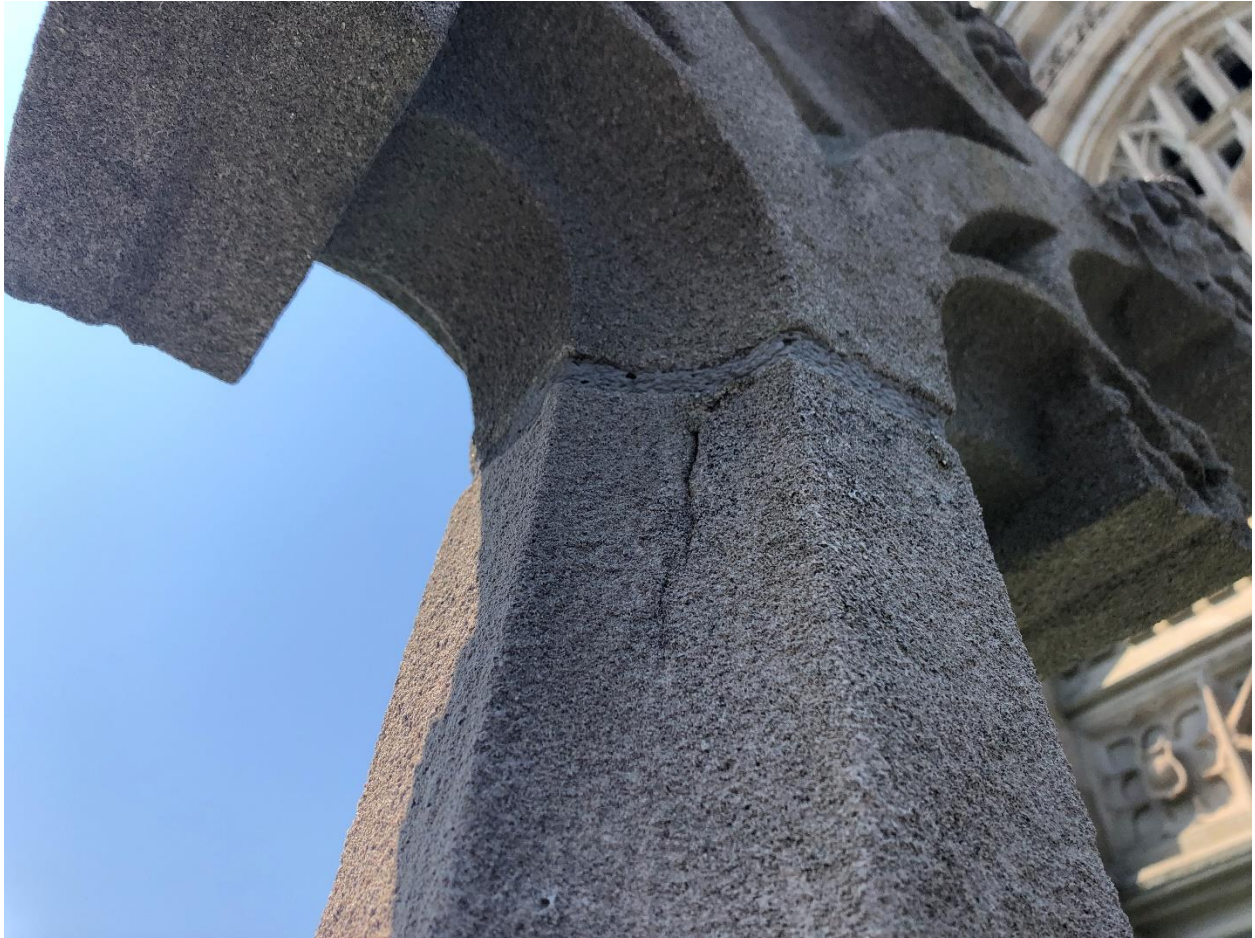
The unit that supports the Celtic Cross on the east elevation is cracked in several places. The cracking may be due to the corrosion of a steel pin between the units but is more likely the result of water freezing in the dowel hole in the lower unit. Water travels easily through the setting beds of freestanding units because it has access from all sides.

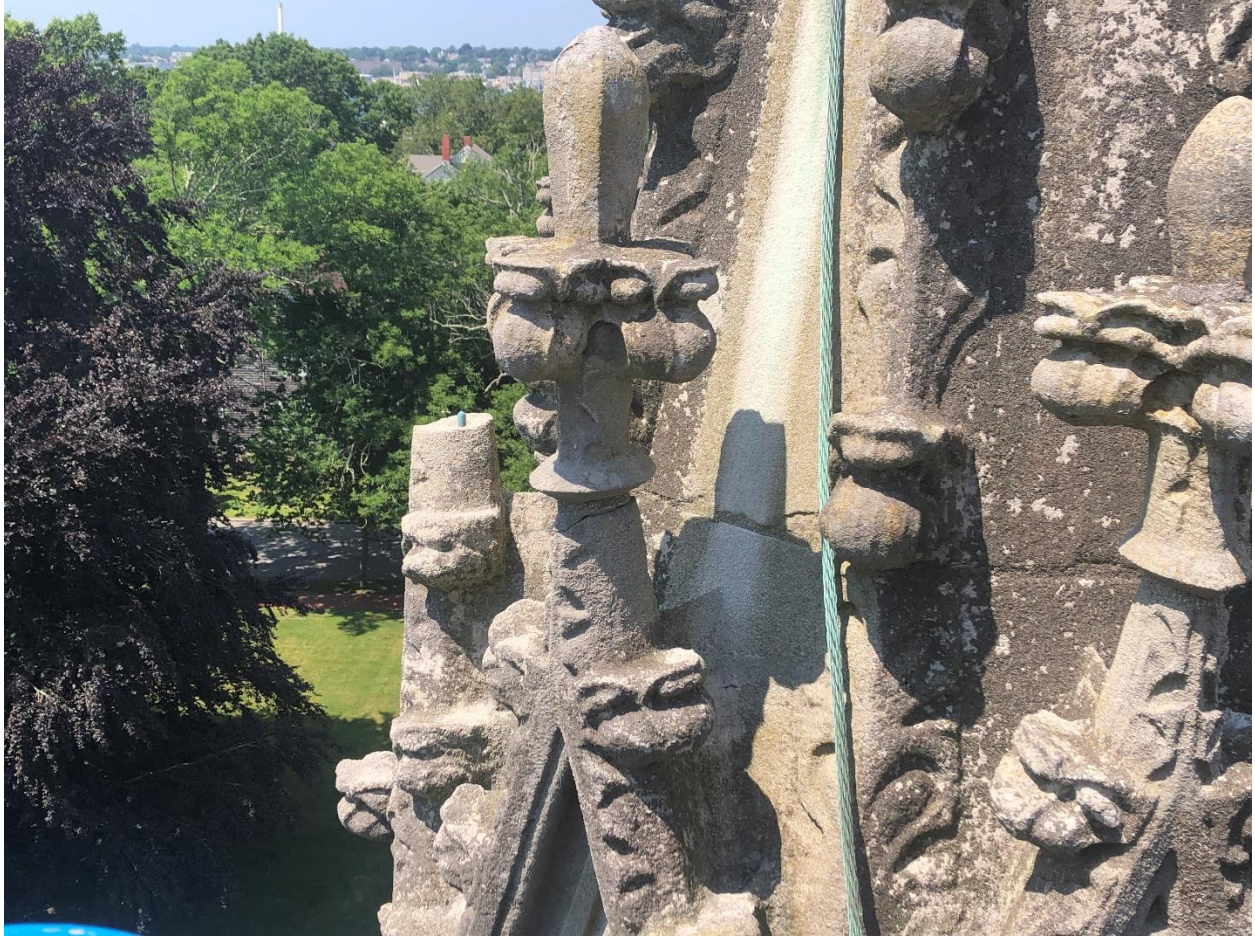
The finial on the left has cracked as a result of water freezing in the dowel hole not from the corrosion of a steel pin. The original pin made from bronze remains in the stone. The mortar bed of the finial in the foreground is cracked and the unit is loose. The pin at the center is keeping the unit in place but left untreated, it will eventually crack in the same manner as the unit to the left.

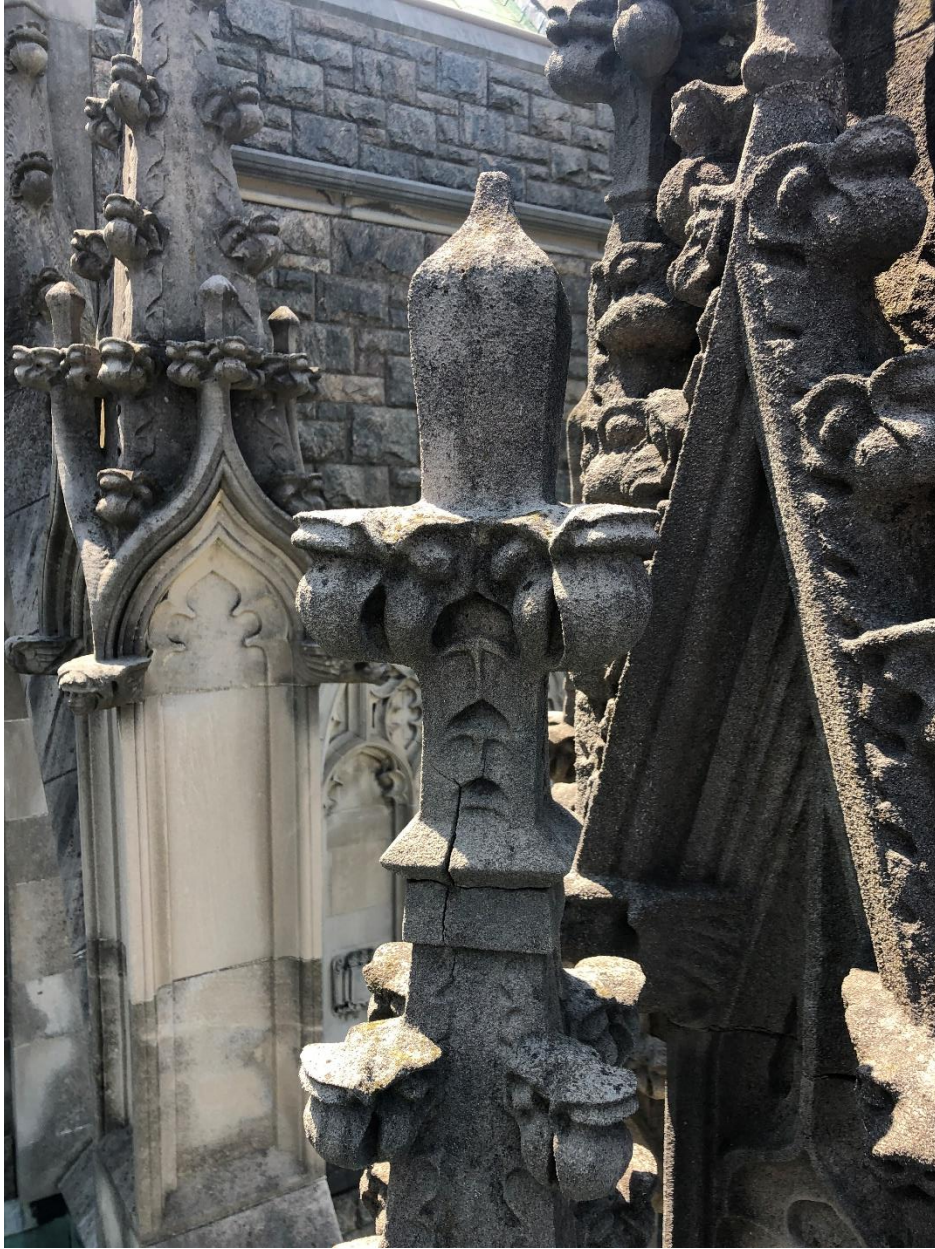
The cracking of the finial in the center of the image is due to the expansion of a corroding steel pin. When this unit was removed during the survey in August, the remains of the corroded steel pin were visible.

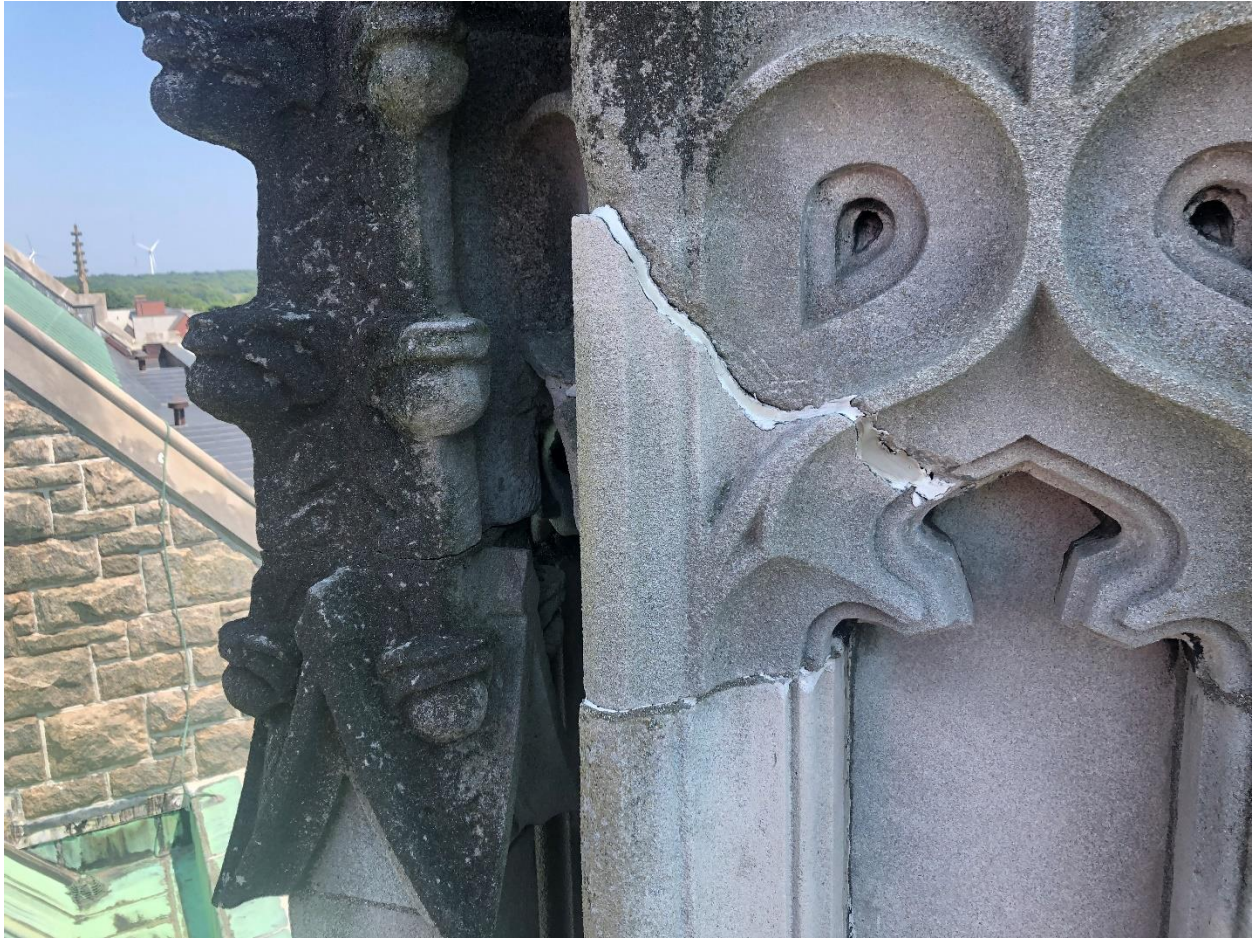
The large pinnacle on the southside of the west elevation was damaged by lightning and repaired with sealants. The repairs have reached the end of their service life. The cracked fragments have to be removed and reattached with an exterior rated stone epoxy.

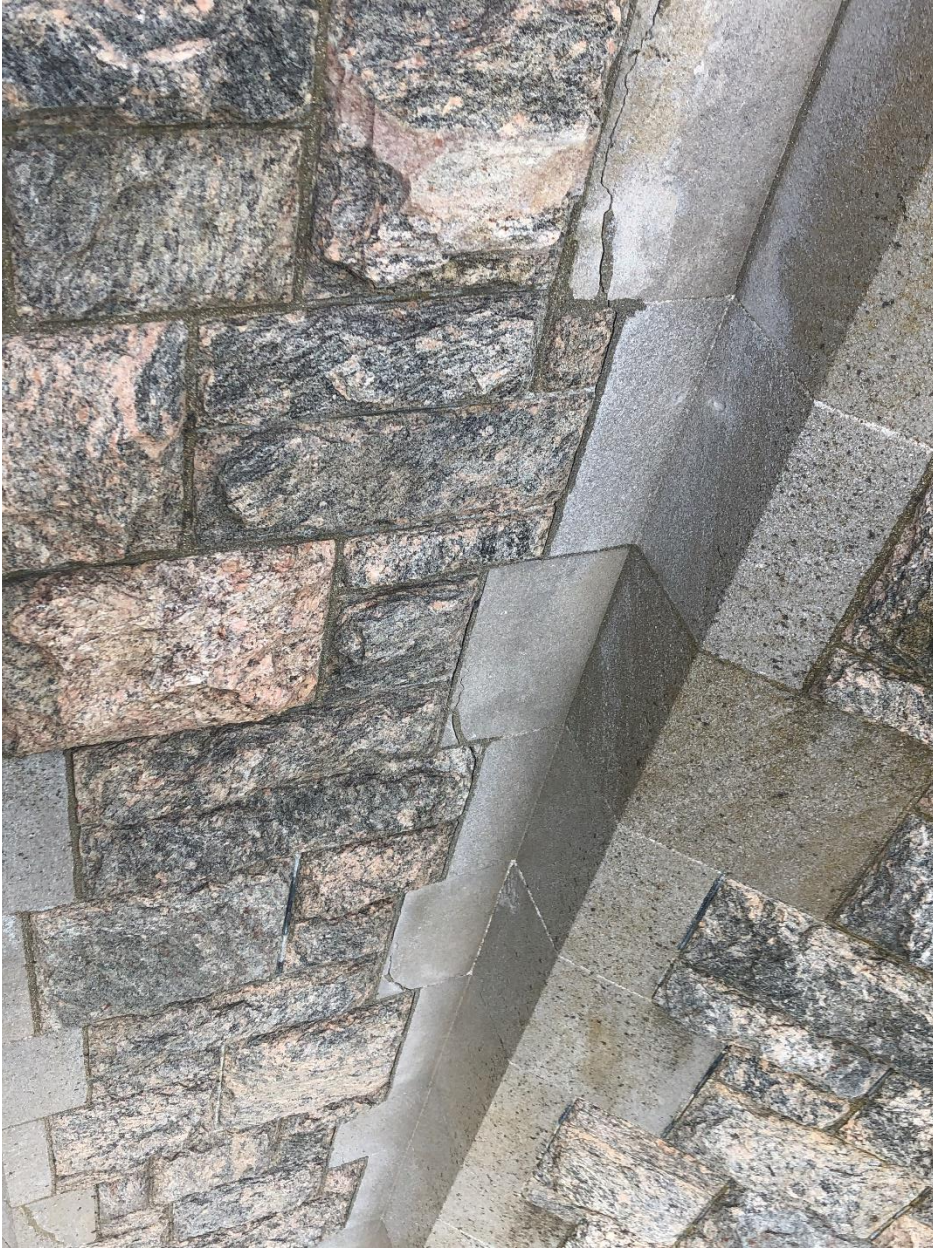
There are several long vertical cracks running through the base of the turret on the northeast corner of the tower. These cracks are likely due to seasonal movement but it is possible that they are the result of steel incorporated into the masonry.

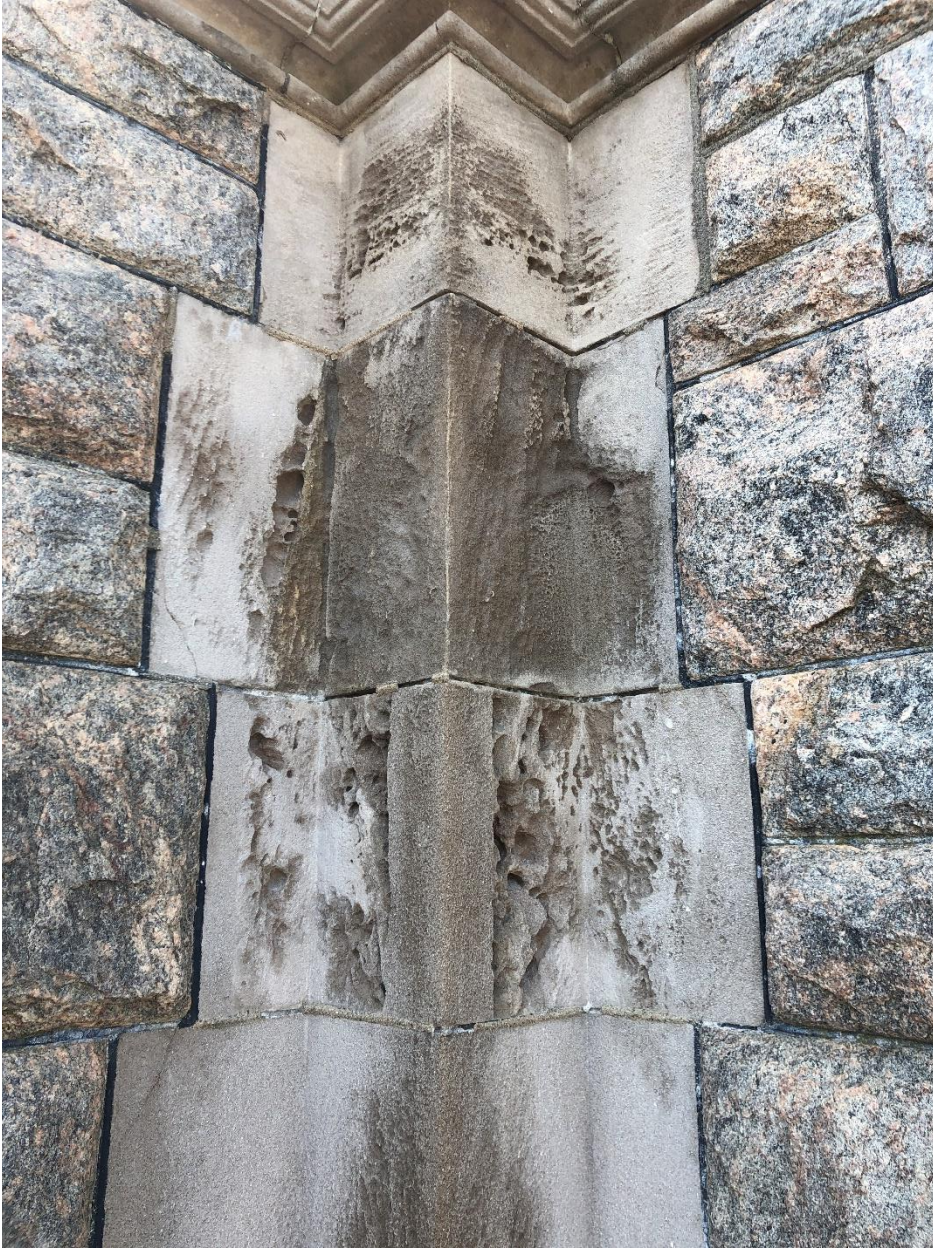
On the east elevation there is severe pitting and erosion of the limestone corner units. This type of deterioration is due to a combination of factors involving the weakening of the stone from salts and wind and water erosion. While this type of pitting is visible on all elevations it is more pronounced at inside corners,

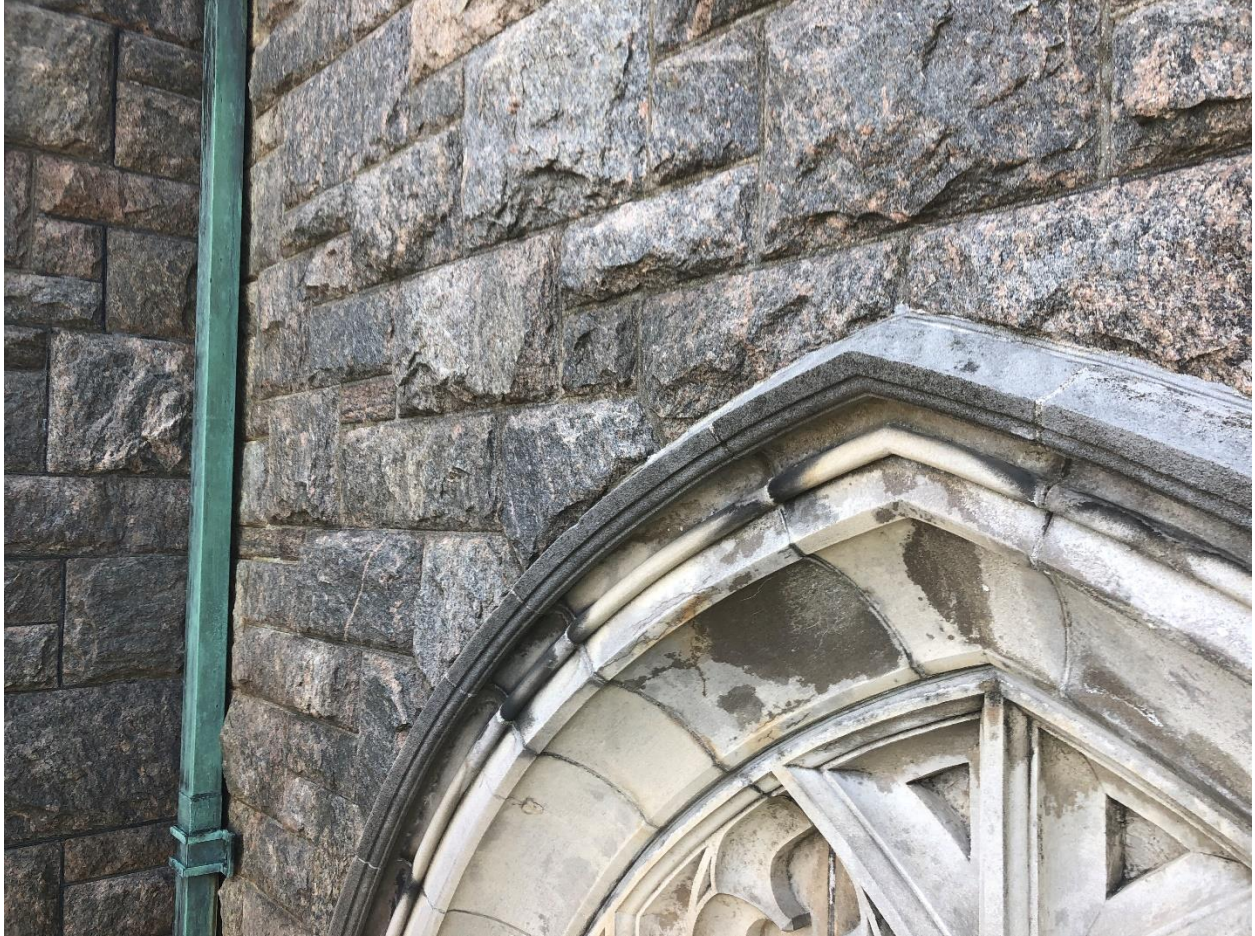
The mortar to the left of the downspout is likely the original mortar. The mortar in this location has a distinctive dark almost black color and a raised, rounded profile.

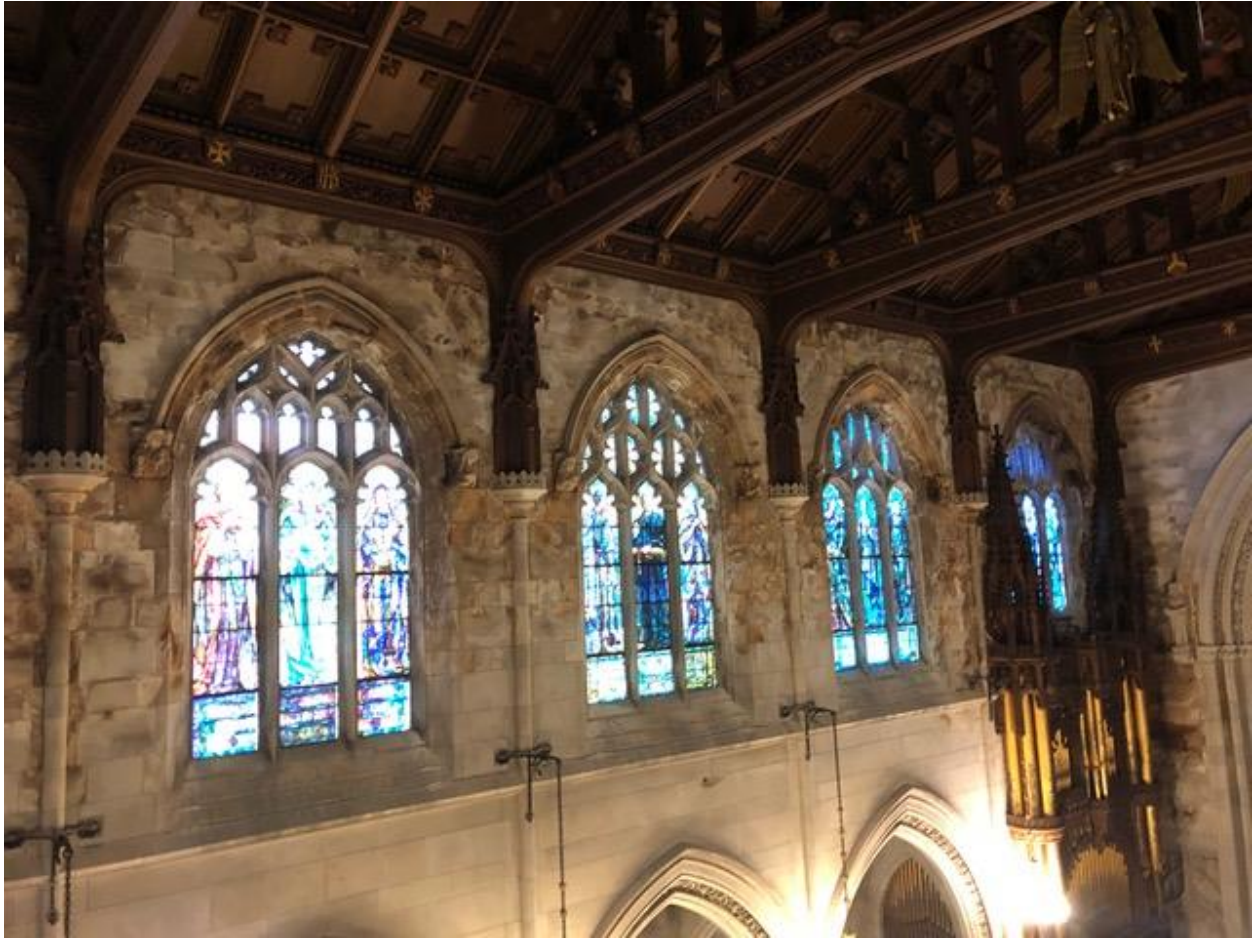
The rust staining and stone deterioration on the interior of the nave are due to water infiltration from the exterior. There are several sources for the water infiltration including defects in the roof gutters, open mortar joints and lack of thru wall flashing. The rust stains are the result of the corrosion of steel anchors and in some locations internal iron downspouts.
