FAIRHAVEN HIGH SCHOOL

EXTERIOR MAJOR IMPROVEMENTS 5 YEAR PLAN

NOVEMBER 2016

SPENCER & VOGT GROUP
architecture preservation

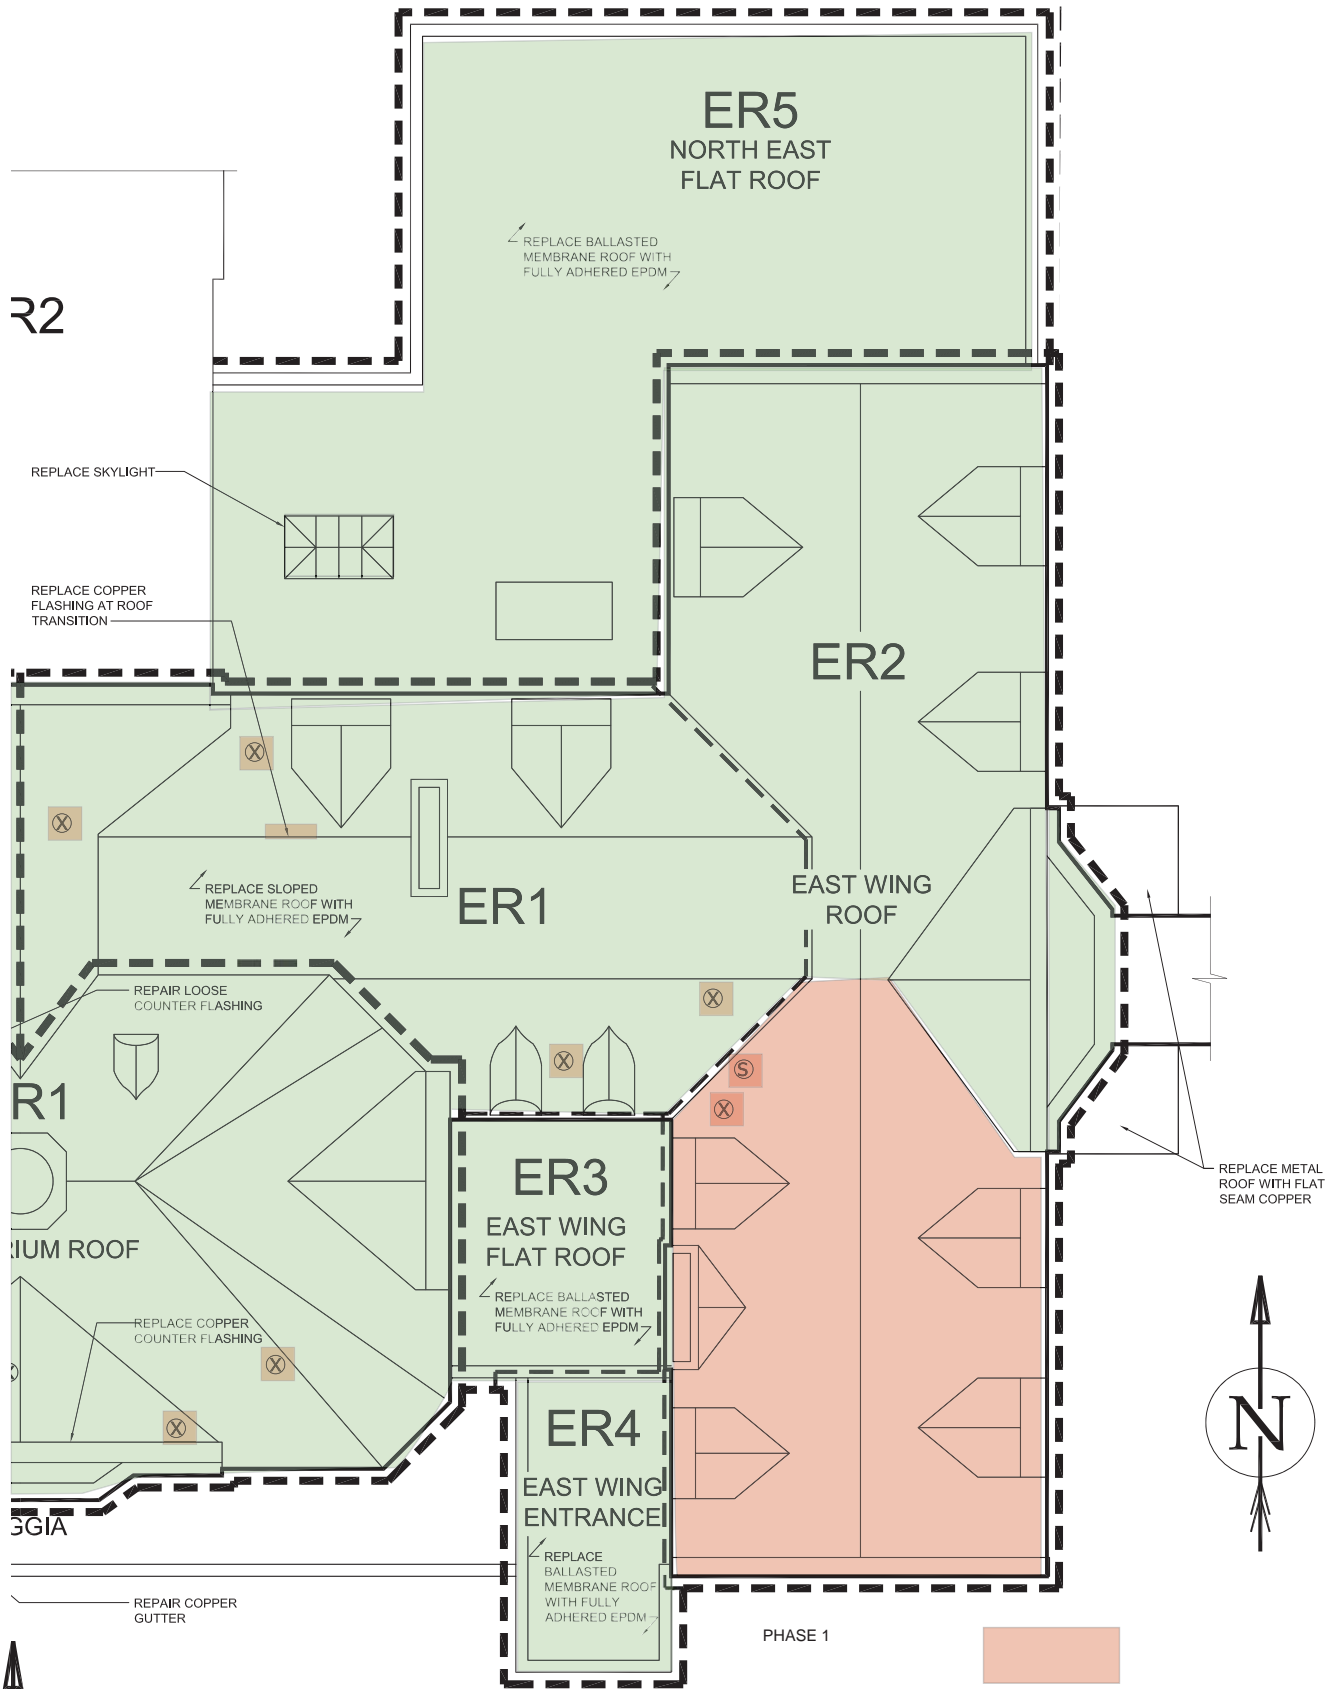
REPAIR LOOSE COUNTER FLASHING

REPLACE SKYLIGHT

REPLACE COPPER FLASHING AT ROOF TRANSITION

REPLACE SLOPED MEMBRANE ROOF WITH FULLY ADHERED EPDM

REPLACE COPPER COUNTER FLASHING

REPAIR COPPER GUTTER

REPLACE BALLASTED MEMBRANE ROOF WITH FULLY ADHERED EPDM

REPLACE METAL ROOF WITH FLAT SEAM COPPER

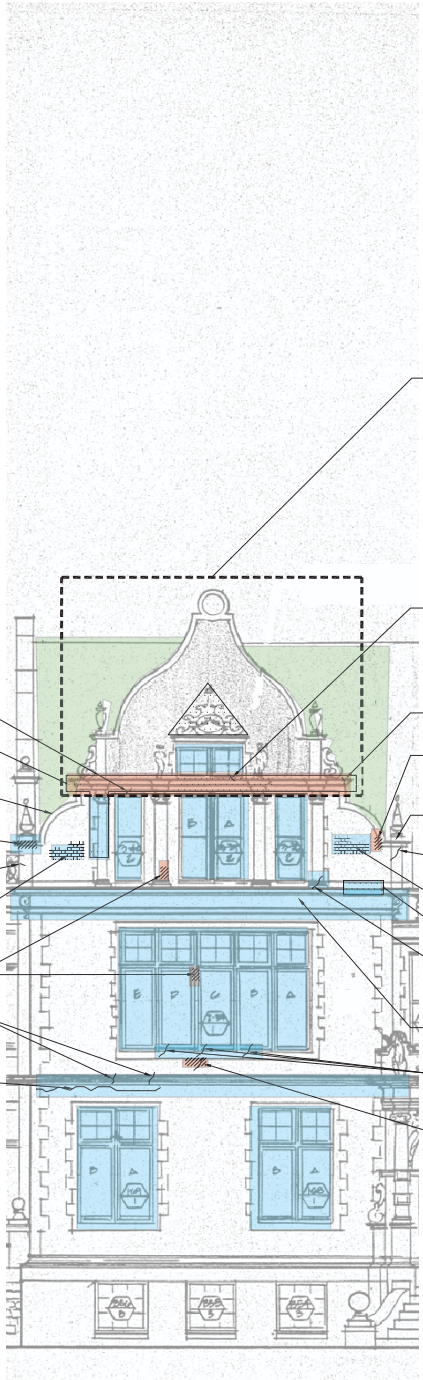
S1

- REPAIR CRACKED LIMESTONE LINTEL
- REPOINT LIMESTONE MORTAR JOINTS
- RESET DISPLACED COPING WITH LEAD TEE CAPS
- REPAIR SPALLED LIMESTONE
- REPAIR CRACKED LIMESTONE
- REPLACE SIX COURSES OF DISPLACED BRICK
- REPAIR SPALLED LIMESTONE
- REPAIR CRACKED LIMESTONE
- LARGE DISPLACED CRACK FILLED WITH COMPOUND

- REPAIR CRACKED LIMESTONE WINDOW SILL
- REPAIR CRACKED LIMESTONE
- REPAIR SPALLED LIMESTONE
- RESET LIFTED CORNER BLOCK
- REPAIR CRACKED LIMESTONE
- REPLACE DISPLACED BRICKS
- REPOINT LIMESTONE MORTAR JOINTS
- REPAIR CRACKED LIMESTONE
- ALL CORNICE JOINTS OPEN, RAKE AND REPOINT
- REPAIR SEALANT FILLED CRACKS
- REPLACE CRACKED BRICKS

- GABLE SCOPE OF WORK:
- DISASSEMBLE GABLE MASONRY TO THIRD FLOOR WINDOWS.
 - REPLACE EXFOLIATED STEEL LINTEL
 - RECONSTRUCT GABLE

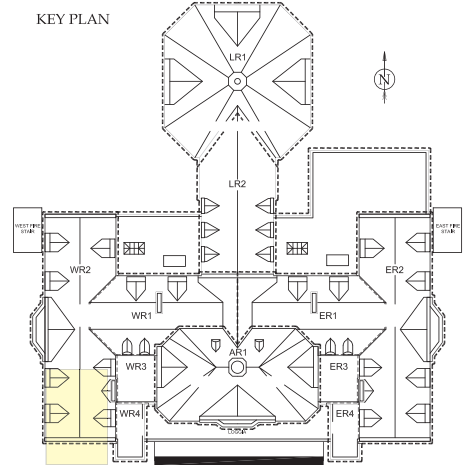
S2

REPAIR SPALLED LIMESTONE

ALL CORNICE JOINTS OPEN, RAKE AND REPOINT

REPLACE COPPER FLASHING ON SOUTH FACE OF CHIMNEY

REPOINT LIMESTONE MORTAR JOINTS

REPLACE 5 CAST STONE BALUSTERS WITH LIMESTONE

REPOINT BRICK CHIMNEY (ALL FOUR SIDES)

NEW COPPER DOWNSPOUT WITH FLANK COLLECTOR BOX

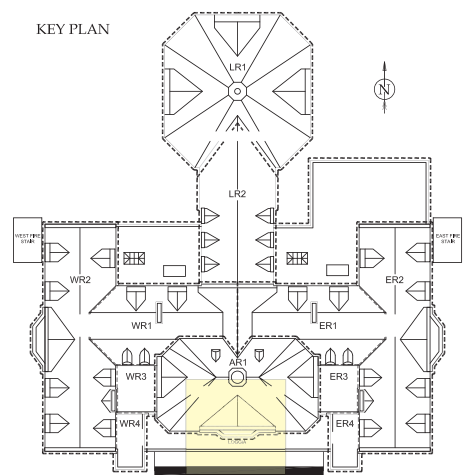
S6

- REPAIR SPALLED LIMESTONE
- REPOINT BRICK MORTAR JOINTS
- REPAIR CRACKED LIMESTONE
- REPOINT LIMESTONE MORTAR JOINTS

- ALL CORNICE JOINTS OPEN. RAKE AND REPOINT
- REPAIR SPALLED LIMESTONE
- RESET COLUMN CAPITAL
- REPAIR CRACK IN COLUMN

- GABLE SCOPE OF WORK:
 - DISASSEMBLE GABLE MASONRY TO ASSESS STRUCTURAL FAILURE
 - REPAIR STRUCTURAL STEEL
 - RECONSTRUCT GABLE
- LARGE CRACK PIN AND MORTAR STONE TOGETHER
- ALL CORNICE JOINTS OPEN. RAKE AND REPOINT
- REPOINT LIMESTONE MORTAR JOINTS
- REPAIR SPALLED LIMESTONE

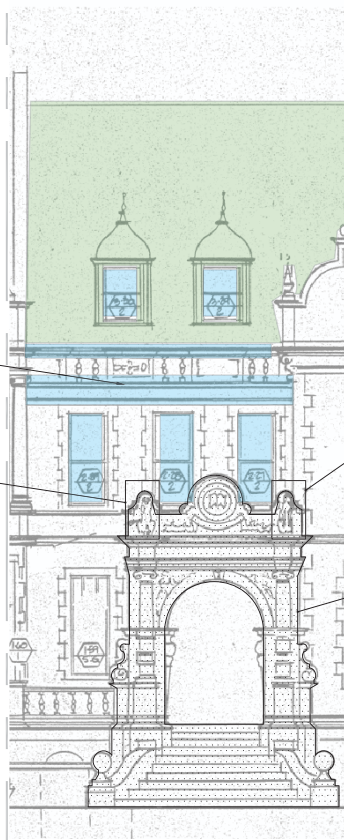
S7

ALL CORNICE JOINTS
OPEN, RAKE AND
REPOINT

RESET DISPLACED
ORNAMENTAL
FIGURE

REPOINT
LIMESTONE
MORTAR JOINTS

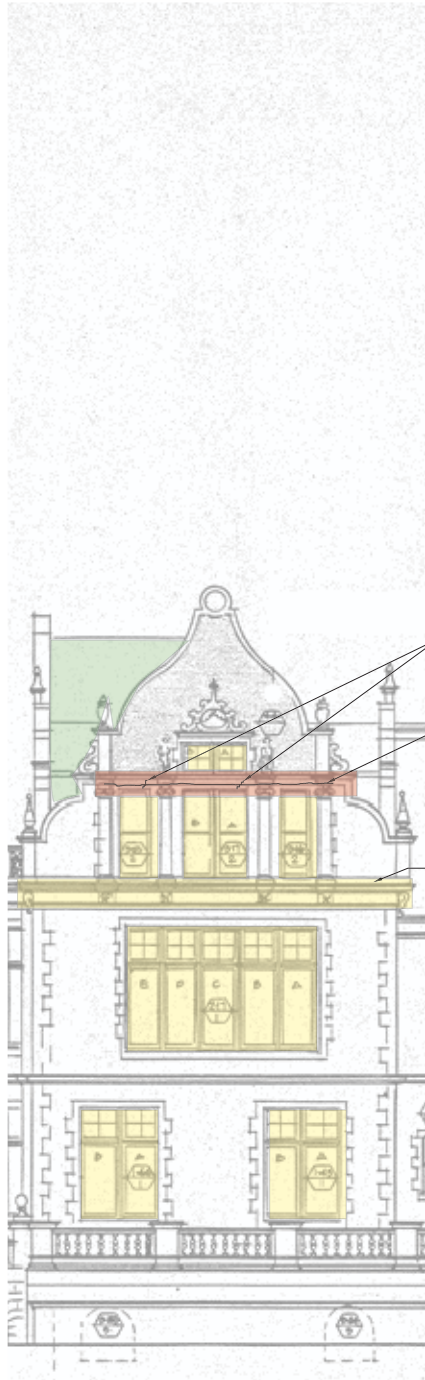
N1

REPAIR CRACKS THROUGH LINTELS

REPOINT LINEAR LINEAR CRACKED JOINT

ALL CORNICE JOINTS OPEN, RAKE AND REPOINT
