CPC PROJECT APPLICATION FORM – FY24

Fairhaven Public School District: Fairhaven High School - Phase I Work Scope for Southeast Gable Repairs

Project Name: Restoration of Roof Surfaces & Related Roof Elements adjacent to Southeast Gable Work

MASTER PLAN: 2021 WORK SCOPE UPDATE

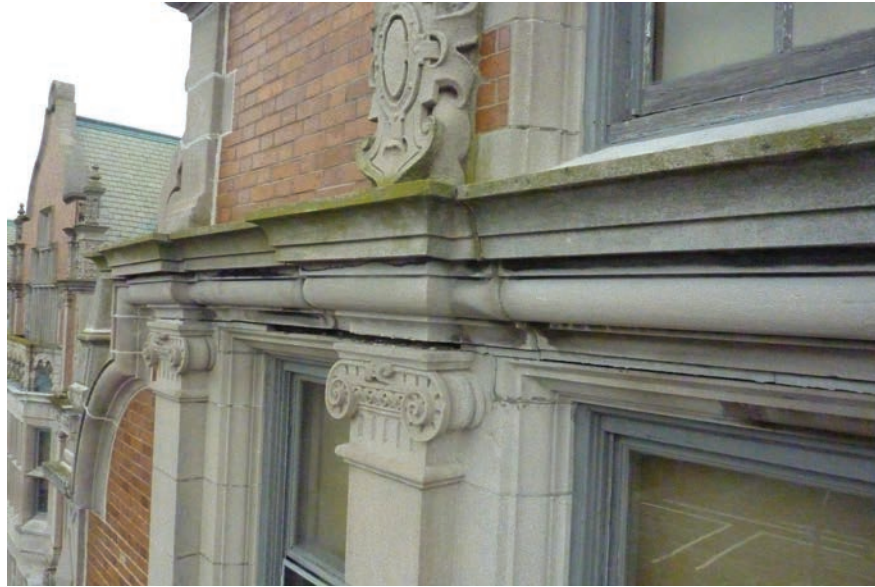
Photograph 1: Existing condition at gable, showing widening cap above pilasters.

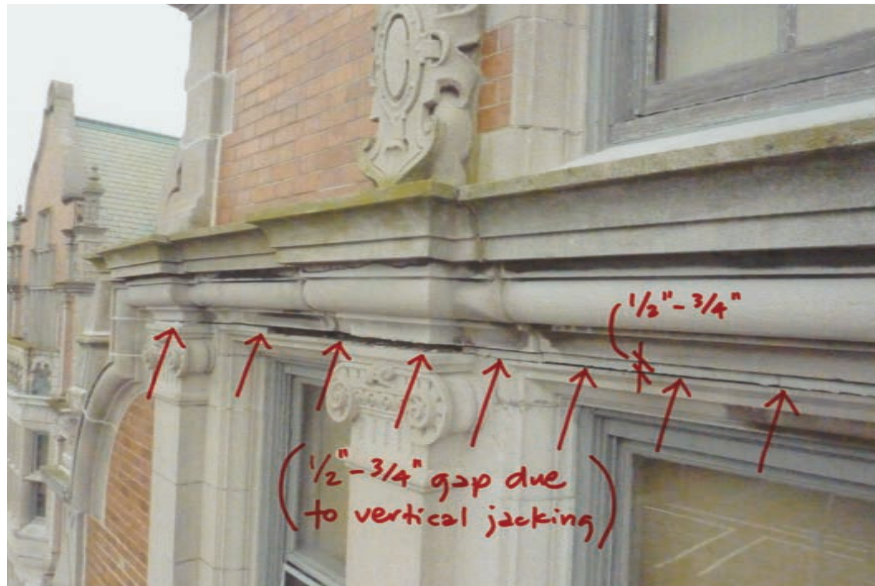
Photograph 2: Same photo as above, indicated location of widening horizontal gap due to vertical jacking of steel (extent indicated by arrows). Gap is approximately 1/2" to 3/4" wide.

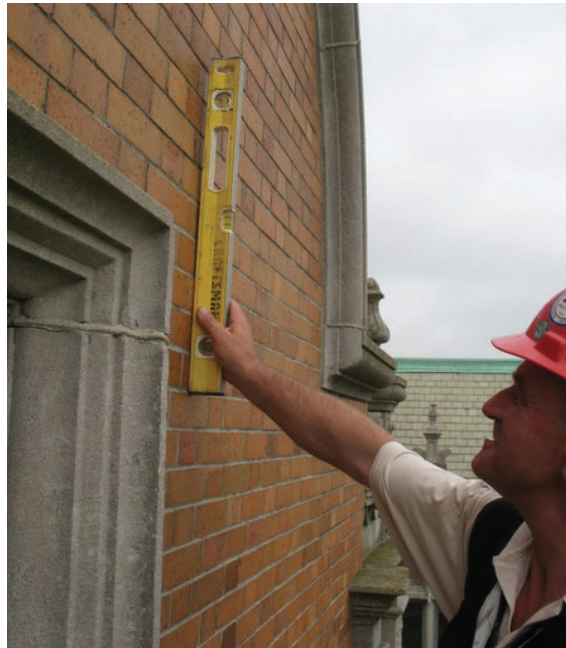
Photograph 3: Existing condition showing inward-leaning masonry.

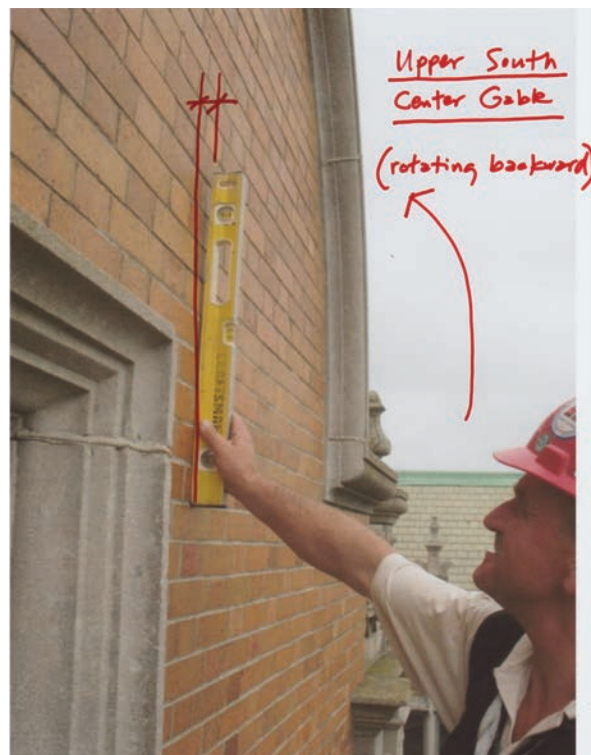
Photograph 4: Same photos as above, showing inward-leaning masonry wall. *Note angle of level positioned against masonry wall.*

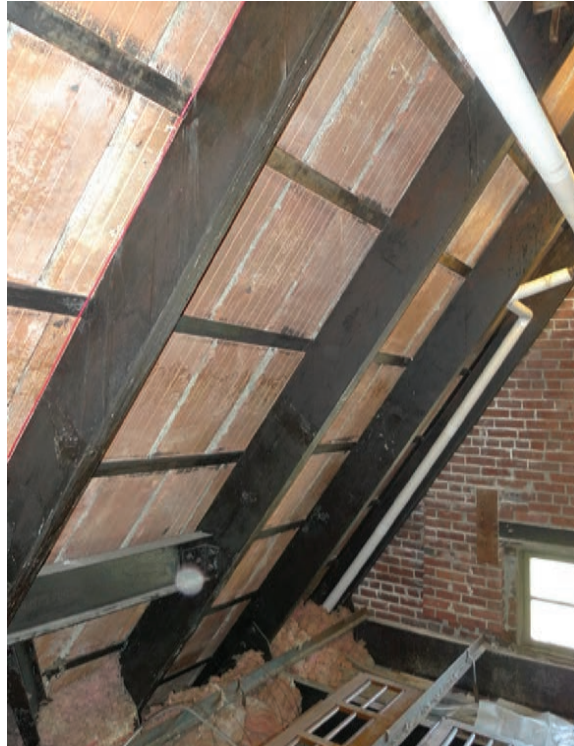
Photograph 5: Existing steel framing at gable windows.

4. Remove rust from iron and steel to remain, by sandblasting exposed surfaces to bare metal.
5. Apply zinc-rich primer immediately to exposed existing iron and steel.

6. Replace severely damaged steel with new hot-dip galvanized sections.
7. Follow with two coats of marine epoxy paint system on steel to remain.
8. Install new rain-screen and cavity wall system to allow water to drain from base of rebuilt wall.

11. Pin broken stone elements; provide new brick masonry where necessary.
12. Provide weep holes at edge of relieving angles to drain rain-screen cavity.

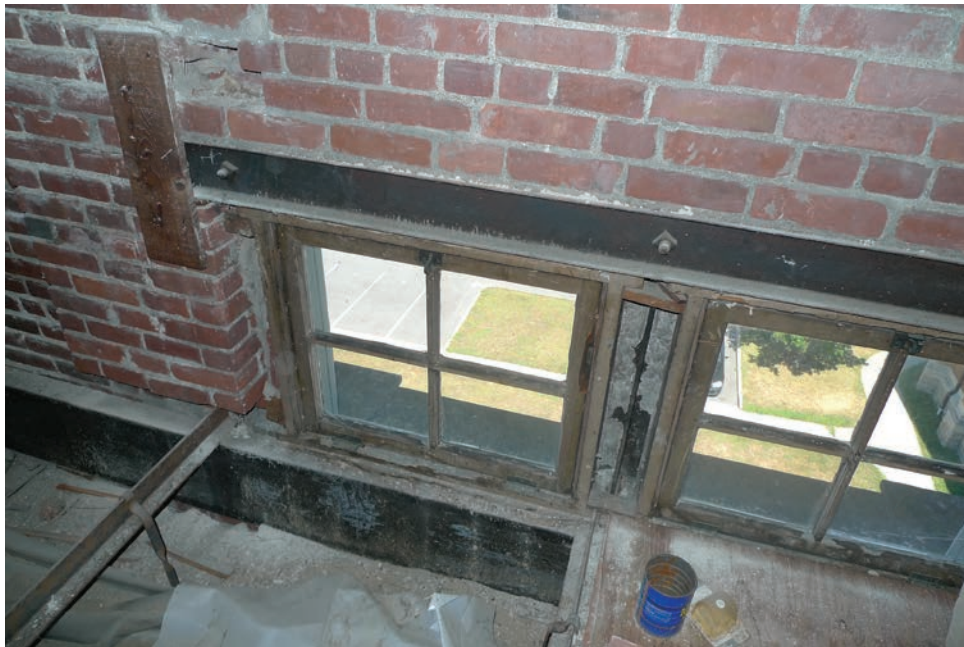
Photograph 6: Closeup of existing steel at gable windows.
