**Water System Capital Efficiency Plan™  
Fairhaven, Massachusetts**

June 2011

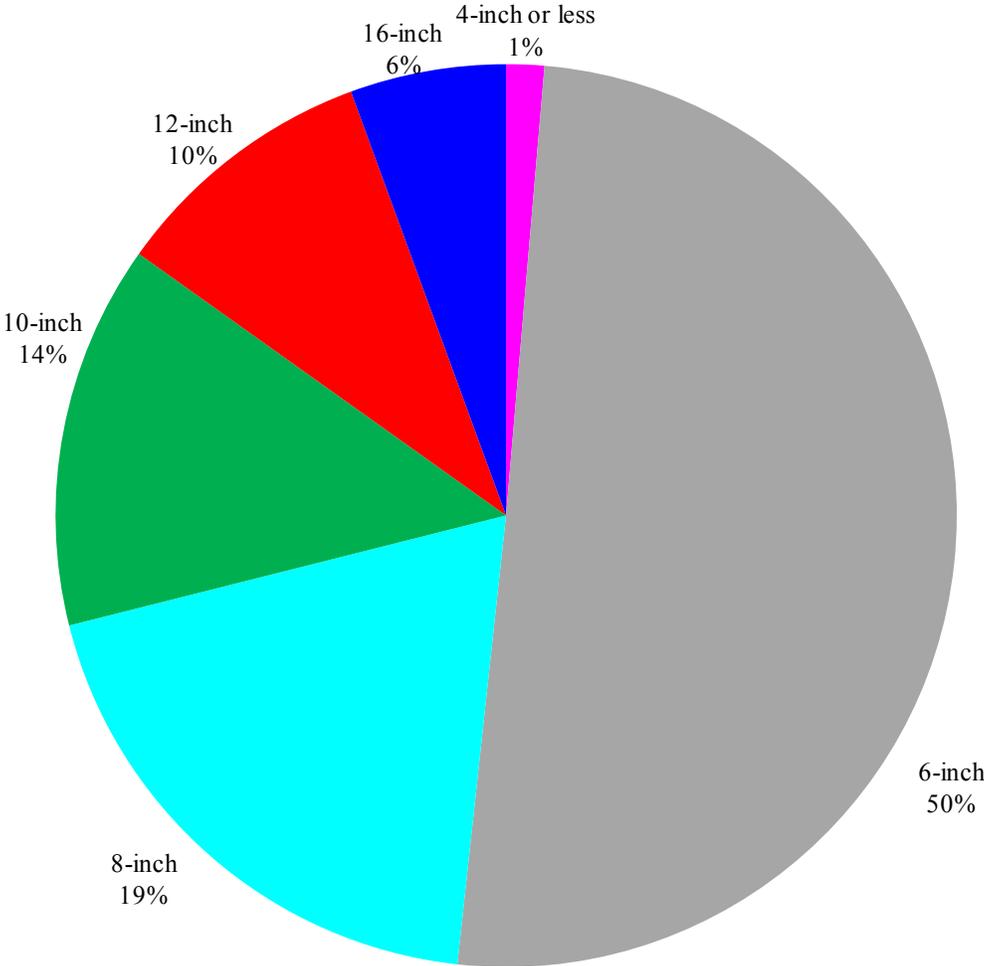
**Figure No. 2-1**  
**Water Main Diameter Distribution**

The Town of Fairhaven's distribution system consists of approximately 100 miles of water mains ranging in size from two to sixteen inches in diameter. Figure No. 2-1 shows a breakdown of the water main size distribution of the existing water system. Approximately 50 percent of the water main is 6-inch diameter pipe. These mains are constructed of various materials including cement lined ductile iron (DI), cast iron (CI), polyvinyl chloride (PVC) and asbestos cement (AC) as shown in Figure No. 2-2. It is noteworthy, that the majority of the system is AC (39 percent) and unlined cast iron (22 percent). A Water Distribution System Map is included in Appendix A.

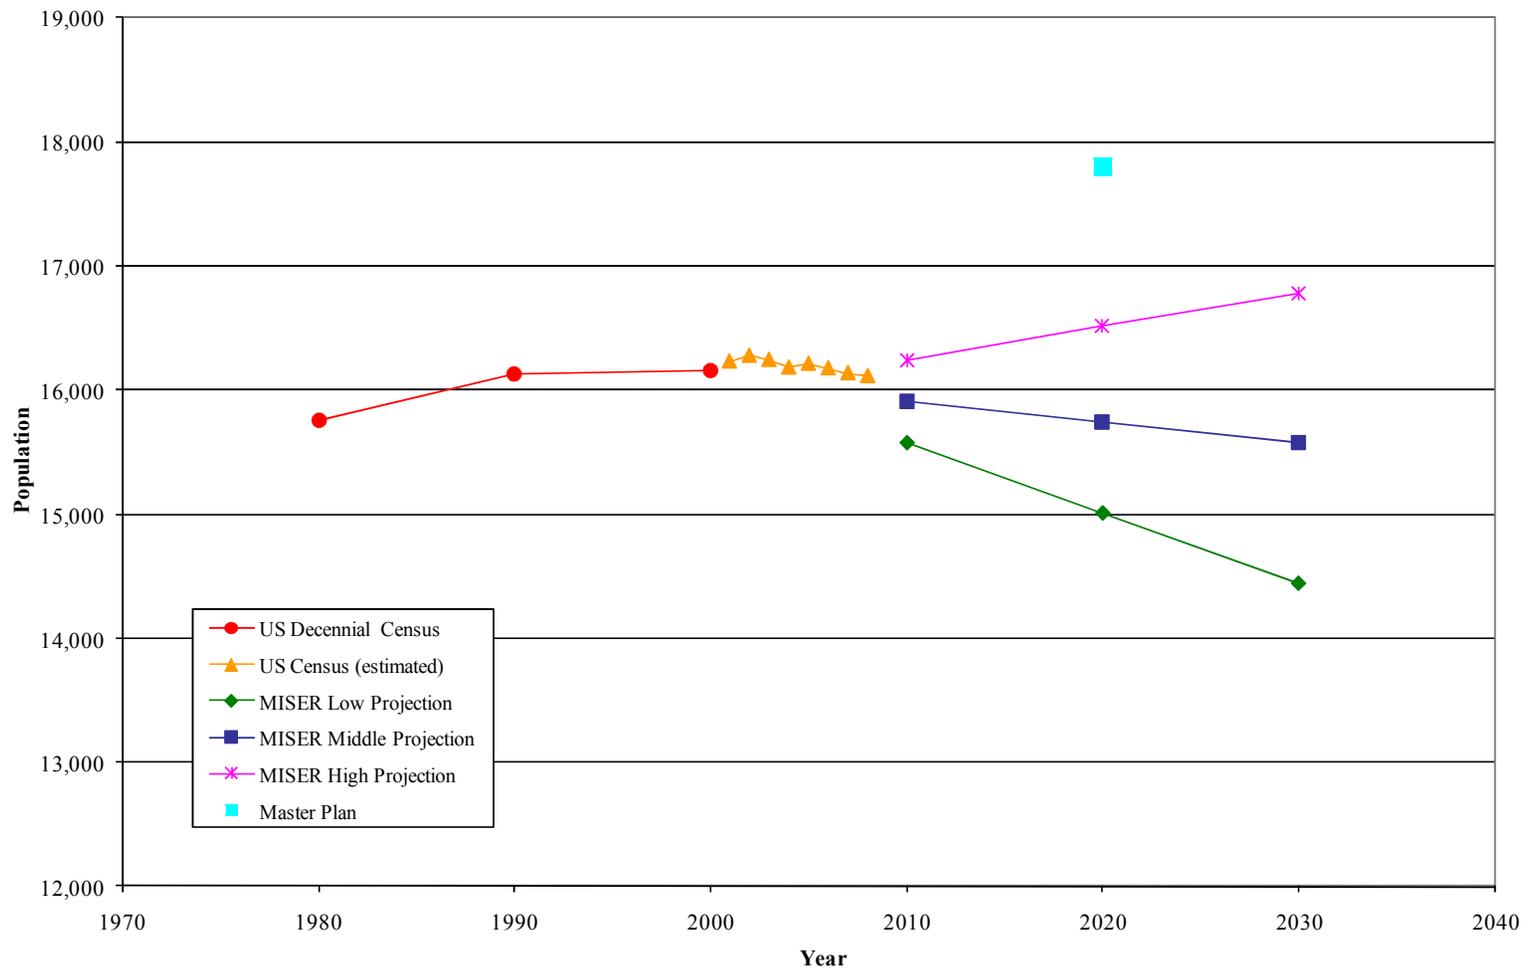
**Figure 3-1**  
**Historic and Projected Populations**

Demand projections through 2020 were completed by Tata & Howard in the 2002 Water System Capital Improvements Plan. The demand projections, in this report, were based on a 2020 projected population of 17,803 as presented in the Town's Master Plan. The 2002 population projections did not anticipate the recent economic downturn, and prior to the recession the Town's growth rate did not increase as originally projected. Based on the US Census estimated populations, the Town's population has remained steady between 2000 and 2008. Figure No. 3-1 depicts the historic population and the 2020 population projected in the Town's Master Plan. Population projections for the Town of Fairhaven were obtained from the Massachusetts Institute for Social and Economic Research (MISER). MISER's high, middle and low projections are through 2020; therefore, the populations were interpolated through 2030 as shown in Figure No. 3-1. The MISER middle and low projection data result in the population decreasing over time, while the MISER high projection is increasing but at a lower rate than the Master Plan projections. Based on the information provided, the MISER high projection is more consistent with current population trends, and was therefore used in this study. The estimated 2030 population based on the MISER high projection is approximately 16,800 which was used to estimate future demand projections.
