UNITARIAN MEMORIAL CHURCH CONDITIONS ASSESSMENT

Unitarian Memorial Church | Fairhaven, Mass. | February 13, 2019

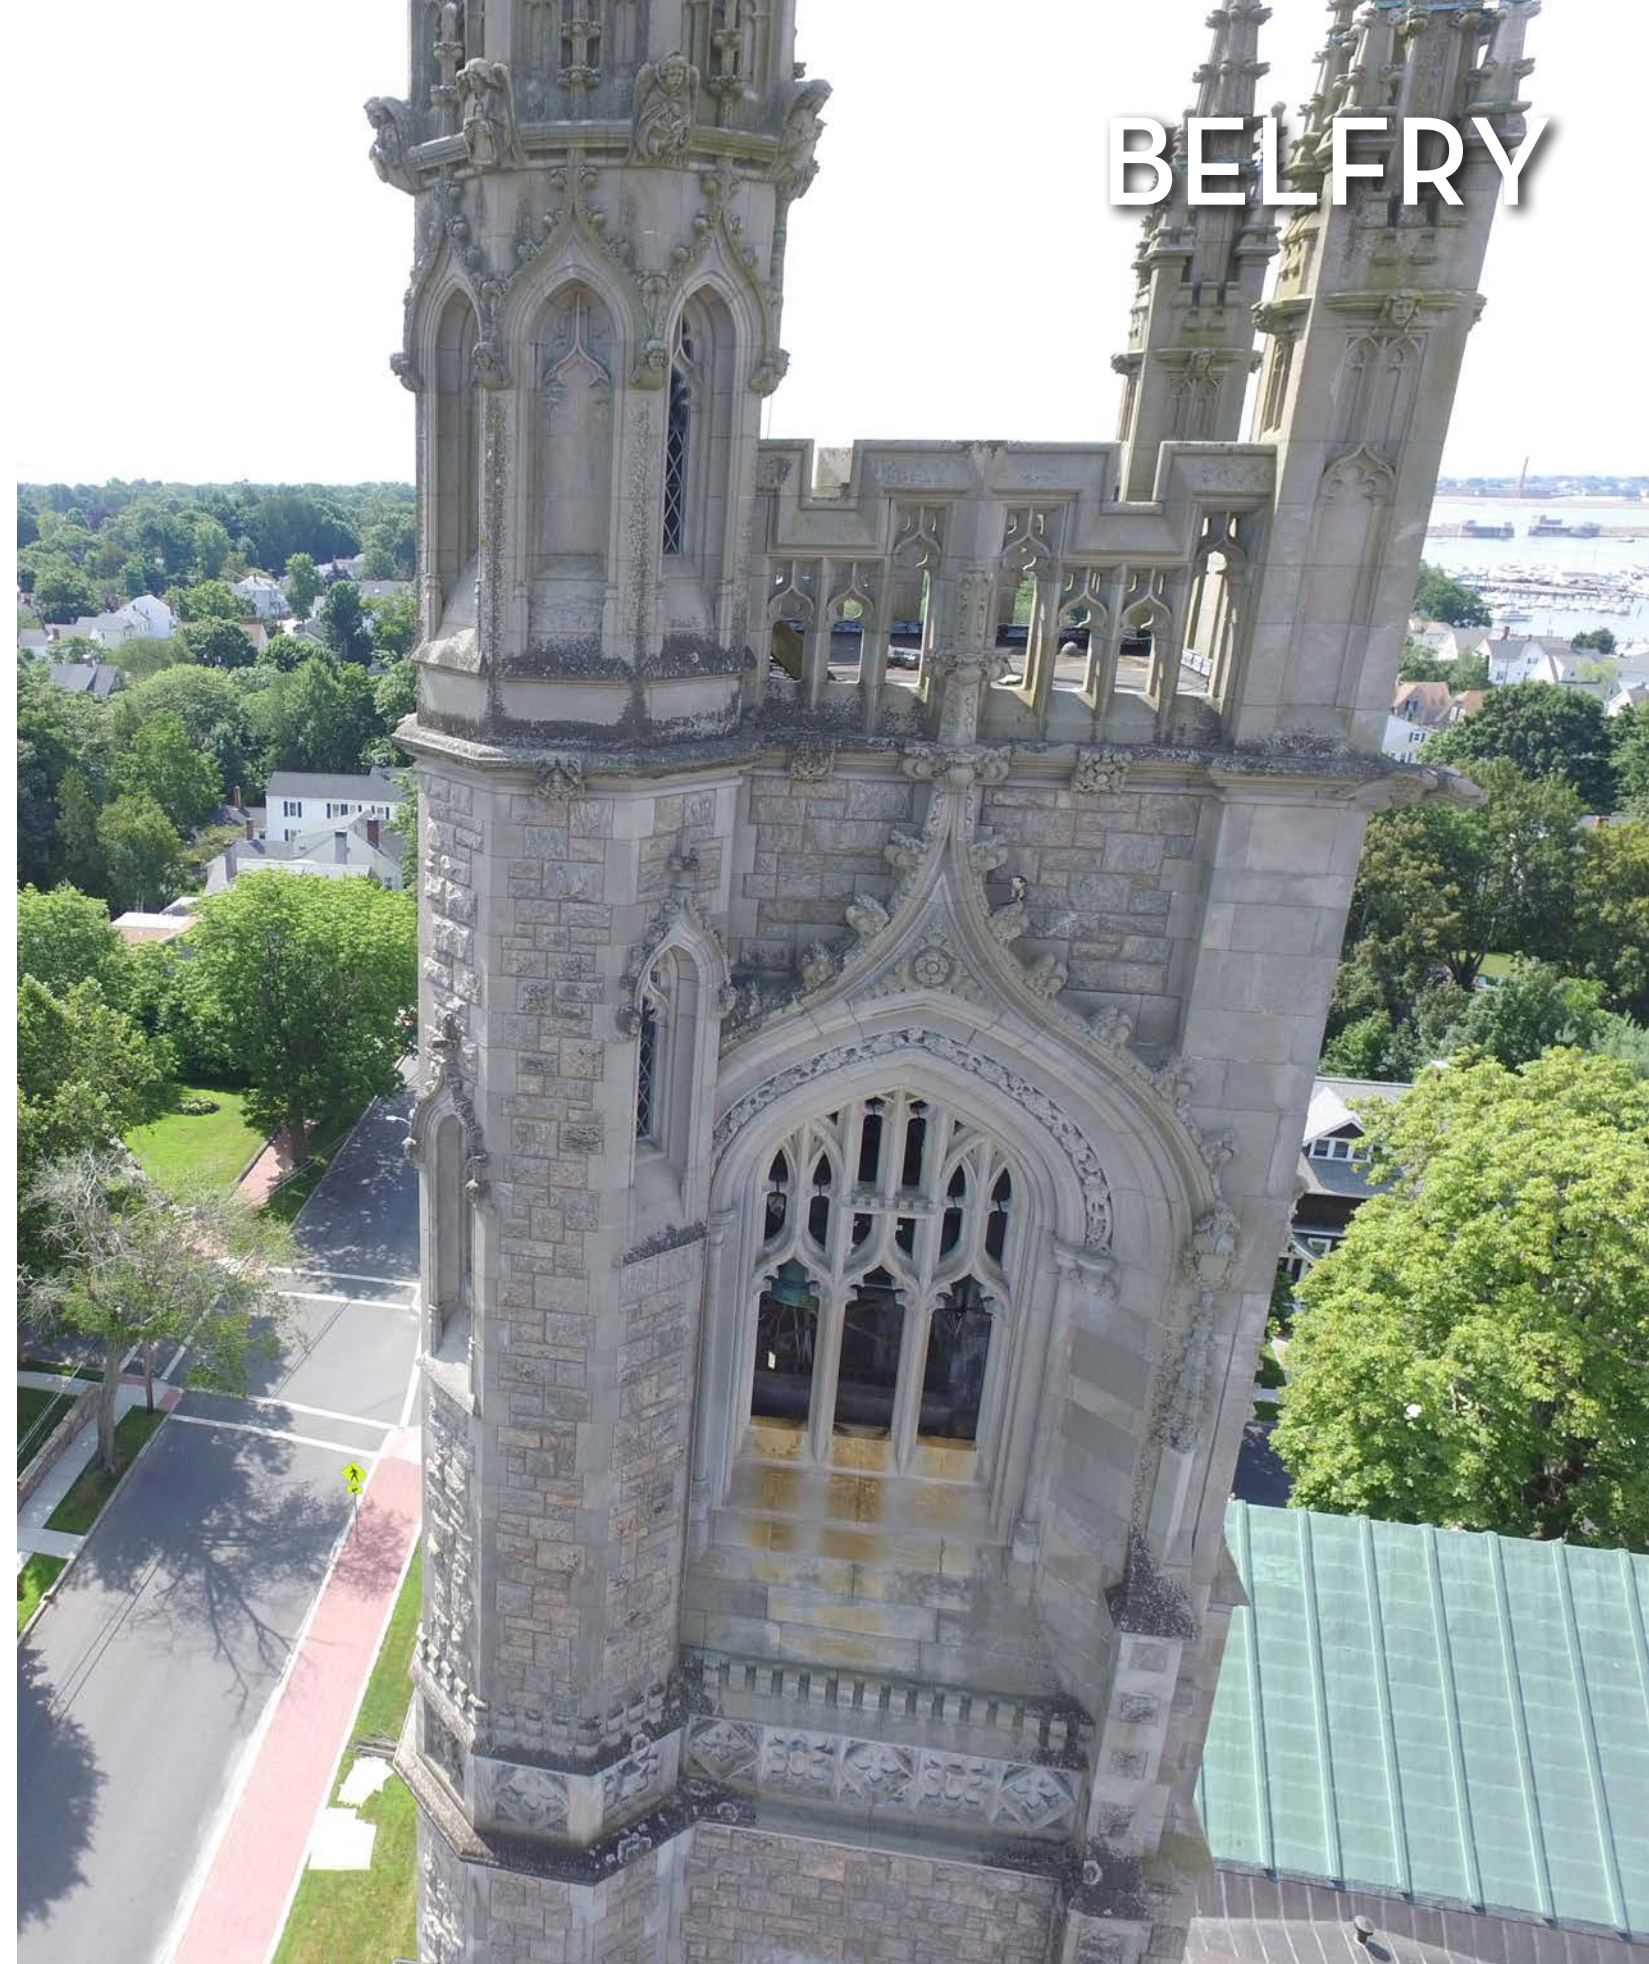
NORTH ELEVATION - primary

BELFRY

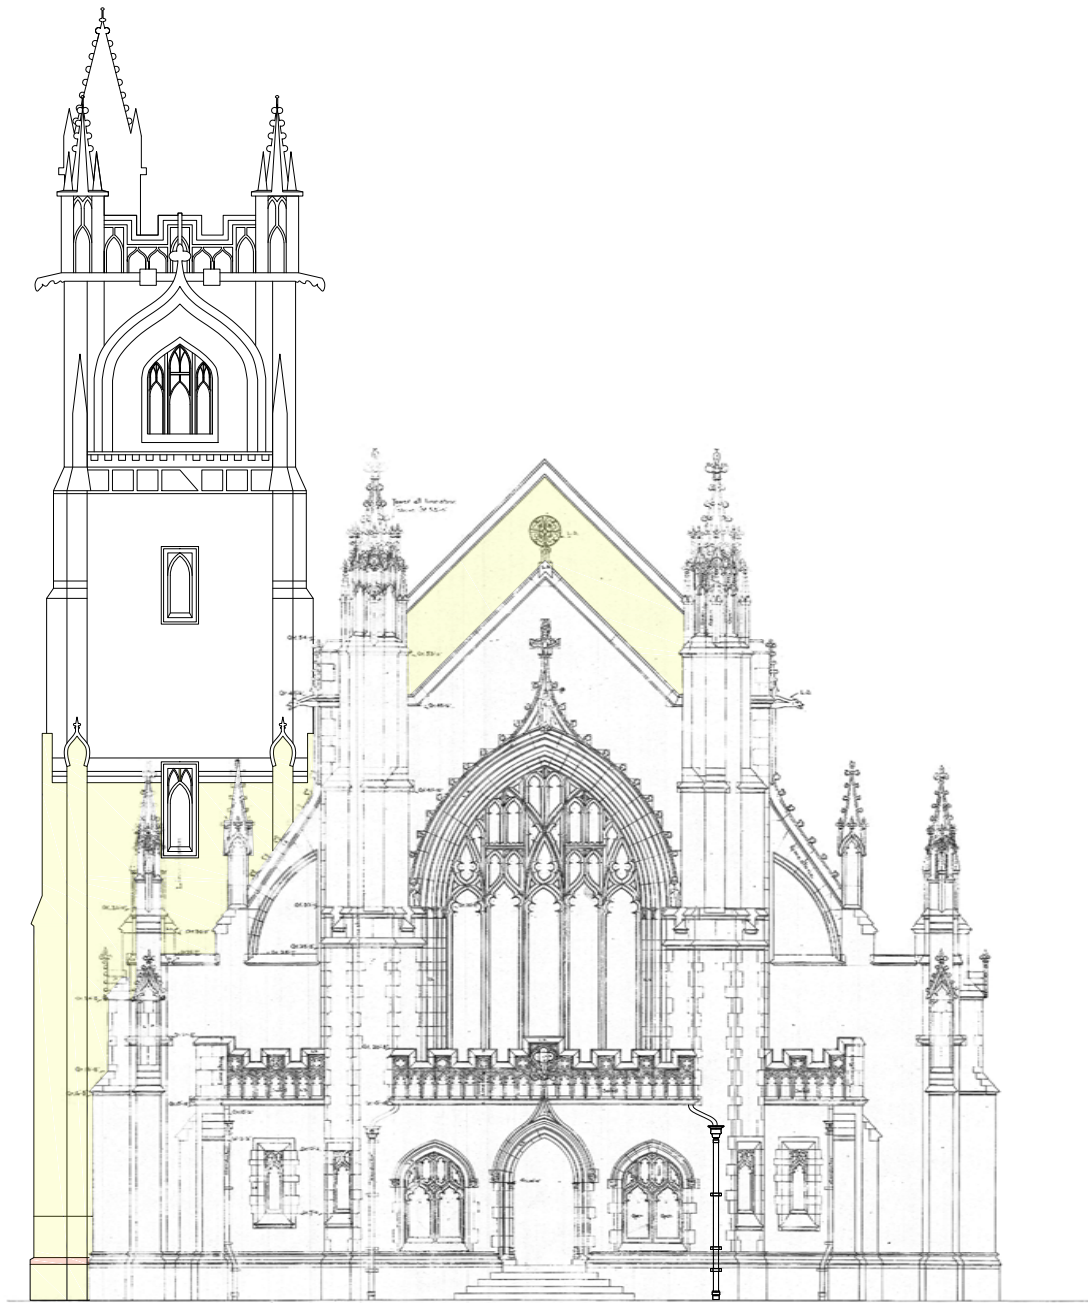
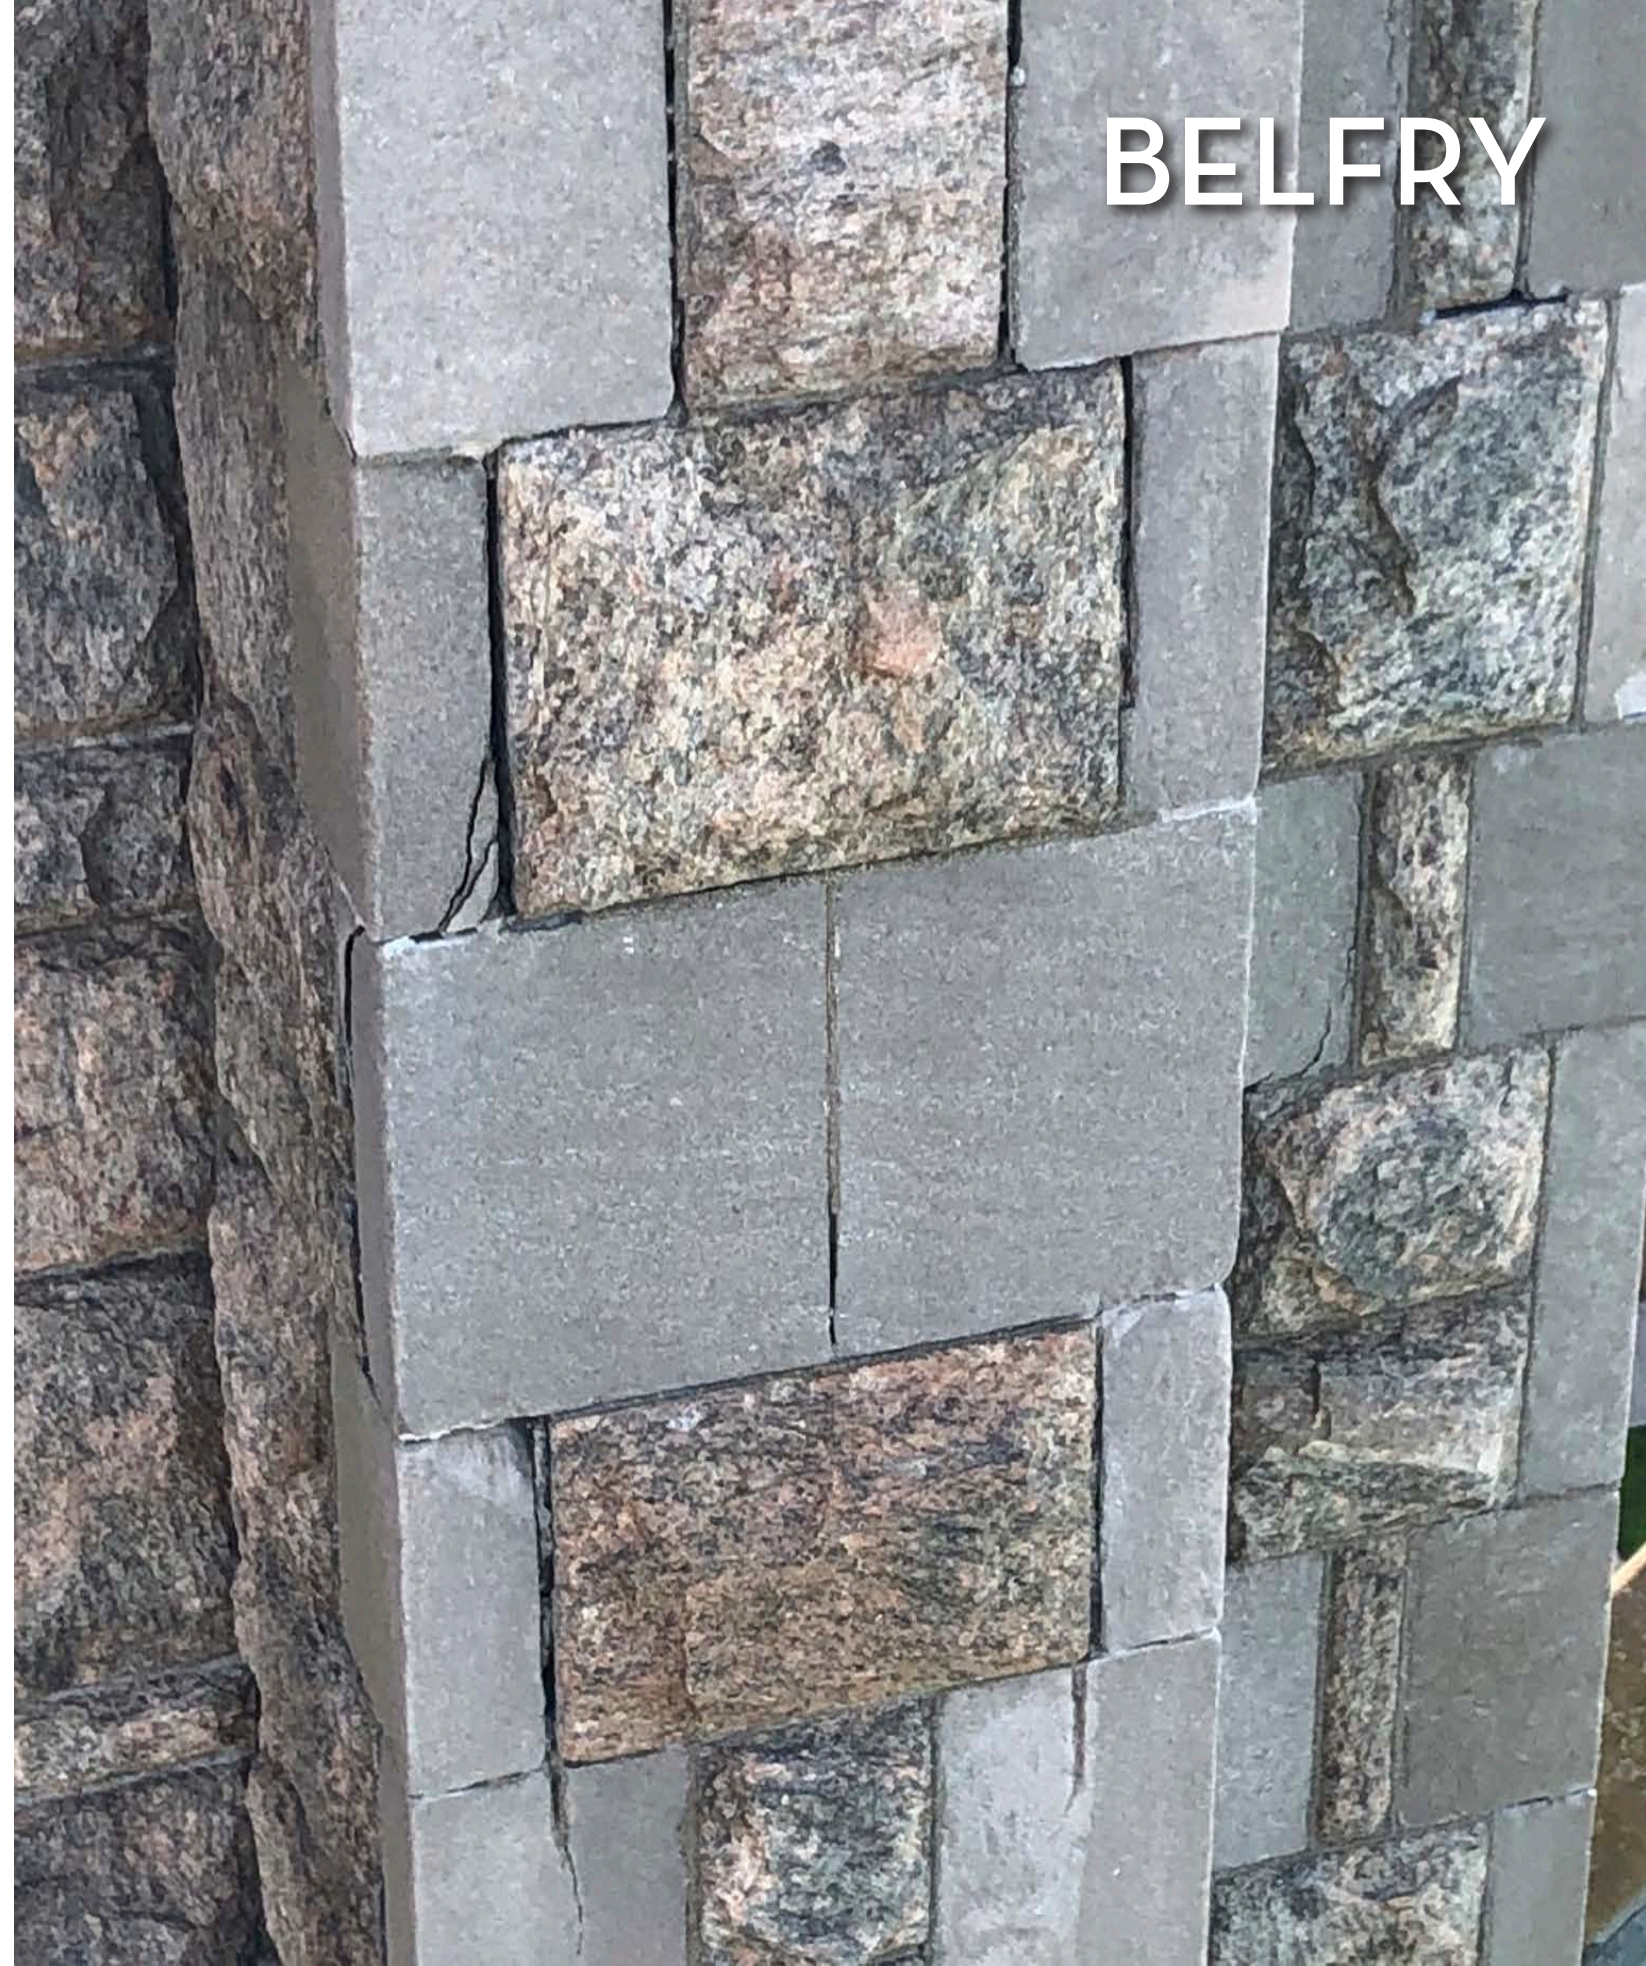
WEST ELEVATION - secondary

BELFRY
