FAIRHAVEN HIGH SCHOOL

EXTERIOR MAJOR IMPROVEMENTS 5 YEAR PLAN

NOVEMBER 2016

SPENCER & VOGT GROUP
architecture preservation

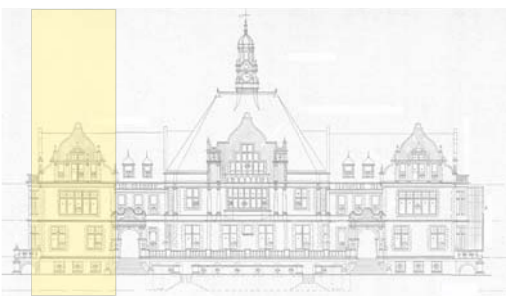
S1

- GABLE SCOPE OF WORK:
- DISASSEMBLE GABLE MASONRY TO THIRD FLOOR WINDOWS.
 - REPLACE EXFOLIATED STEEL LINTEL
 - RECONSTRUCT GABLE

- REPAIR CRACKED LIMESTONE LINTEL
- REPOINT LIMESTONE MORTAR JOINTS
- RESET DISPLACED COPING WITH LEAD TEE CAPS
- REPAIR SPALLED LIMESTONE
- REPAIR CRACKED LIMESTONE
- REPLACE SIX COURSES OF DISPLACED BRICK
- REPAIR SPALLED LIMESTONE
- REPAIR CRACKED LIMESTONE
- LARGE DISPLACED CRACK FILLED WITH COMPOUND

- REPAIR CRACKED LIMESTONE WINDOW SILL
- REPAIR CRACKED LIMESTONE
- REPAIR SPALLED LIMESTONE
- RESET LIFTED CORNER BLOCK
- REPAIR CRACKED LIMESTONE
- REPLACE DISPLACED BRICKS
- REPOINT LIMESTONE MORTAR JOINTS
- REPAIR CRACKED LIMESTONE
- ALL CORNICE JOINTS OPEN, RAKE AND REPOINT
- REPAIR SEALANT FILLED CRACKS
- REPLACE CRACKED BRICKS
